# **Town of Southborough**

## **Self-Evaluation and Transition Plan**

### **June 2021**

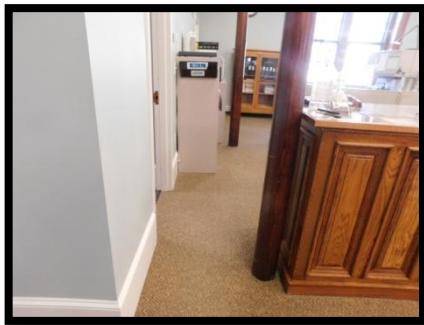
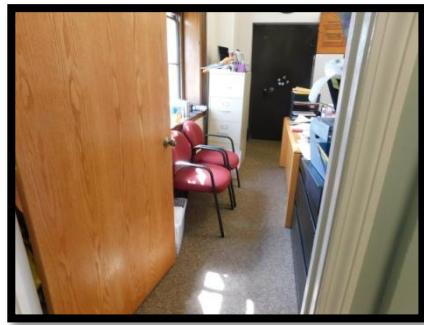
The entrance to the town clerk's area and benefits office/collector's office are restricted to 27" to 28" clear width due to presumed required structural support columns. A number of offices have insufficient clear widths throughout the entirety of the respective office due to partitions, chairs, desks, etc. It may be necessary to rearrange furniture/equipment in the future as a reasonable accommodation to achieve the required 36" minimum clear width. As the structural columns cannot be moved, access to these areas for staff would also have to be addressed as a reasonable accommodation. No further action on these areas is required at the present time. *See photos below.*

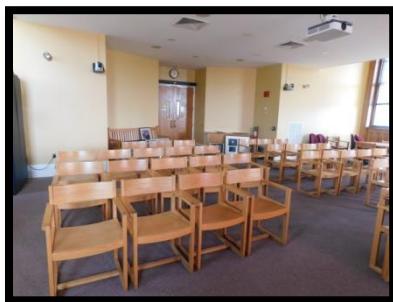
The seating layout at the time of assessment did appear to allow for dispersed wheelchair seating, however, there were no designated wheelchair areas and companion seating. Although there is not regulated fixed seating, it is recommended that wheelchair spaces with companion seating be designated in more than one location and integrated into the seating plan. Wheelchair spaces must be 36" wide and 60" deep. At least one companion seat must be provided next to each wheelchair designated space. Wheelchair spaces must also adjoin an accessible route of travel. (*Citations:* 2010 ADA Standards s.221.2, 802.1-802.4; 521 CMR s.14.2-14.4). *See photo below.*

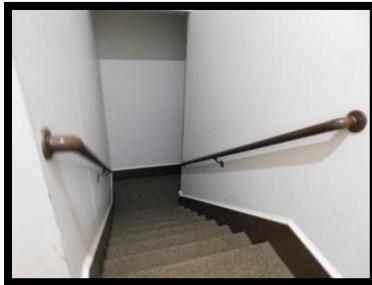
The stairs to the basement are located immediately to the right upon entry into the Level 1 men's bathroom. This is a restricted non-public area. As this is an open staircase with no gate or door, a visually impaired individual using the adjacent wall for cane detection could easily veer to the right into the open staircase and fall down the stairs causing serious injury. It is strongly recommended that this open staircase be secured via a gate, chain, or some other means and tactile and regular signage also be placed on the bathroom entrance noting the location of the stairway and that is for employees only and not for public access. *See photo below.*

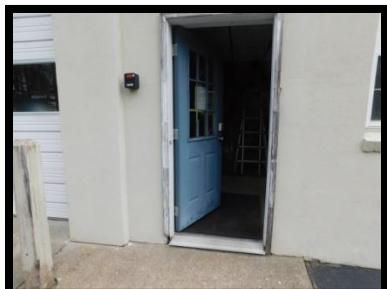
Photo DPW Annex 1

The DPW Annex building does not comply with 521 CMR or ADAAG accessibility requirements. There is no designated accessible parking. The main level entrance door has an exterior 1" abrupt change in level surface at the doorway threshold and lacks a level landing at the entry. The main entrance door has non-compliant knob-style hardware. **See Photos DPW Annex 1, 2, and 3 below.**

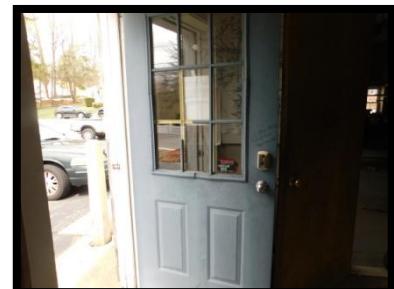
Photo DPW Annex 3

There are abrupt changes in level surface of 1" – 4" throughout the building to access interior offices and spaces. Interior doors have non-compliant knob-style hardware and lack signage. The doorway to the former bathroom has less than required minimum 32" of clear width. Note: Plumbing fixtures have been removed from the bathroom. The kitchen counter is too high and the sink lacks knee clearance. The mezzanine storage has non-compliant open stair risers and non-compliant railings. At least one light switch is too high. **See Photos DPW Annex 3, 4, and 5 below.**

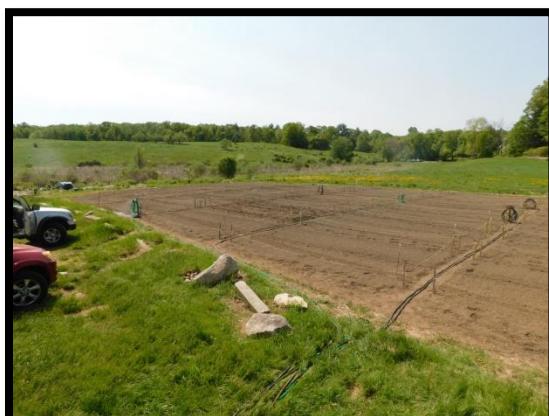
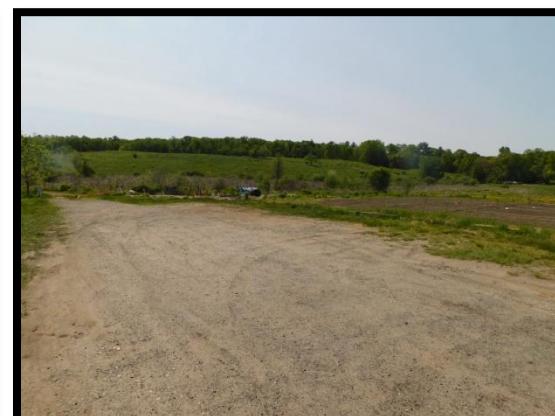
Community Gardens. Parking for the community garden area is an unimproved gravel and dirt surface. No signage or striping is provided. There are no compliant accessible routes of travel to the community gardens or water sources (hoses).

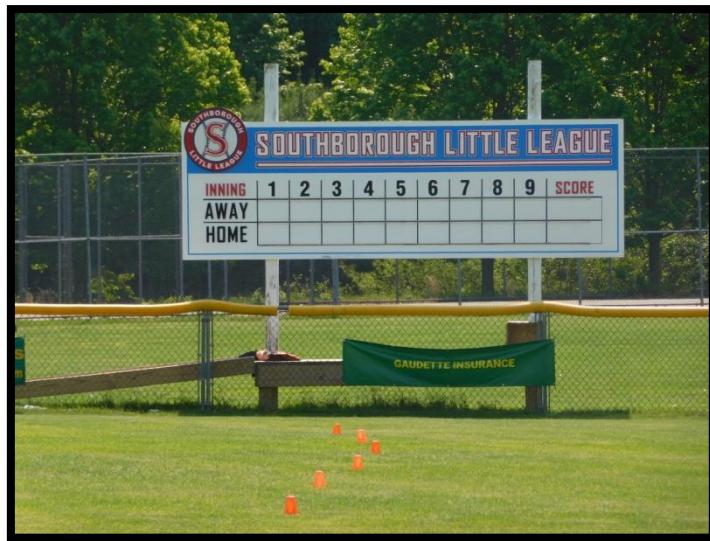
under the 2010 ADA Standards. As lowering the scoreboard would not make it visible for spectators, the modification of the ramp to comply with 521 CMR and the 2010 ADA Standards would be counterproductive and not cost effective. In fact the cost to construct a ramp with railings to access the scoreboard would far outweigh any benefit gained. It is recommended that a variance be sought to maintain the scoreboard ramp and the actual scoreboard as it currently exists. **See Photo Below.**

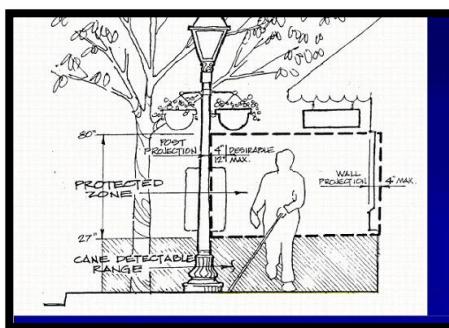
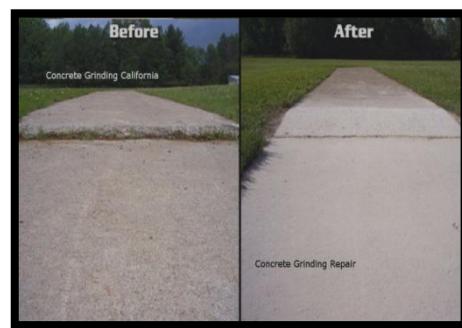
- All sidewalks/accessible routes of travel must be maintained and kept in a good quality condition including being kept free of snow and ice or other debris which would restrict access.
