Town of Southborough

Self-Evaluation and Transition Plan

June 2021

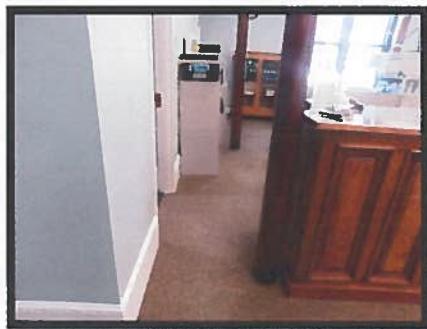
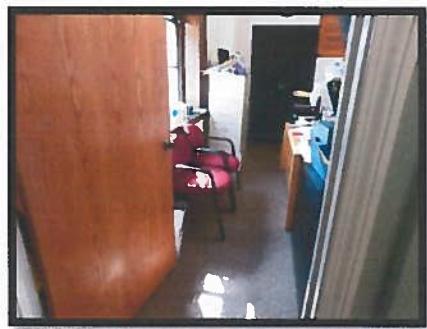
Reasonable Accommodations

The entrance to the town clerk's area and benefits office/collector's office are restricted to 27" to 28" clear width due to presumed required structural support columns. A number of offices have insufficient clear widths throughout the entirety of the respective office due to partitions, chairs, desks, etc. It may be necessary to rearrange furniture/equipment in the future as a reasonable accommodation to achieve the required 36" minimum clear width. As the structural columns cannot be moved, access to these areas for staff would also have to be addressed as a reasonable accommodation. No further action on these areas is required at the present time. *See photos below.*

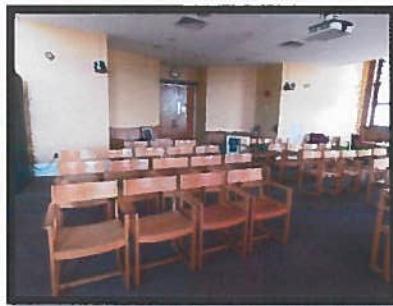
Wheelchair Seating

The seating layout at the time of assessment did appear to allow for dispersed wheelchair seating, however, there were no designated wheelchair areas and companion seating. Although there is not regulated fixed seating, it is recommended that wheelchair spaces with companion seating be designated in more than one location and integrated into the seating plan. Wheelchair spaces must be 36" wide and 60" deep. At least one companion seat must be provided next to each wheelchair designated space. Wheelchair spaces must also adjoin an accessible route of travel. (*Citations: 2010 ADA Standards s.221.2, 802.1-802.4; 521 CMR s.14.2-14.4*). *See photo below.*

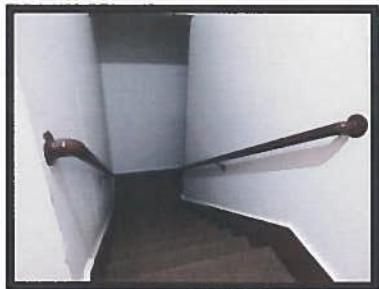
Basement Stairway in Level 1 Men's Bathroom

The stairs to the basement are located immediately to the right upon entry into the Level 1 men's bathroom. This is a restricted non-public area. As this is an open staircase with no gate or door, a visually impaired individual using the adjacent wall for cane detection could easily veer to the right into the open staircase and fall down the stairs causing serious injury. It is strongly recommended that this open staircase be secured via a gate, chain, or some other means and tactile and regular signage also be placed on the bathroom entrance noting the location of the stairway and that is for employees only and not for public access. *See photo below.*

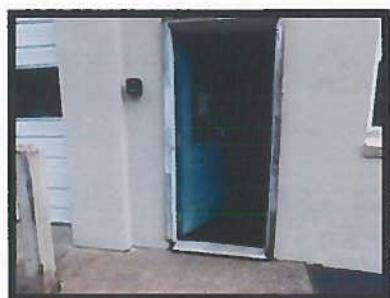
Photo DPW Annex 1

The DPW Annex building does not comply with 521 CMR or ADAAG accessibility requirements. There is no designated accessible parking. The main level entrance door has an exterior 1" abrupt change in level surface at the doorway threshold and lacks a level landing at the entry. The main entrance door has non-compliant knob-style hardware. **See Photos DPW Annex 1, 2, and 3 below.**

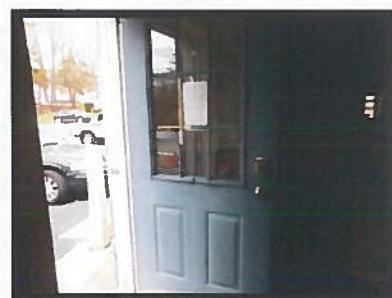
Photo DPW Annex 3

There are abrupt changes in level surface of 1" – 4" throughout the building to access interior offices and spaces. Interior doors have non-compliant knob-style hardware and lack signage. The doorway to the former bathroom has less than required minimum 32" of clear width. Note: Plumbing fixtures have been removed from the bathroom. The kitchen counter is too high and the sink lacks knee clearance. The mezzanine storage has non-compliant open stair risers and non-compliant railings. At least one light switch is too high. **See Photos DPW Annex 3, 4, and 5 below.**

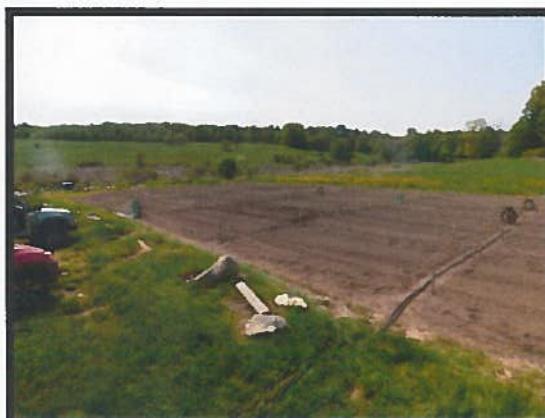
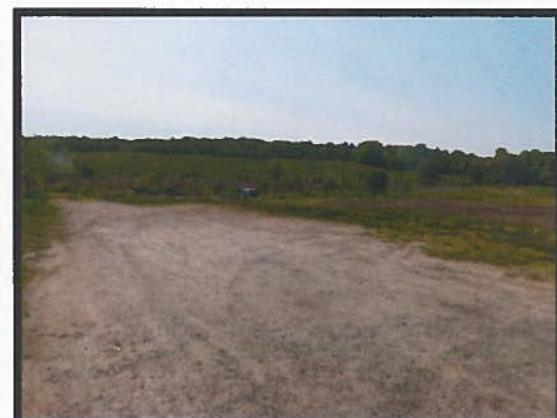
Community Gardens. Parking for the community garden area is an unimproved gravel and dirt surface. No signage or striping is provided. There are no compliant accessible routes of travel to the community gardens or water sources (hoses).

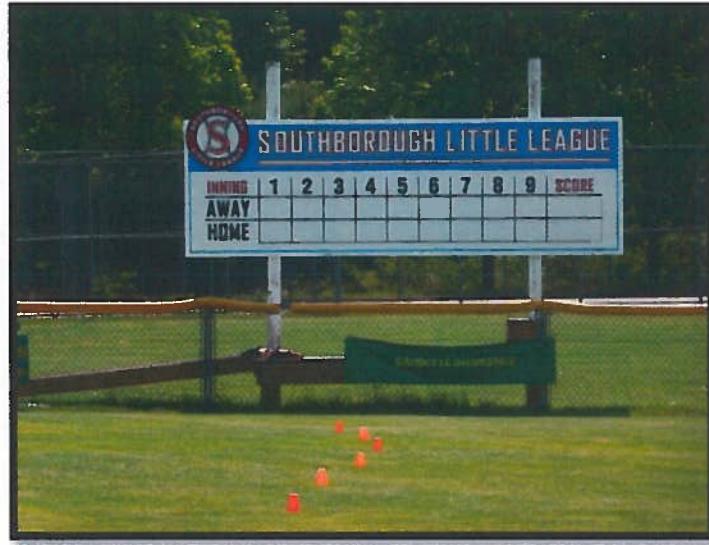
under the 2010 ADA Standards. As lowering the scoreboard would not make it visible for spectators, the modification of the ramp to comply with 521 CMR and the 2010 ADA Standards would be counterproductive and not cost effective. In fact the cost to construct a ramp with railings to access the scoreboard would far outweigh any benefit gained. It is recommended that a variance be sought to maintain the scoreboard ramp and the actual scoreboard as it currently exists. **See Photo Below.**

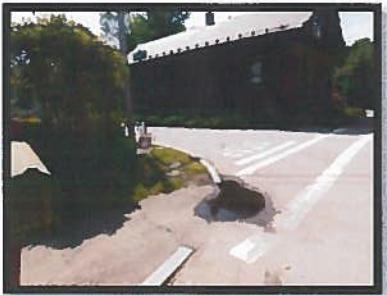
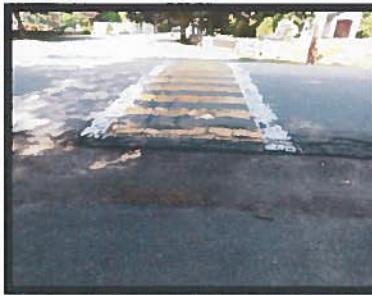
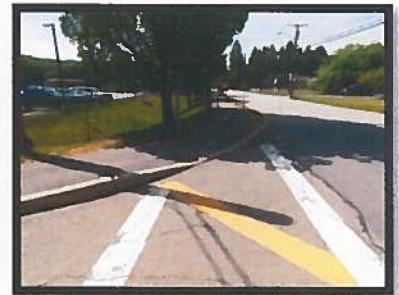
Parkerville Road Sidewalks and Curb Ramps (Southville Road to Finn School)

- Puddling of water at base of curb ramp at #26 Highland Street
- One inch abrupt change in level surface opposite Southwood Drive
- Southwood Drive concrete near Parkerville Road heaving creating $\frac{1}{2}$ " to 1" abrupt changes in level surface
- Abrupt change in level surface of 1" to 4" at Finn School driveway crosswalk near school side

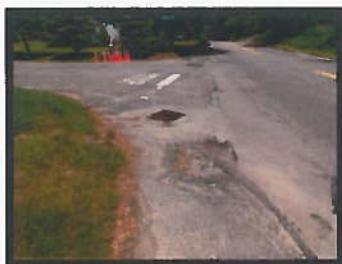
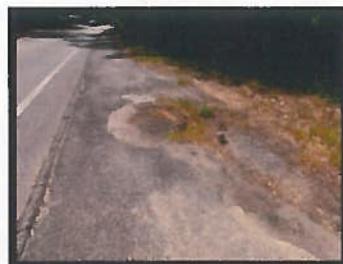
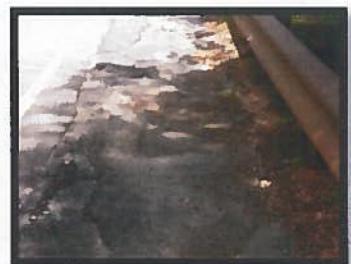
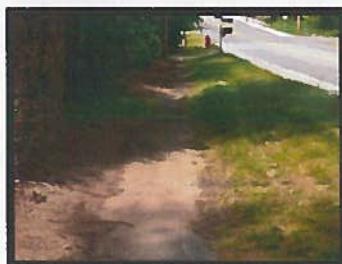
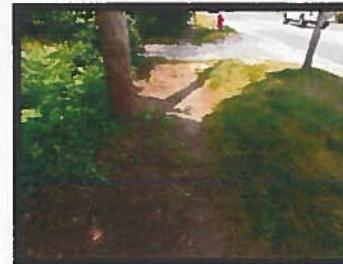
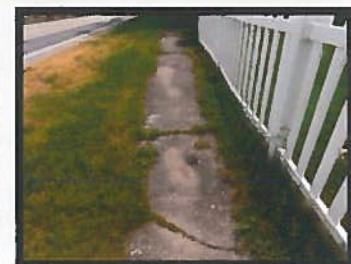
Cordaville Road Sidewalks and Curb Ramps

- Recycling and trash bins blocking sidewalk at #237 Cordaville Road
- Cordaville Raod and Richards Road crosswalk terminates at a guardrail
- Cordaville and Rockpoint Road curb ramp have 1" to 2" abrupt changes in level surface at the base and are severely deteriorated
- Catch basins are located at the base of the curb ramps (2) at Rockpoint Road and Cordaville Road
- Areas of sidewalk deterioration and heaving along southerly segments of Cordaville Road and in the vicinity of Cordaville Hall including restricted clear width
- Reduced width of curb ramp level landing at Rockpoint Road and Cordaville Road

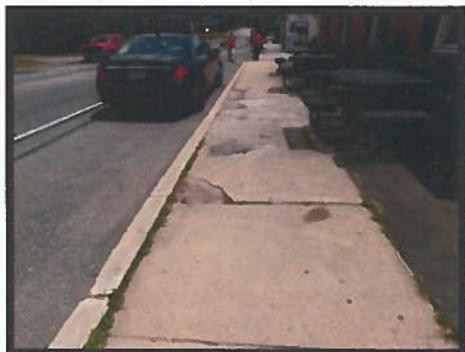
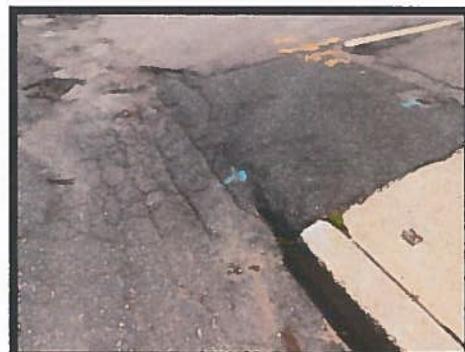
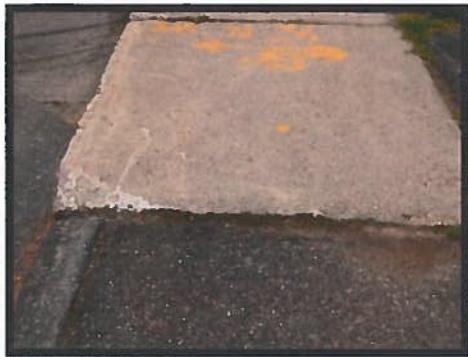
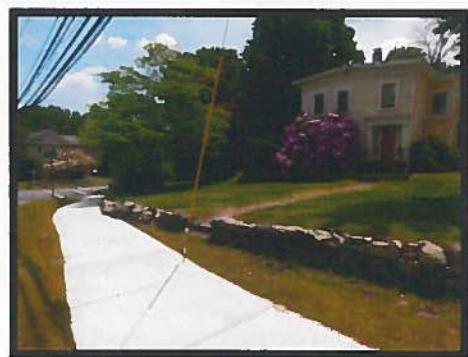
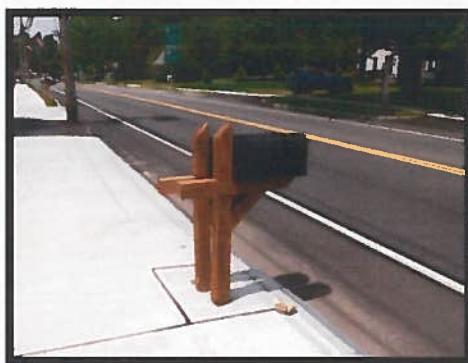
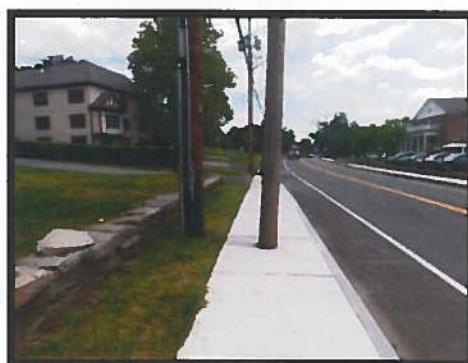
Main Street/Town Center Sidewalks and Curb Ramps

- Park Street and Main Street crosswalks/curb ramps have abrupt changes in level surface of up to 2"
- Concrete sidewalk at Mauro's Village Café has severe deterioration and abrupt changes in level surface
- Cross walk at Mauro's Café to Knights of Columbus lacks a curb ramp and has a 4" abrupt change in level surface
- Sidewalk transition from asphalt to concrete at Hiller's Cleaner's has an abrupt change in level surface of 1+"
- A telephone guy wire for telephone pole #5 creates reduced head room and is a protruding object
- Telephone poles in front of the Brackett House and between the Brackett House and a St. Mark's building reduce the sidewalk clear width to only 20" to 26"
- Mailboxes at #'s 18, 22, and 26 Main Street are protruding objects as they protrude more than 4" at a height of between 27" and 80" a.f.f. into the accessible route of travel

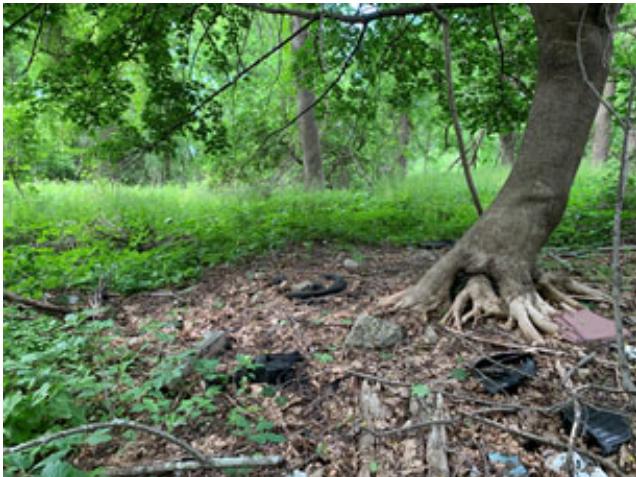
Photo 1: Sparsely vegetated area and debris including brick, concrete, tires, plastic waste, and scrap metal observed at the eastern-central portion of the site; view to the west

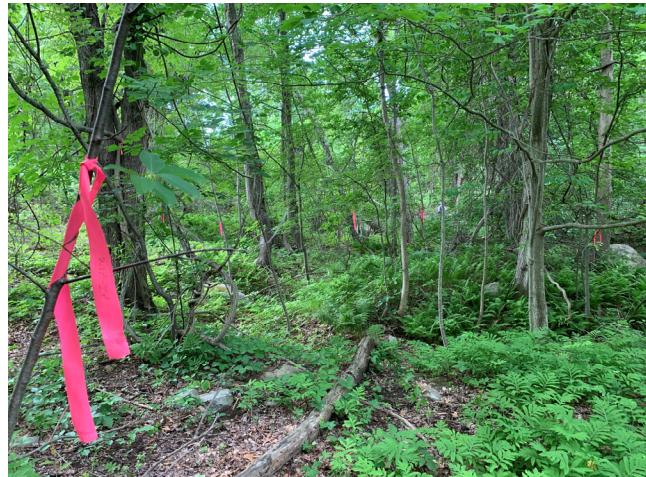
Photo 2: Several wetland delineation flags observed at the northeastern portion of the site; view to the north

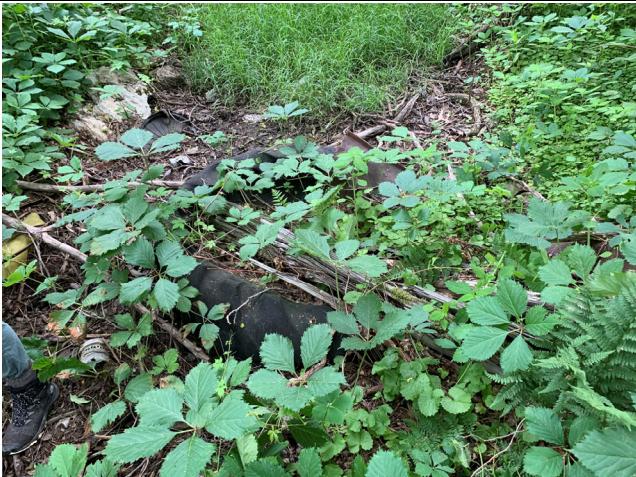
Photo 3: Rubber tire and refuse observed at the northern portion of the site; view to the south

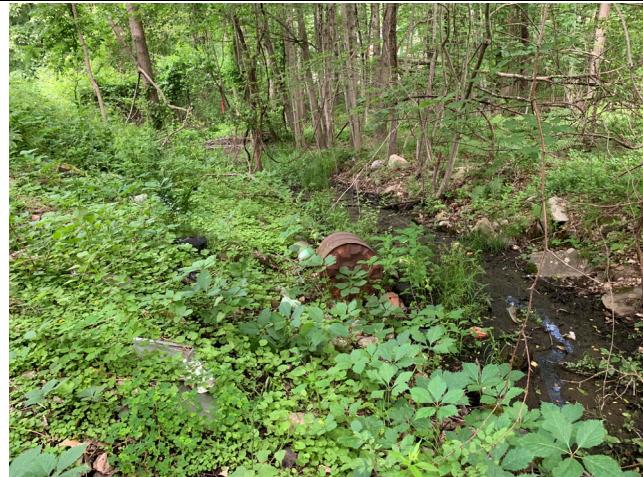
Photo 4: Debris including scrap metal and a 55-gallon drum observed along the wetland area at the northwestern portion of the site; view to the southwest

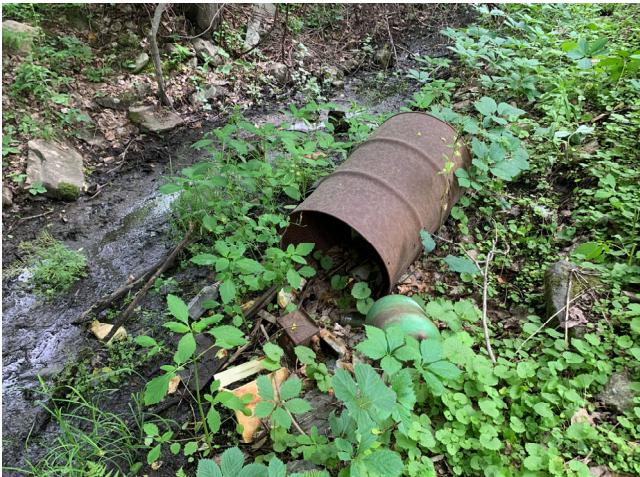
Photo 5: Rusted 55-gallon drum, metal tank, brick, wood debris, and bottles observed along the wetland area at the northwestern portion of the site; view to the north

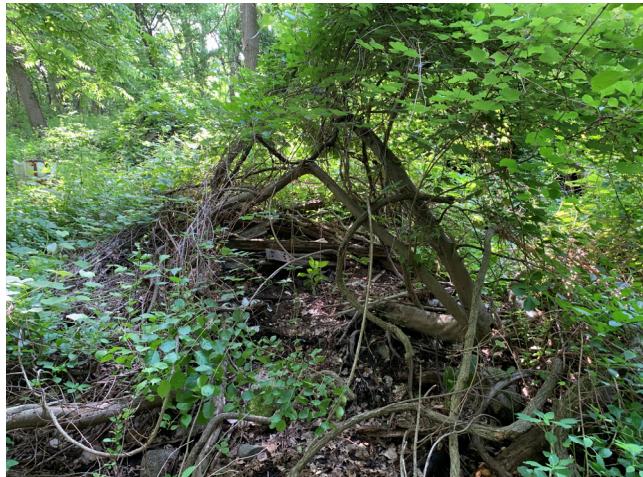
Photo 6: Treated wood observed at the western portion of the site; view to the northeast

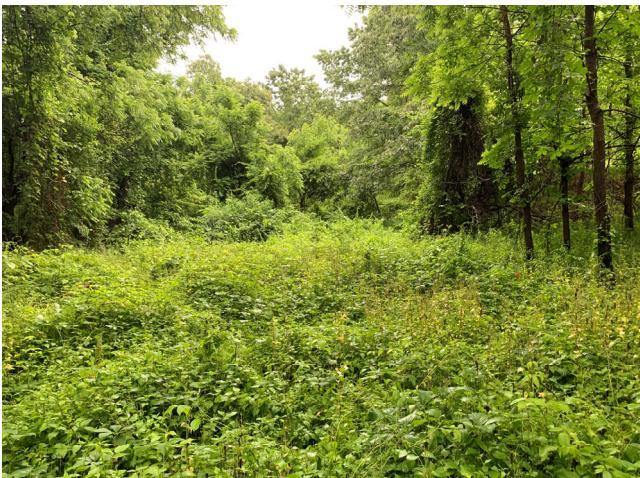
Photo 7: Densely vegetated area housing debris and holes located at the northeastern portion of the site; view to the north

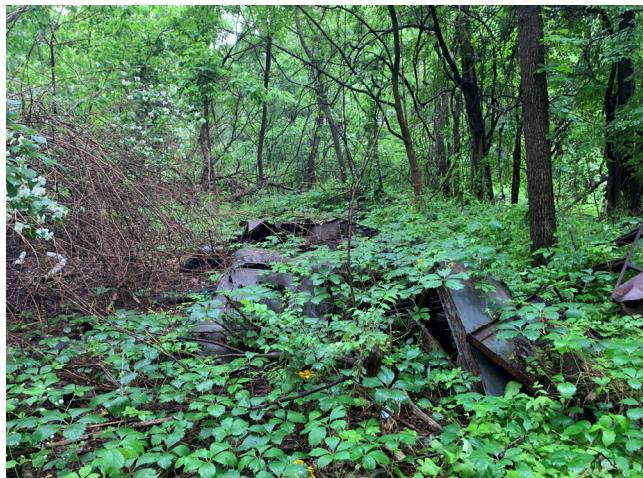
Photo 8: Abandoned car/tractor components and miscellaneous scrap metal observed at the northwestern portion of the site; view to the southwest

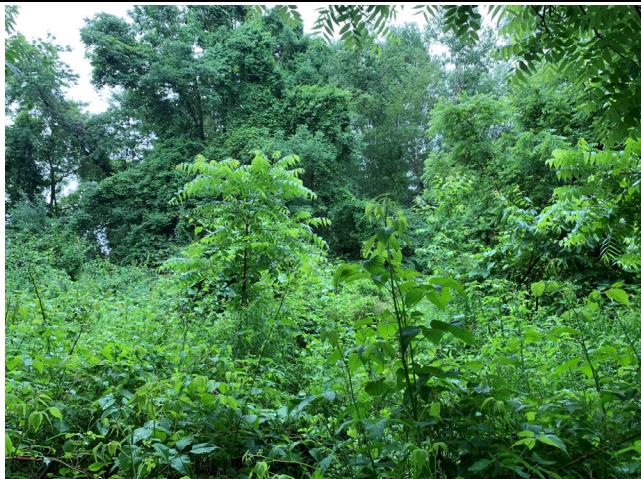
Photo 9: Very densely vegetated area housing miscellaneous trash and debris observed at the southern-central portion of the site; view to the southwest

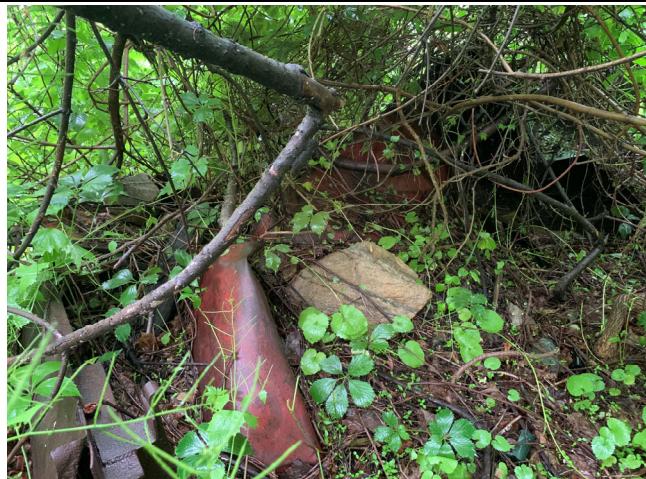
Photo 10: Partially buried metal and debris observed in the densely vegetated area at the southern-central portion of the site; view to the west

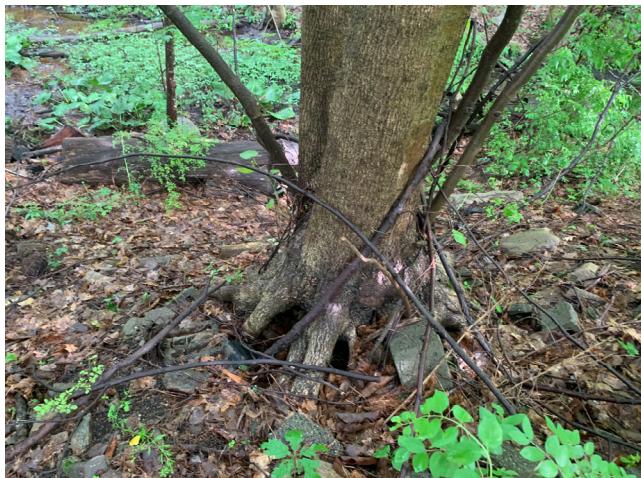
Photo 11: Partially buried cinder block and brick observed along the steep slope at the southwestern portion of the site; view to the west

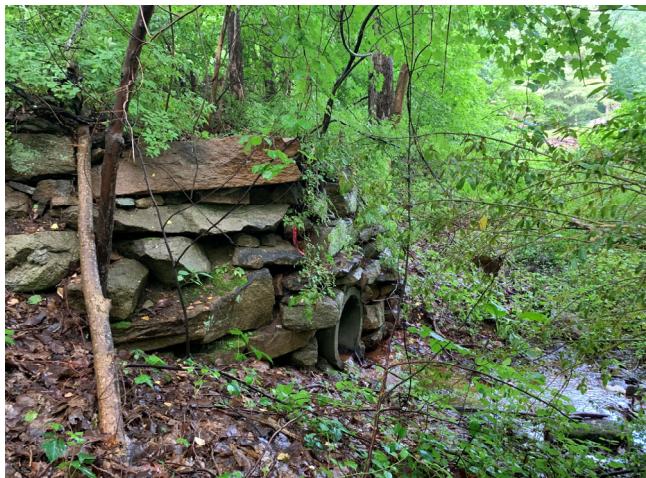
Photo 12: Outfall observed at the southwestern portion of the site; view to the south
