LIMITED ASBESTOS SURVEY SUMMARY REPORT

Solid Waste Assessment

Breakneck Hill Farm Dumping Site
Breakneck Hill Road,
Southborough, Massachusetts

Report Date: October 5, 2022

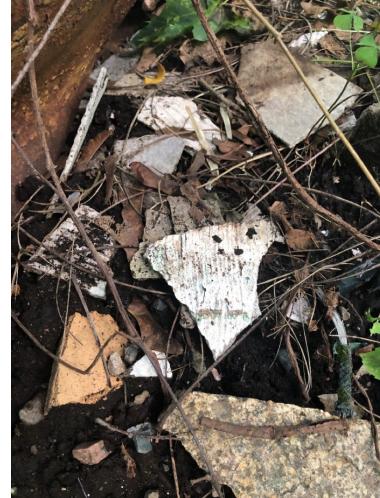
Sample Numbers: 01-A, 01-B, 01-C
Material Description: Cement Board
Material Color: Grey
Accessible Material: Accessible
Reason Inaccessible: N/A
Asbestos Detected: Positive
Asbestos Type: 20% Chrysotile
Homogeneous Area: 200,150 Surface , 100,180 Truck
Total Approximate Quantity: 300 SF
Condition: N/A
Material Type: N/A
NESHAP Category: N/A
Notes: Not Applicable

Results of laboratory analysis confirmed asbestos was identified within three of the suspect materials, as summarized in Section 4.1. The ACM were found to be in poor condition at the time of the inspection. The identified ACM should be securely covered with polyethylene sheeting to restrict access.

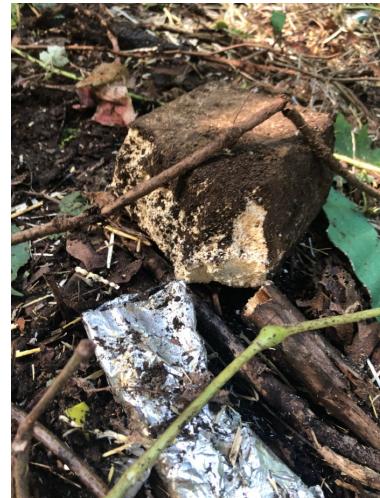
Sample Numbers: 02-A, 02-B, 02-C
Material Description: Boiler Brick
Material Color: Tan
Accessible Material: Accessible
Reason Inaccessible: N/A
Asbestos Detected: Negative
Asbestos Type: No Asbestos Detected
Homogeneous Area:
Total Approximate Quantity: TBD
Condition: N/A
Material Type: N/A
NESHAP Category: N/A
Notes: Not Applicable

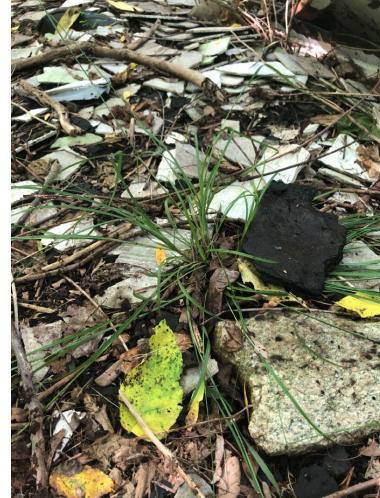
Sample Numbers: 03-A, 03-B, 03-C
Material Description: Roofing Asphalt Based Built-Up
Material Color: Black
Accessible Material: Accessible
Reason Inaccessible: N/A
Asbestos Detected: Positive
Asbestos Type: 5% Chrysotile
Homogeneous Area: 200,150 Surface
Total Approximate Quantity: 200 SF
Condition: N/A
Material Type: N/A
NESHAP Category: N/A
Notes: Not Applicable

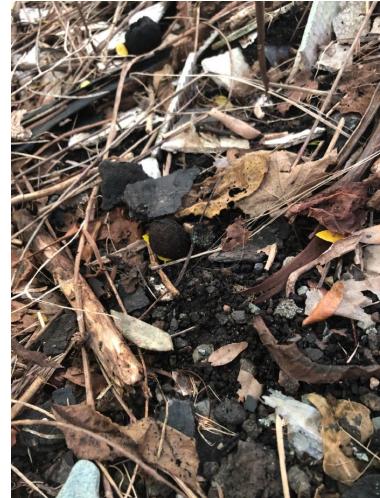
Sample Numbers: 04-A, 04-B, 04-C
Material Description: Roofing Felt Paper
Material Color: Black
Accessible Material: Accessible
Reason Inaccessible: N/A
Asbestos Detected: Negative
Asbestos Type: No Asbestos Detected
Homogeneous Area: 200,150 Surface
Total Approximate Quantity: 200 SF
Condition: N/A
Material Type: N/A
NESHAP Category: N/A
Notes: Not Applicable

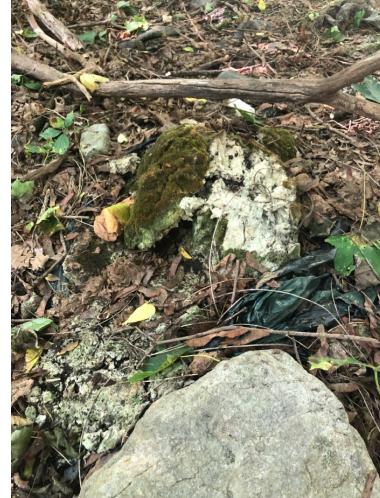
Sample Numbers: 05-A, 05-B, 05-C
Material Description: Insulation Unknown
Material Color: Grey
Accessible Material: Accessible
Reason Inaccessible: N/A
Asbestos Detected: Negative
Asbestos Type: No Asbestos Detected
Homogeneous Area: 100,180 By Truck
Total Approximate Quantity: 10 SF
Condition: N/A
Material Type: N/A
NESHAP Category: N/A
Notes: Not Applicable

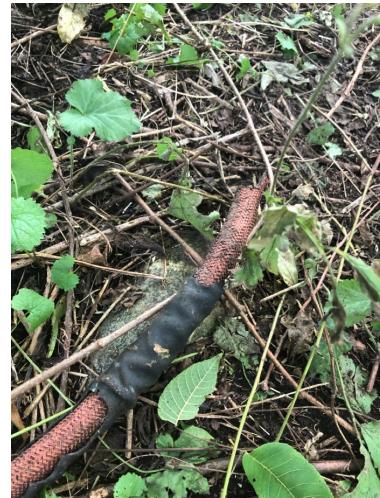
Sample Numbers: 06-A, 06-B, 06-C
Material Description: Wire Insulation
Material Color: Red
Accessible Material: Accessible
Reason Inaccessible: N/A
Asbestos Detected: Negative
Asbestos Type: No Asbestos Detected
Homogeneous Area: 25' SE 100,100
Total Approximate Quantity: 10 LF
Condition: N/A
Material Type: N/A
NESHAP Category: N/A
Notes: Not Applicable

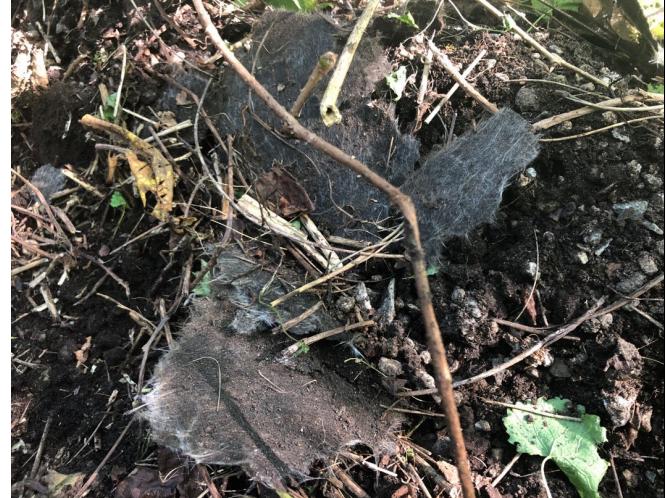
Sample Numbers: 07-A, 07-B, 07-C
Material Description: Roofing Felt Paper
Material Color: Black
Accessible Material: Accessible
Reason Inaccessible: N/A
Asbestos Detected: Negative
Asbestos Type: No Asbestos Detected
Homogeneous Area: 20' SW Of 200,75
Total Approximate Quantity: 1800 SF
Condition: N/A
Material Type: N/A
NESHAP Category: N/A
Notes: Not Applicable

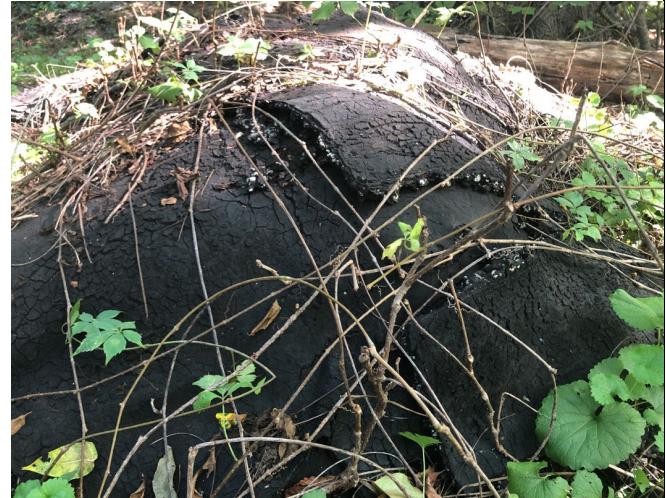
Sample Numbers: 08-A, 08-B, 08-C
Material Description: Roofing Asphalt Based Built-Up
Material Color: Black
Accessible Material: Accessible
Reason Inaccessible: N/A
Asbestos Detected: Positive
Asbestos Type: 3% Chrysotile
Homogeneous Area: 20' SW Of 200,75
Total Approximate Quantity: 1800 SF
Condition: N/A
Material Type: N/A
NESHAP Category: N/A
Notes: Not Applicable

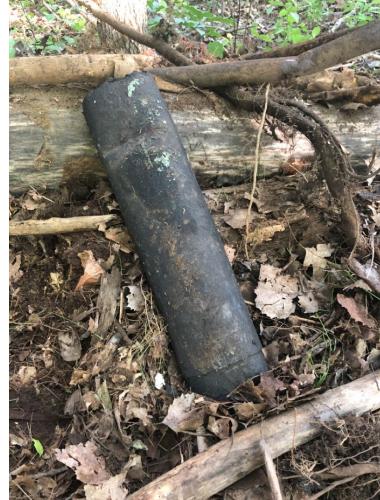
Sample Numbers: 09-A, 09-B, 09-C

Material Description: Conduit

Asbestos Detected: Negative

Homogeneous Area: By 0,100
