**APPLICATION FOR FY 2026 COMMUNITY PRESERVATION FUNDING  
Application is due August 31, 2024**

Community Preservation Act Fund – Historic Flagg School Preservation

# CONDITIONS ASSESSMENT REPORT

*Southborough Historical Society*  
**Southborough Museum**  
 Exterior Conditions Assessment

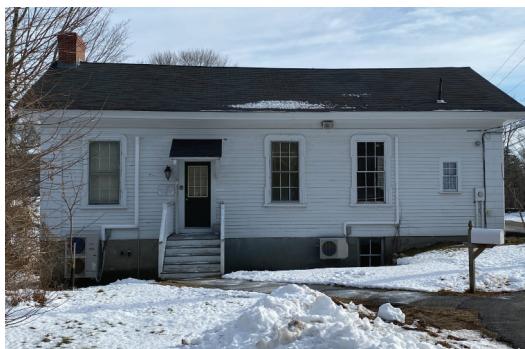
The roof of the Flagg Schoolhouse was observed from the ground level. It is a simple gabled roof with two slopes facing east (Image 6) and west (Image 8). There is a small shed roof over the rear entrance to the building on the west side. Last, the bottom of the pediment at the front creates an overhang (Image 5). All the roof surfaces are covered in three tab asphalt shingles. The shingles appear to be in fair condition, but at 25 years old, the roof is due for replacement - preferably with wood shingles. No shingles are missing and there is no organic growth on the surface of the shingles that would cause moisture to be held on their surfaces. The only roof penetrations are at the chimney and plumbing vent (Images 7 & 8), both penetrations are flashed and appear to be in good condition. Currently the only water management system in place is a gutter and downspout at the shed roof over the west entrance (Image 8). Around the building, there is no water management system to direct water away from the building. Discoloration from splashback can be seen on the parging on the foundation wall.

Image 8: West Elevation: The same as east elevation with plumbing vent at right and awning roof over door..

We observe the aluminum drip edge at the front overhang is uneven and has been face nailed, which may lead to water reaching the fascia. We recommend replacing the aluminum flashing with copper and creating a drip edge to direct water away from the building. Additionally, replacement of the aging asphalt roof with wood shingles is recommended.

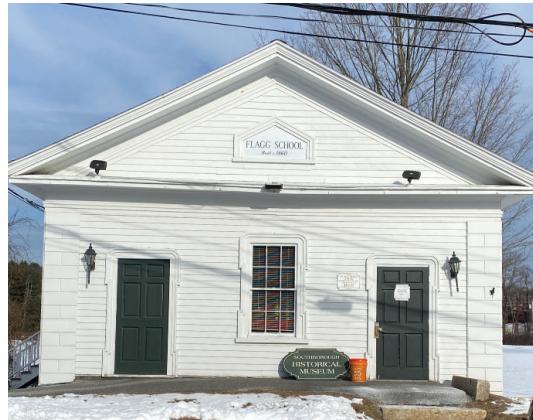
Image 5: South Elevation--Pediment with roof shingles and aluminum flashing at pediment overhang.

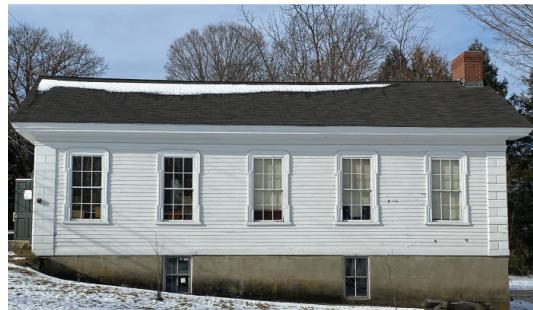
Image 6: East Elevation: Three-tab asphalt roof shingles, aluminum stepped chimney flashing and edge flashing, no gutters.

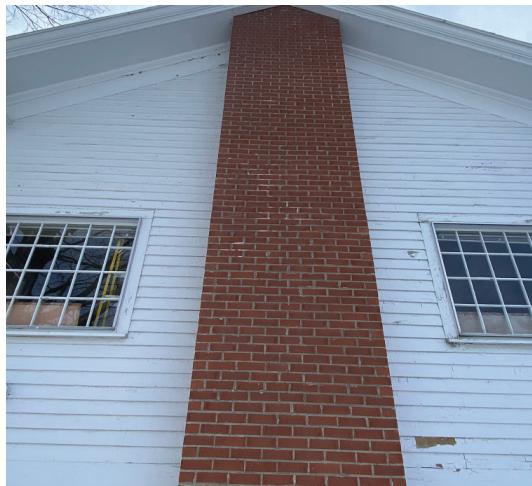
Image 9: Brick chimney on North facade

The chimney on the north facade of the building is red brick, laid in a running bond. The chimney is seven bricks wide and three bricks deep. It is exposed on the north facade of the schoolhouse and penetrates the roof at the overhang of the gable. Three courses of corbeling ornament the top of the chimney--with a mortar wash on top. From the ground, we cannot discern whether a chimney cap covers the opening or not.

At this time we do not recommend any interventions to the masonry.

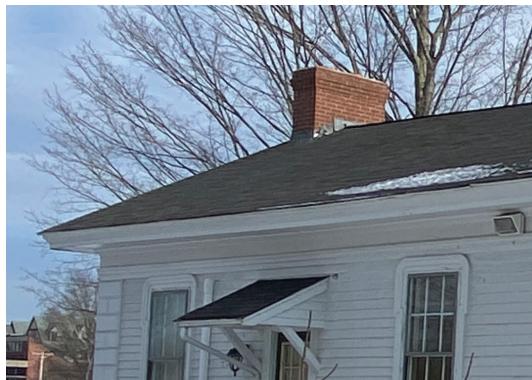
Image 10: View of South side of brick at chimney (No more than two lines of text (meaning this is the last line)).

Through a visual inspection from the ground, the bricks and mortar appear to be in good condition throughout.

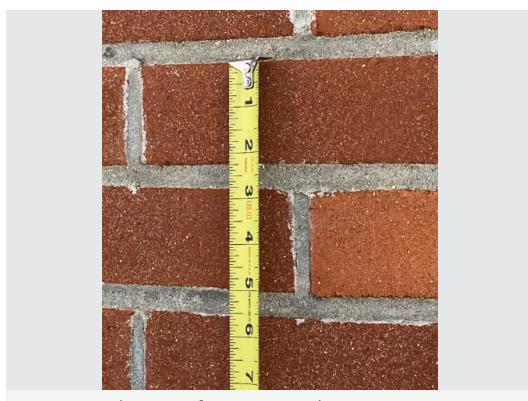
Image 11: Close up of masonry at chimney.

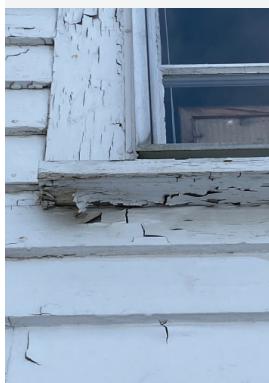
The clapboard and the trim are currently painted white. On all four sides of the building there are places where the paint finish shows alligatoring; places where it has delaminated from the wood clapboards (Image 18); other places where several layers are peeling (Images 19, 20, 21). The condition of the painted surfaces is equally poor on all sides.

**Image 20:** Loose quoins.

We recommend scraping, priming and painting all wood surfaces. At the joints between the trim and clapboard, we recommend sealing these gaps (Image 22) with a paintable caulk. All nailheads that have surfaced should be hammered flush with the wood surfaces along with loose building elements (Image 20). Recreating/restoring the historic flagpole would be a worthy addition to scope.

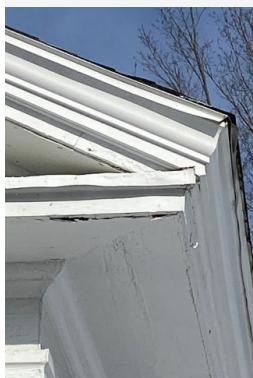
**Image 21:** Evidence of peeling paint at soffit.

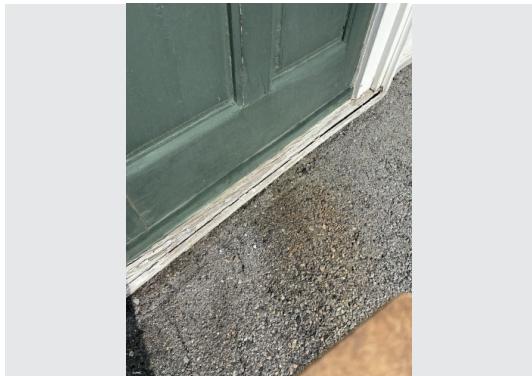
**Image 23:** Sill of Front Door--The sills at both front doors are deteriorating and should be replaced.

With the exception of peeling paint, the two doors are in good condition. The lead flashing over each door is also in good condition (Image 24). However, the threshold of each door is worn and deteriorated (Image 23). The six-over-six lite window has also suffered from deterioration. The putty at the muntins needs to be stripped, reglazed and repainted along with the sashes and trim (Image 25).

Replace thresholds on south facade.

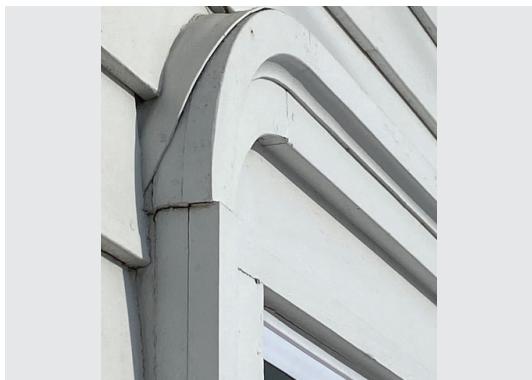
**Image 24:** Lead flashing over front door trim.

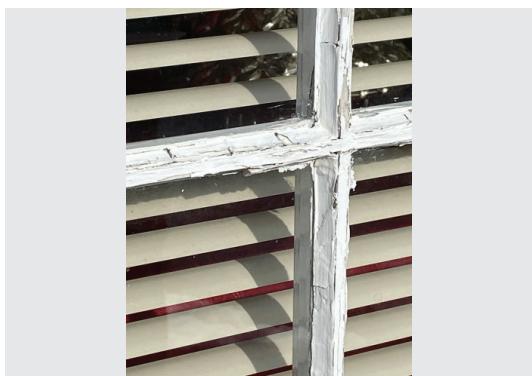
**Image 25:** Muntin on front window: Example of putty in need of stripping, reglazing and repainting, a common condition.

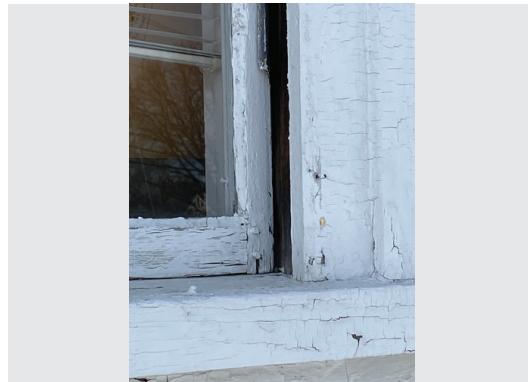
On the east elevation, five six-over-six double hung windows let the light inside. The condition of all the windows is similar. Reglazing is needed at all the muntins. The sash cords and balances are broken on several windows. The stop and casings are broken at the bottom right on one window (Image 26). We also note that no storm windows were attached to the outside of the building on the east elevation, although evidence that they once existed was apparent from screw holes in the casings.

**Image 26:** Example of broken stop at the bottom sash at one of the six-over-six double hung windows. .

- Replacing stops and broken window casings at original windows where needed on main level
- Replacing sash cords and balances where needed
- Replacing the parting beads
- Replacing sash locks across all windows to match and lock the sashes and to reduce infiltration of outside air

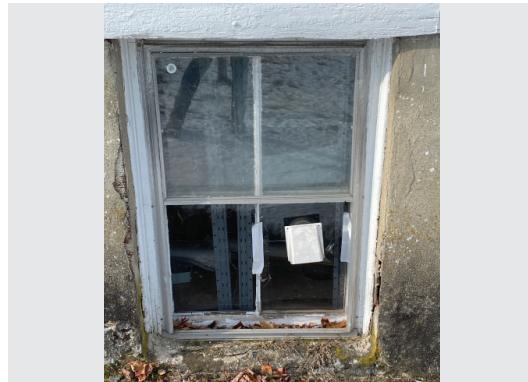
The two basement windows, not original to the building, are in fair condition. Some storm windows are attached to these windows. Their sills have deteriorated (Image 27).

**Image 27:** East Elevation Basement Window--Sill is deteriorated. Storm window missing.

Replace sills at basement windows

Regrade the ground at the basement windows to insure that water runs away from the building, preventing window sills from becoming saturated.

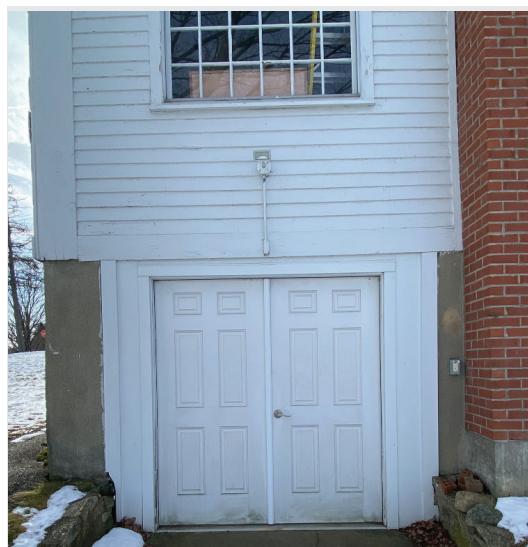
On the north elevation, the service door to the basement level is in good condition. The windows on the main level are generally in good condition, though paint is peeling on the muntins, sashes and trim. (Image 28).

**Image 28:** Basement Service doors.

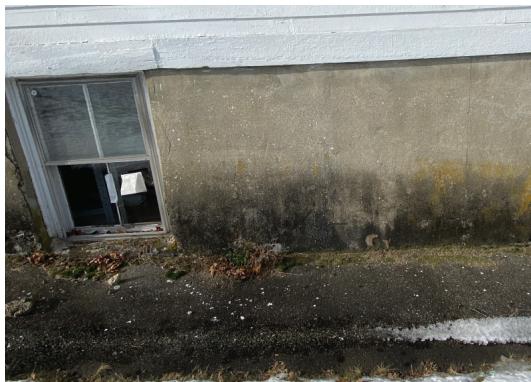
**Image 29:** Foundation Wall--Stains from splashing at the drip line are evident on foundation wall. Delamination at window.

The foundation is visible on three sides of the building. The cementitious parging applied to the brick foundation is delaminating in various places on all three sides. Additionally the bottom foot of the foundation is discolored from the splashing caused by dripping of rainwater from the edge of the roof on to the asphalt surrounding the foundation wall.

We recommend patching the parging on the brick foundation wall. Further, we recommend removing the asphalt paving and laying a crushed stone apron extending from the foundation away from the building to beyond the drip line in order to eliminate splashing dirt onto the foundation wall.

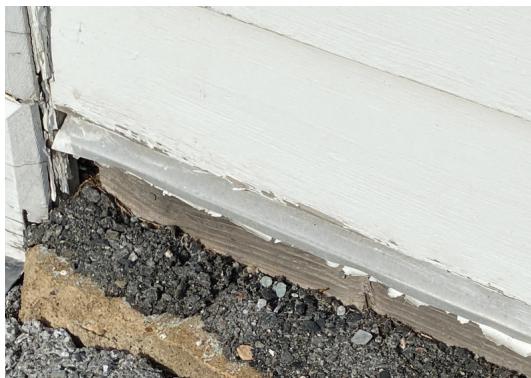
**Image 30:** Asphalt walkway at front facade is touching the wood clapboards.

On the south facade, where the asphalt walkways meets the clapboard, we recommend addressing the problem of the asphalt touching the bare wood clapboard in a redesign of this walkway discussed in the recommendations of the next section.

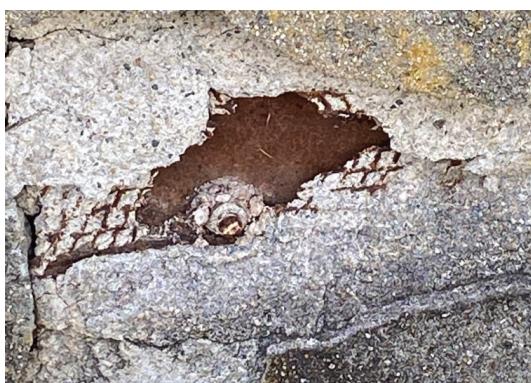
**Image 31:** Delamination of parging over brick foundation: Deteriorating wire mesh is visible.

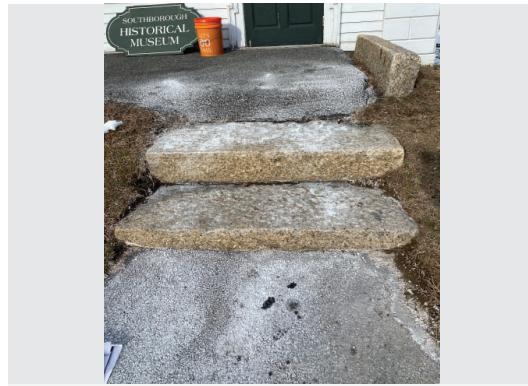
The asphalt walkway for the accessible path is in good condition at the moment, though it should be monitored for changes in its surface. The granite steps and asphalt step leading to the main entrance are of uneven rise. The granite block to the right of the asphalt is beginning to tip. Last, there are no handrails (Image 32).

**Image 32:** Granite steps to main entrance: Step are of unequal rise, and pose a tripping risk. Granite block at door is tipping..

We recommend a redesign of the accessible entrance and the granite steps. This redesign would include granite slabs that rise evenly, a handrail at the steps and railing at the entrance and a walkway that does not touch the clapboard on the front facade.
