Tree Evaluation Report 1

Town of Southborough, MA

John T Campanini, Jr, Consultant, *Tree Technologies, LLC*

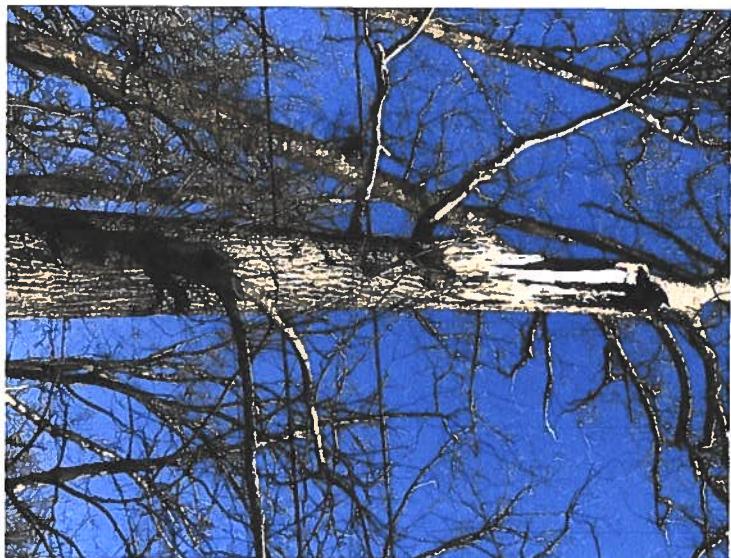
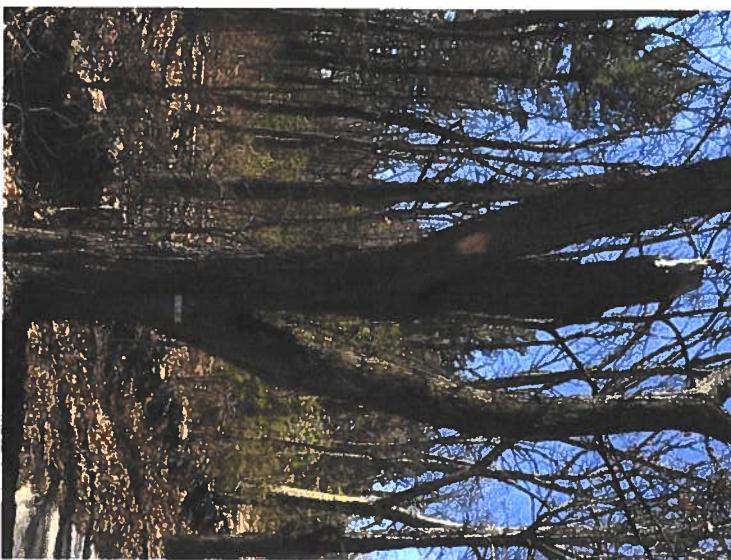
16 trees, or 27% of population, have hazardous trunk cavities.
Left: #2 Pignut hickory. Right: #7 Pignut hickory between 31-37 Edgewood Road.

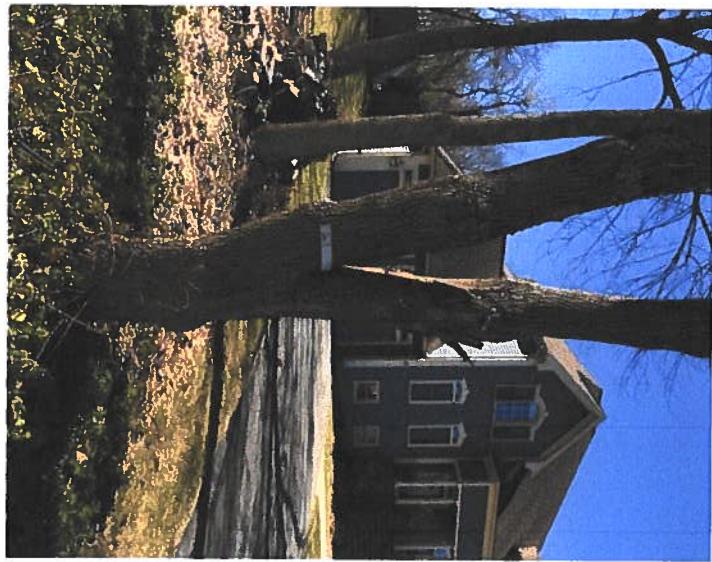
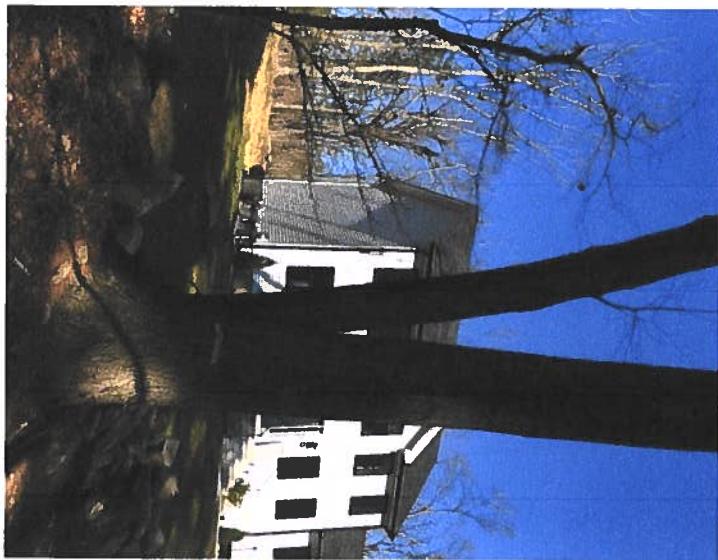
Several trees with multiple structural defects (co-dominant stems and deadwood) are unstable and hazardous. Left: #3 White ash. Right: #38 Red oak near 22 Edgewood Road.

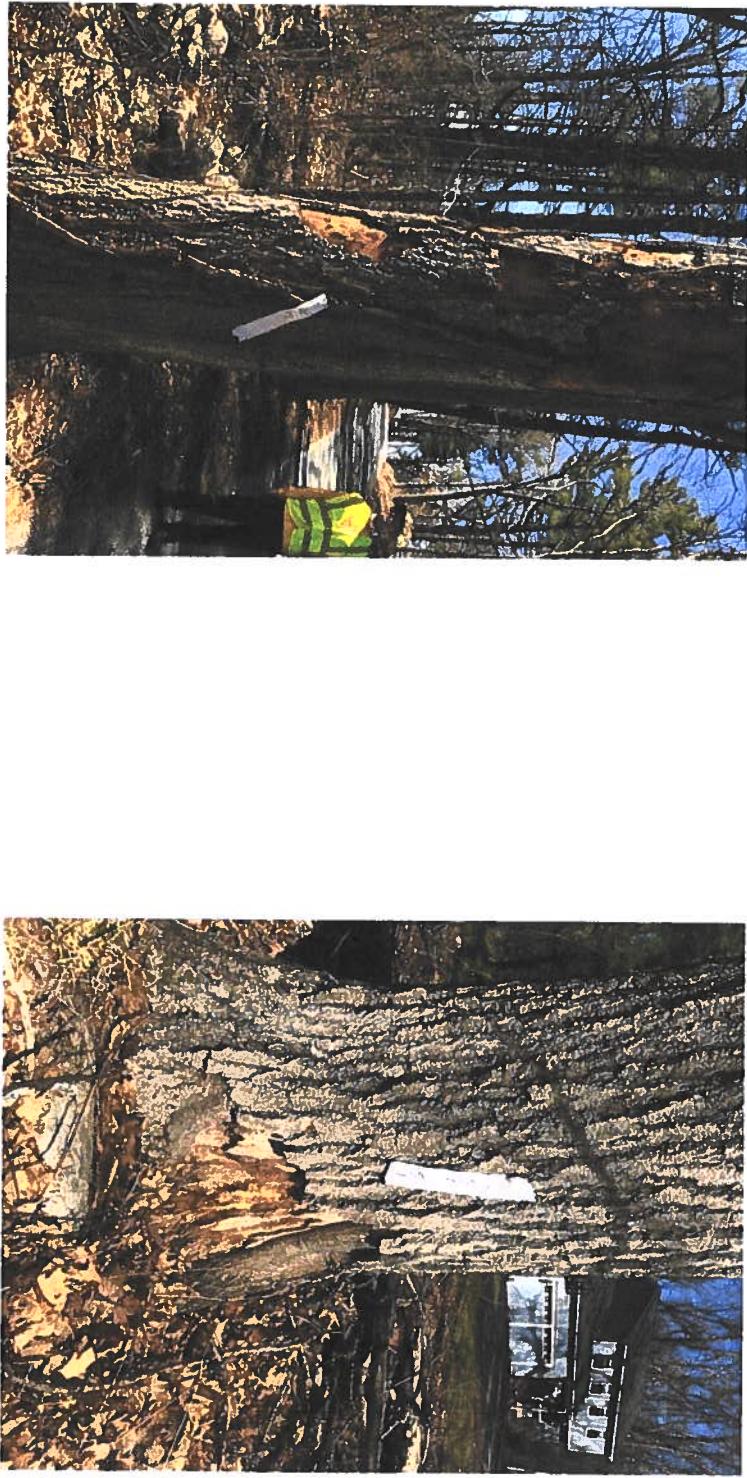
Left: #17 Red oak at 19 Edgewood Road. Right: #51 Red oak near 52 Edgewood Road.

17 trees, or 29% of total tree count, have significant defects and like these trees are unstable.

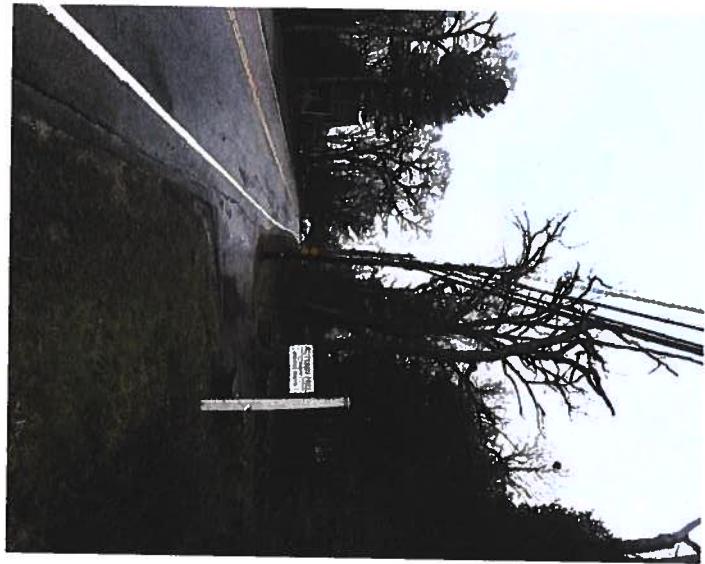
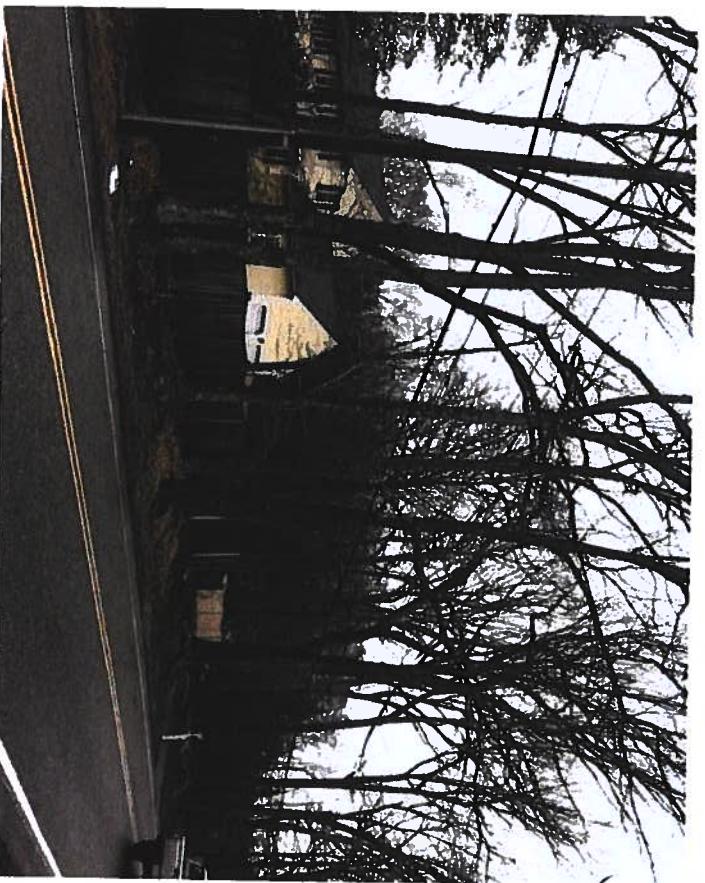
27 trees, or 40% of population have dead branches overhanging utility wires and roadway.
Left: Several oaks northeast of Autumn Hills. Right: Oaks after 64 Marlboro Road, Pole 51.

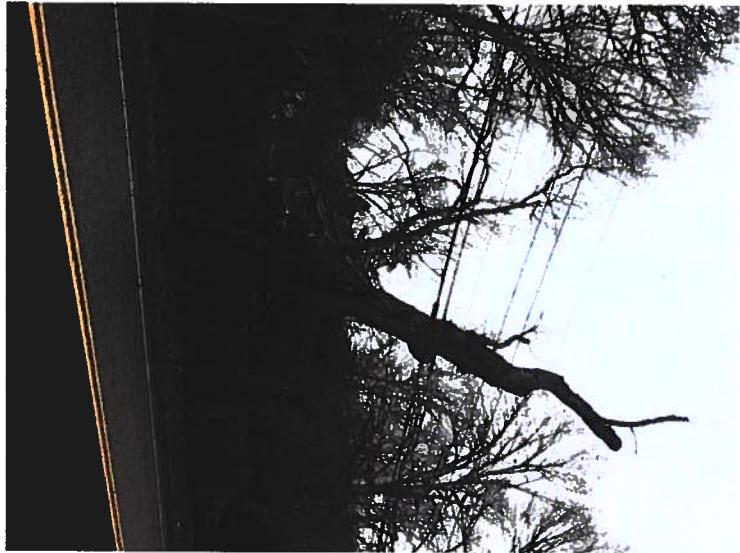
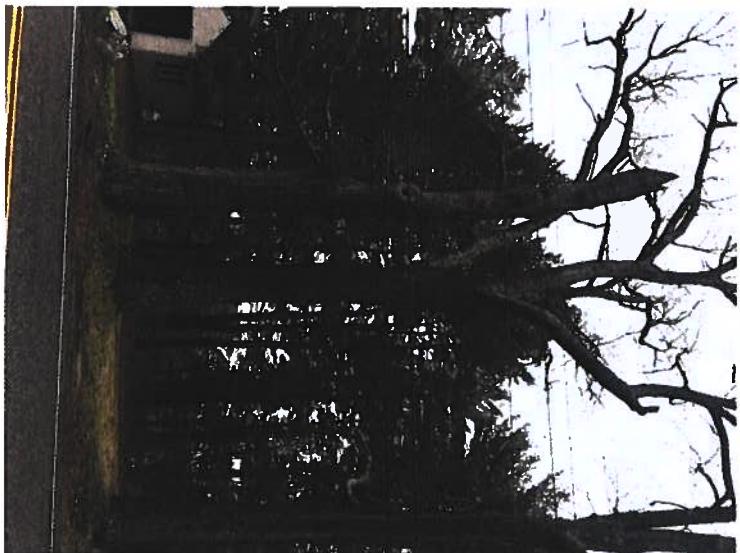
Left: #31 White oak north of Ledge Road. Right: #42 White oak near #44 Marlboro Road.

Dead trees with major parts or crown missing are **very dangerous**.

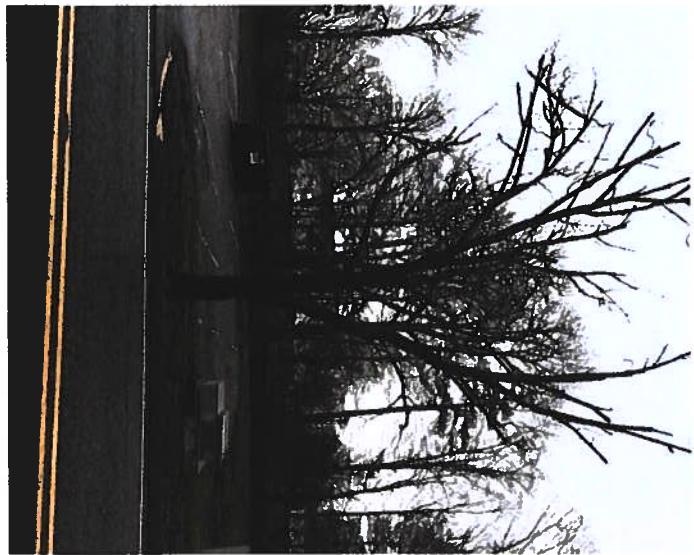
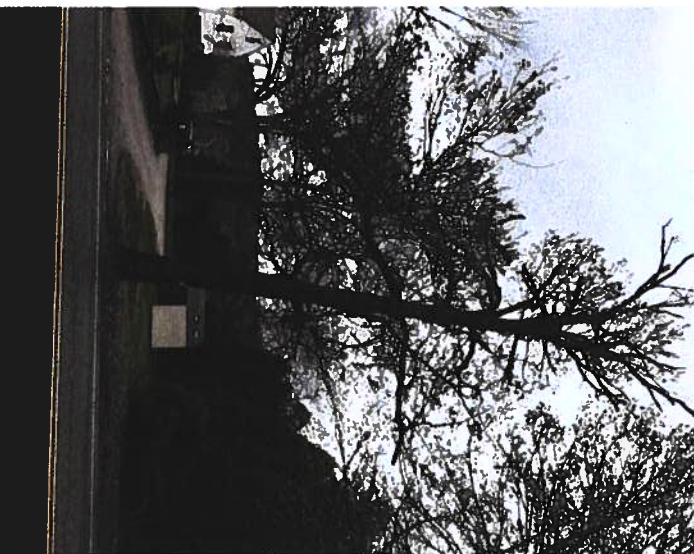
Left: #43 Norway maple northeast Library. Right: #60 Red maple at 65 Marlboro Road

25 trees, or 40% of population, were rated poor or dead. They are unstable and unsafe.

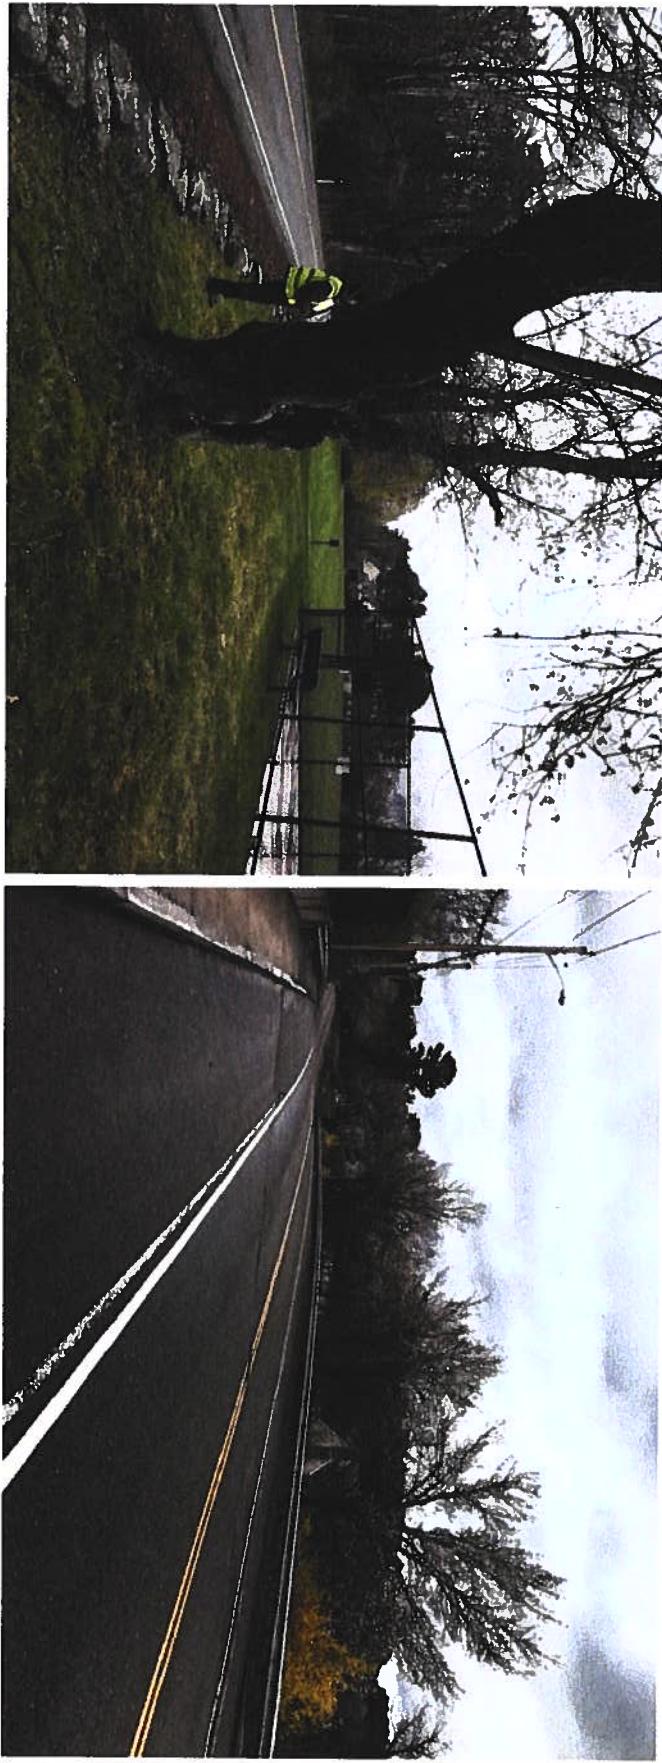
There are numerous private property trees with serious structural defects located along Marlboro Road.
Left: St. Mark's East Campus at tennis court. Right: Gallery pear trees abutting Foley Memorial Bridge.

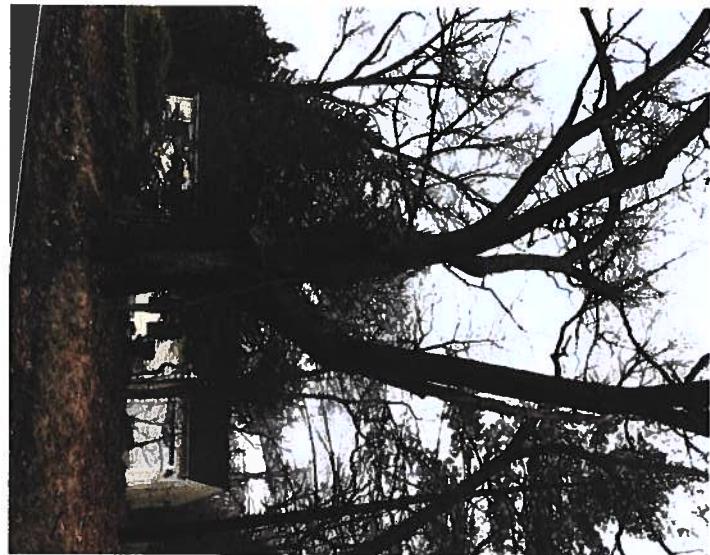
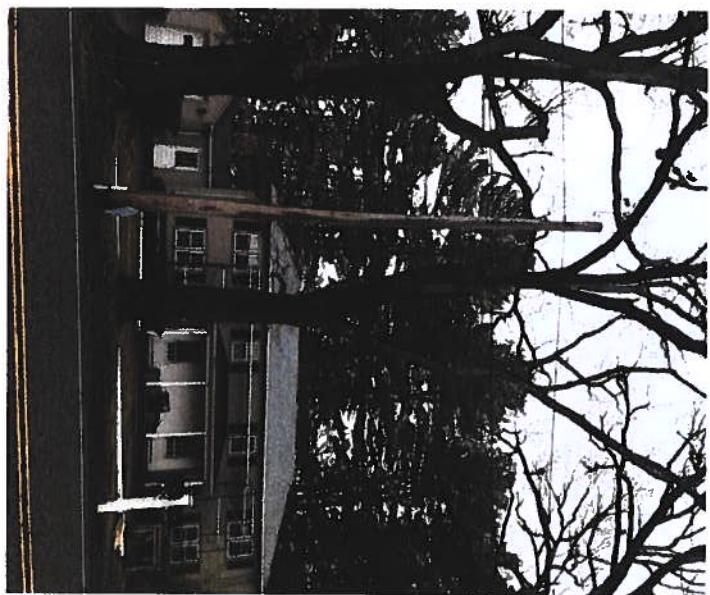
Left: #26 Red oak with 3,000sf TFZ has several major defects and is unsafe. Right: There are 5 large oaks located at 34 Marlboro Rd. Two need to be removed #38 & #41, three need pruning #39, #40 & 42.

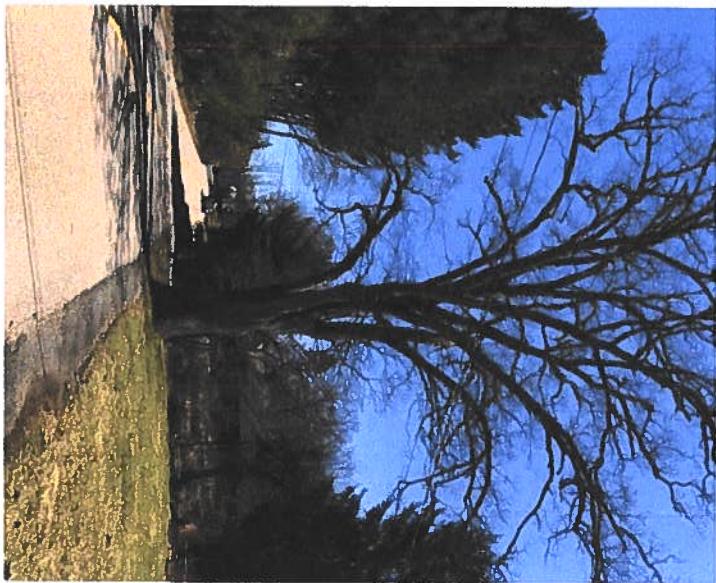
- 34% of tree population like this White Oak #27 have minor deficiencies that require sanitation pruning.

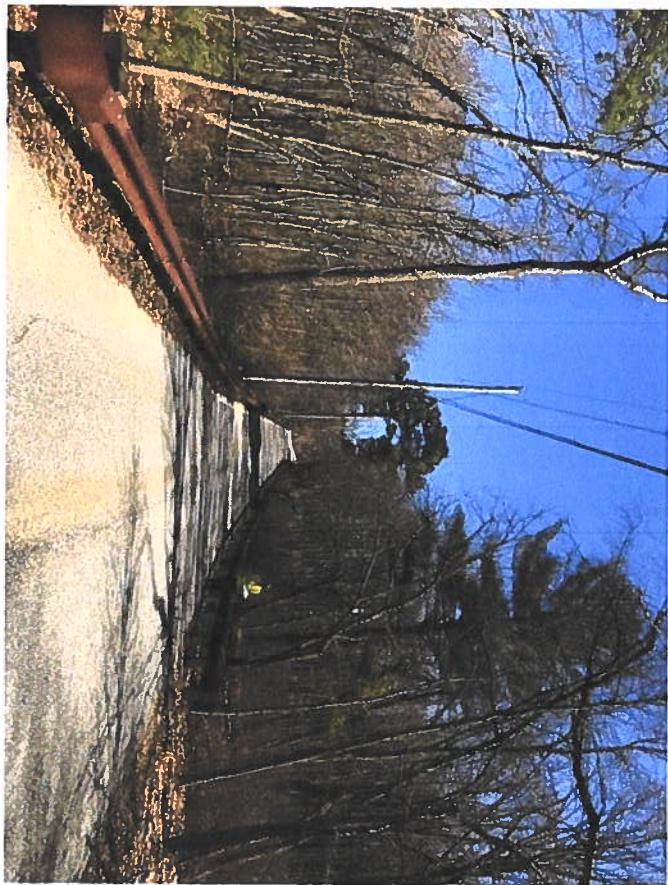
Many small trees are located inside woodlands or on private property. Their branches overhang the roadway. Many trees and/or limbs should be removed to avoid future problems.

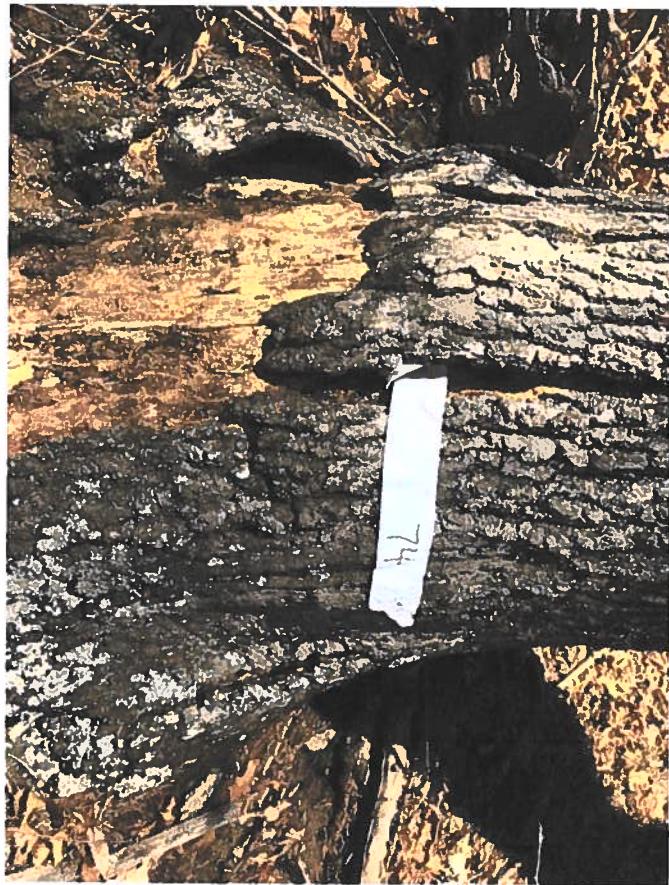
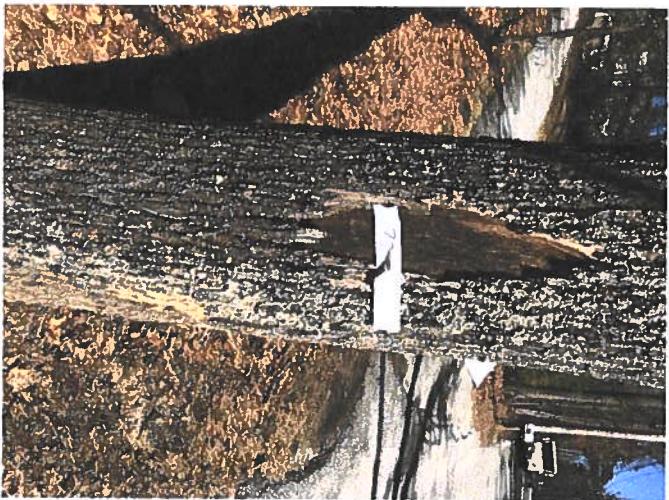
19 trees, or 24%, of tree population have trunk cavities that make them unstable and unsafe.
Left: #74- Red oak at 48 Oregon Rd. Right: #77 White ash located at 50 Oregon Rd.

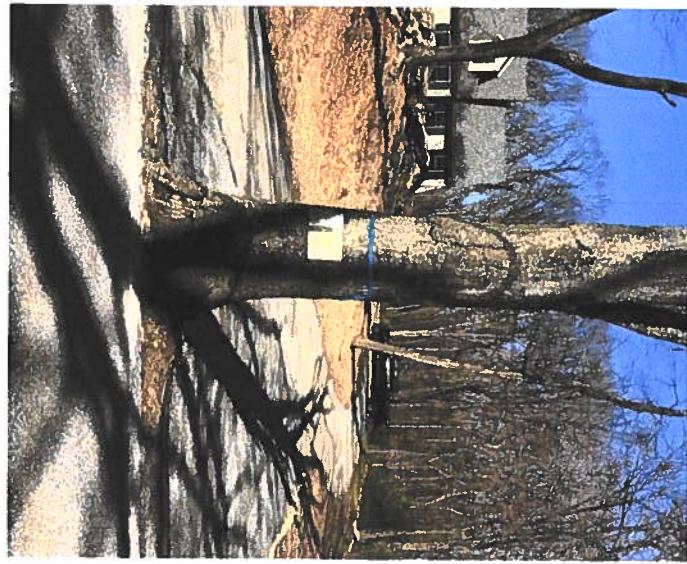
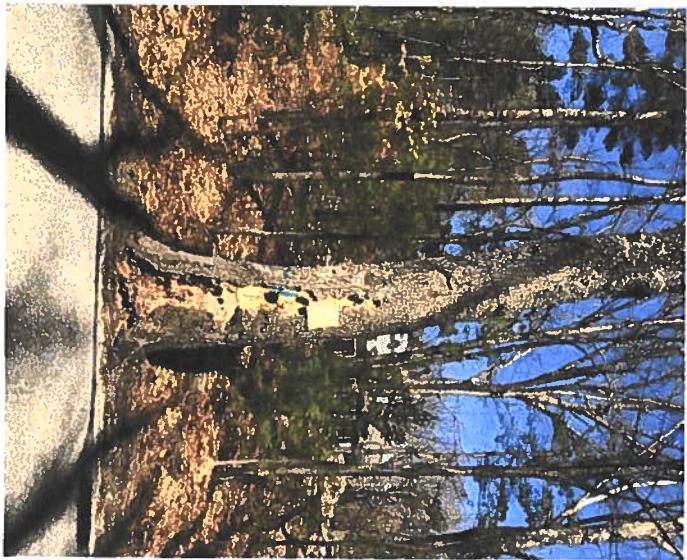
#53 Red Oak near 22 Oregon Road (Right) and #47 Pignut hickory near 52 Oregon Road are dead and are marked for removal by the Town.

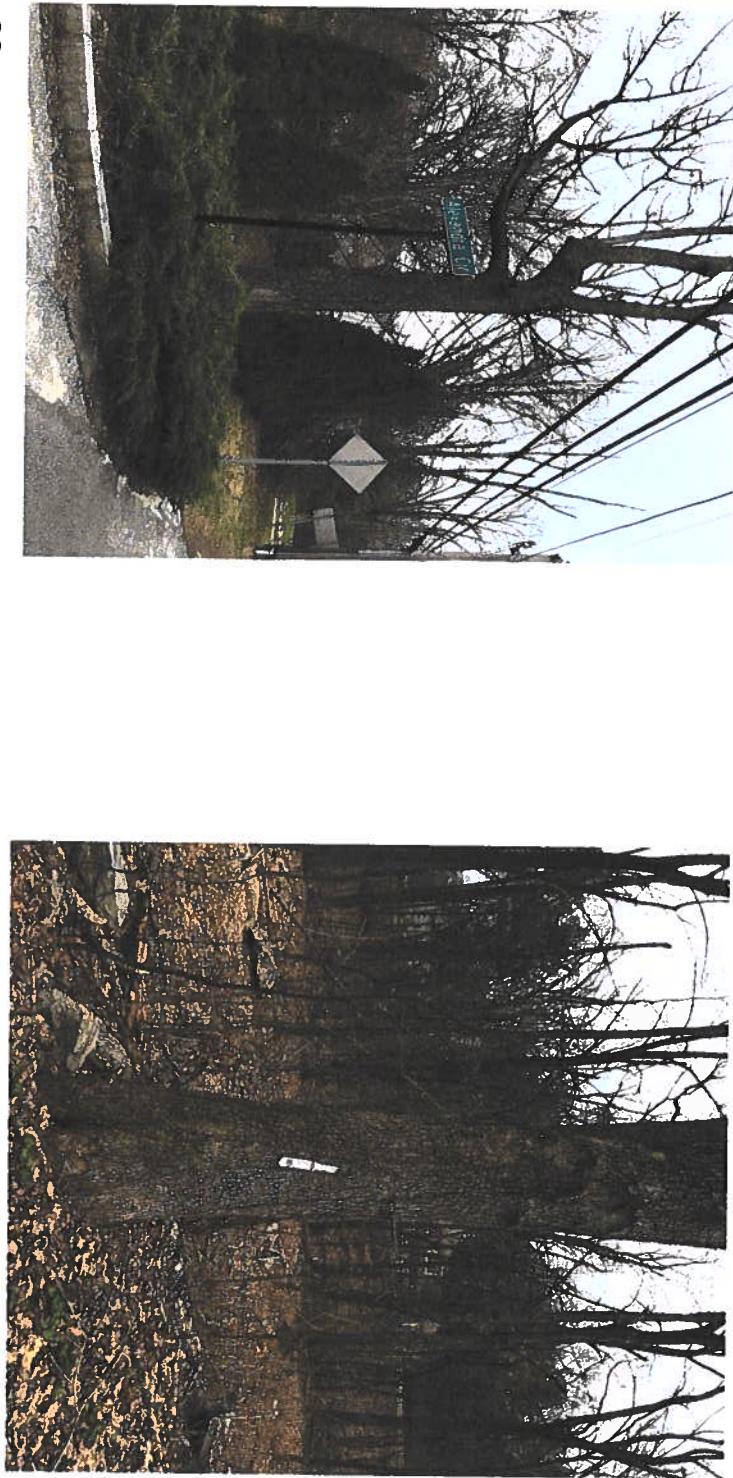
Left: #131-Red maple. Right: #172- White oak near 150 Parkerville Road.

33 trees, or 24% of population, have trunk cavities which compromise their mechanical stability. Many like these two are hazardous and require removal.

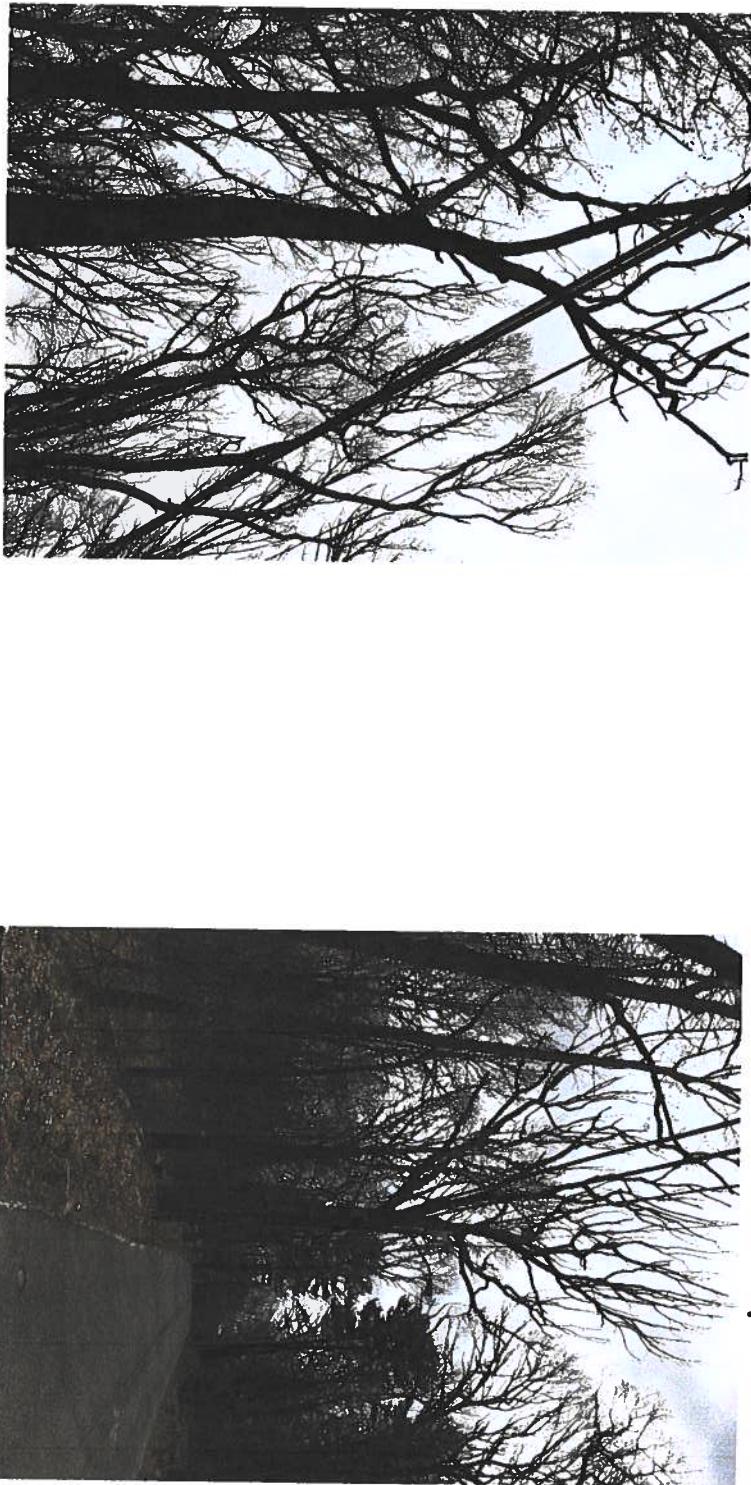
Utility infrastructure abutting woodlands are potential targets for many roadside trees with large diameter deadwood. Both photos taken north of school grounds.

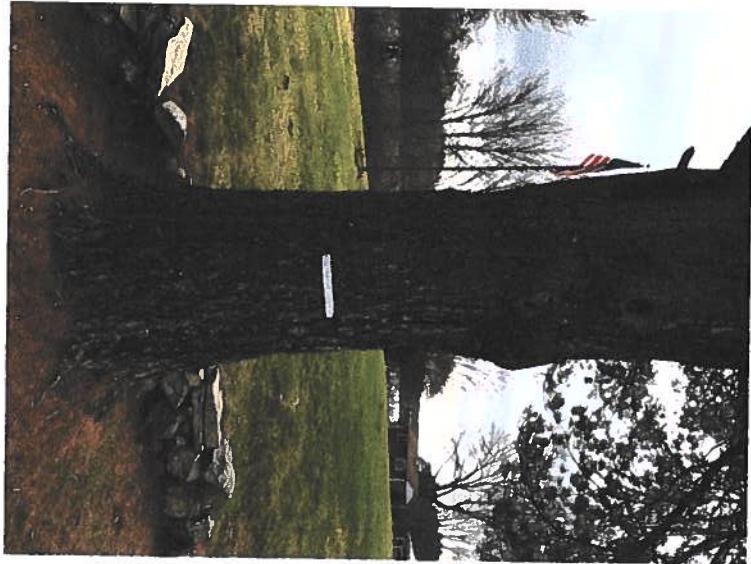
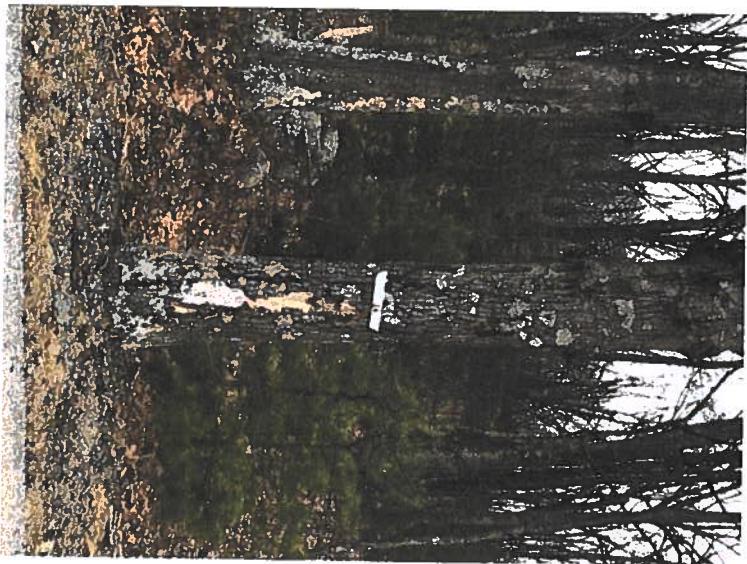
40 trees, or 22% of the tree population, have serious structural defects. They are unstable and were recommended for removal. Left: #14 White pine. Right: #42 White oak.

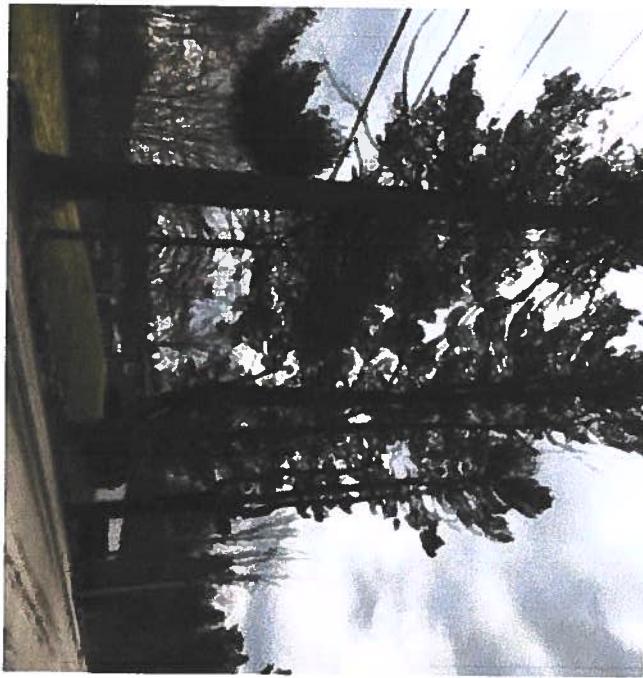
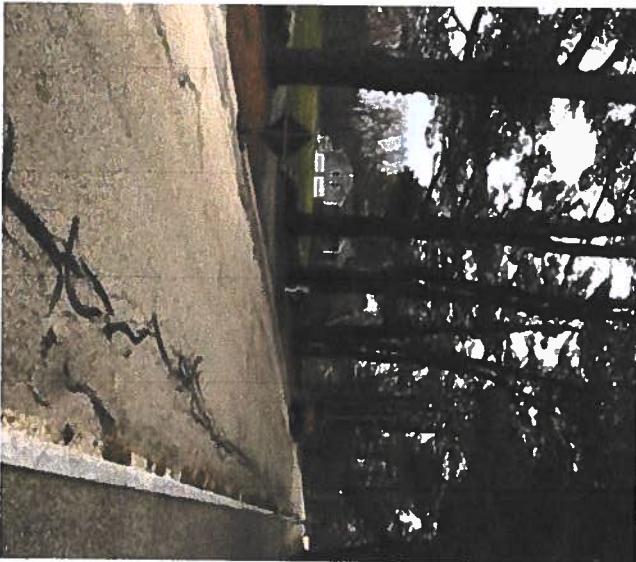
Most White pines are relatively healthy. They are among the 132 trees, or 71% of the population, that exhibited only minor deadwood or no structural defects at study time.

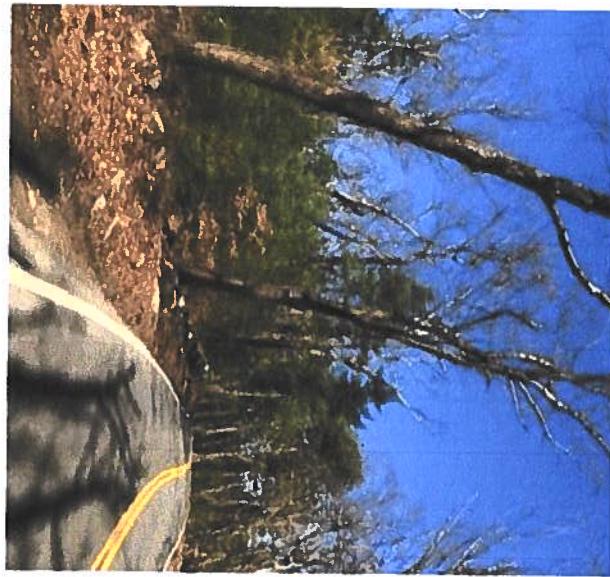
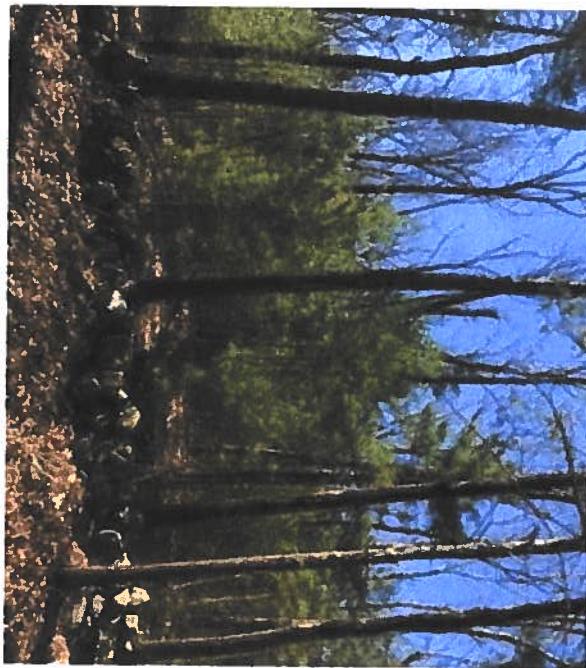
Survey identified 43 hazardous trees located on private property with the potential to impact targets on Parmenter Road.

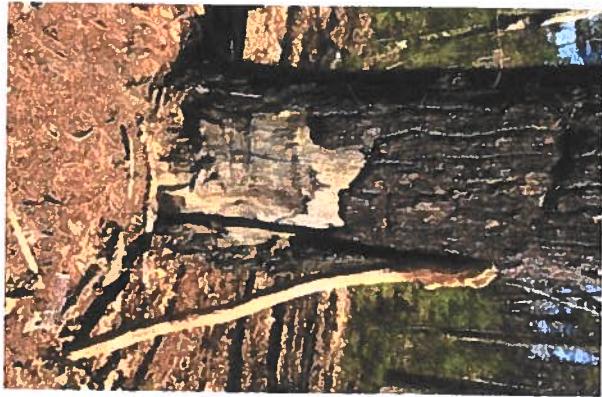
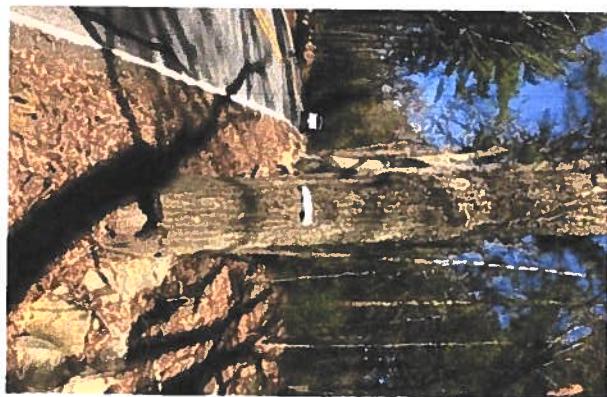
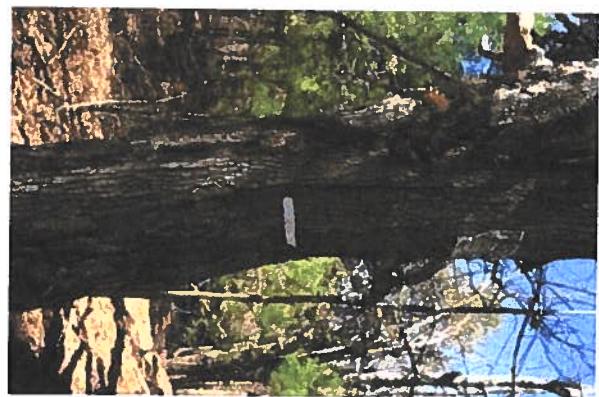
16 trees, or 50% of the population, have serious structural defects, are unsafe and recommended for removal. Left: #31 White pine. Center: #6 Red oak. Right: #25 White oak

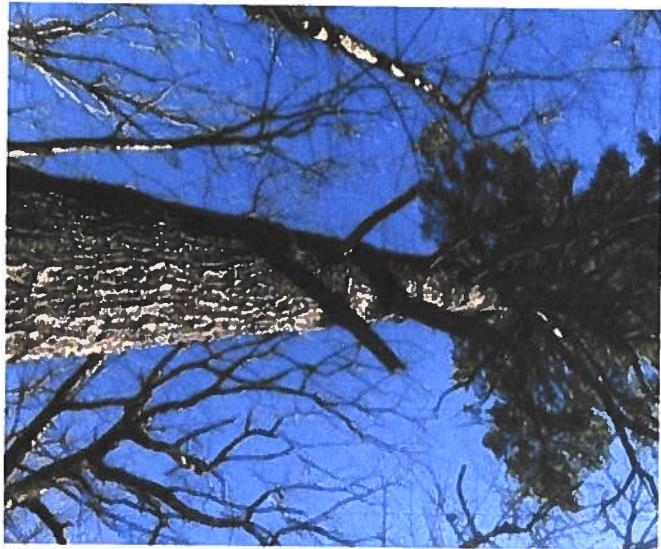
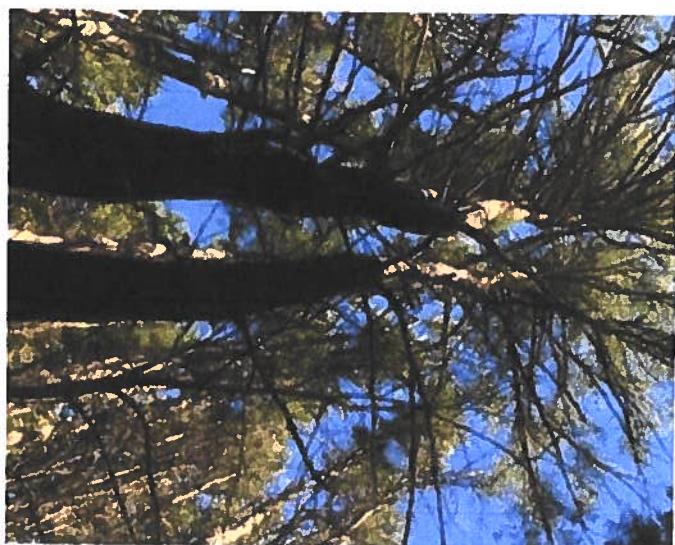
11 trees, or 34% of the population, like these trees have deadwood that require either sanitation pruning or future inspection to monitor their condition.

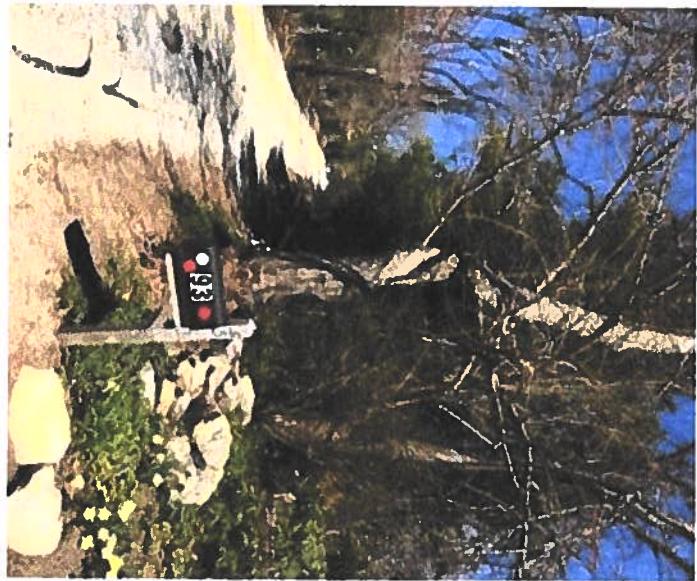
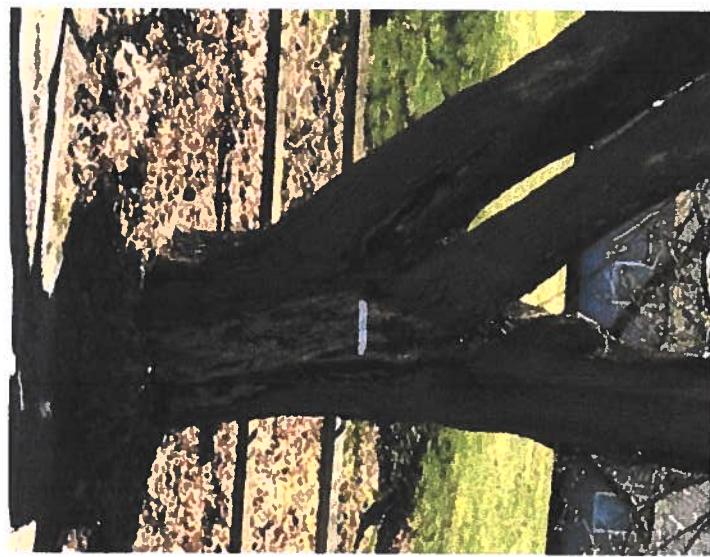
Left: #24 Red maple. Right: #72 Norway maple.

26 trees, or 22% of the population, are unsafe and recommended for removal.

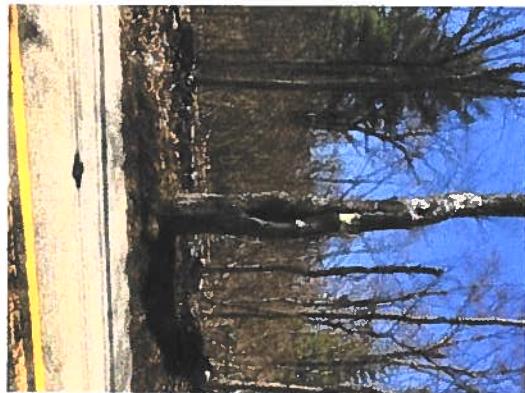
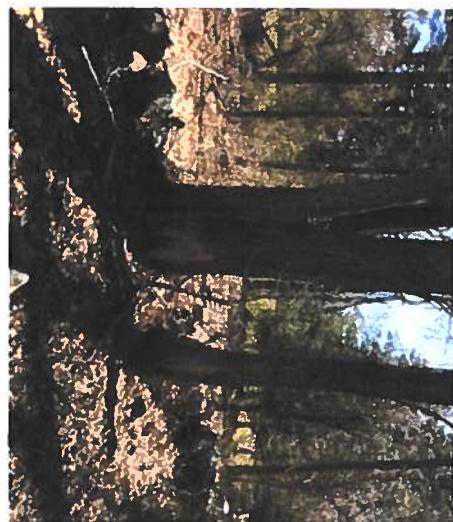
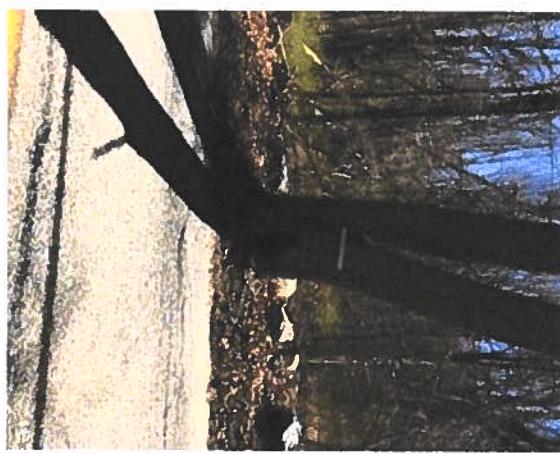
Left: #34 White oak. Center: #35 & #36 Red maple. Right #92 Norway maple

Trunk cavities were recorded on 27 of the 119 trees on Pine Hill Road. Some were very serious and led to the tree's being recommended for condemnation.

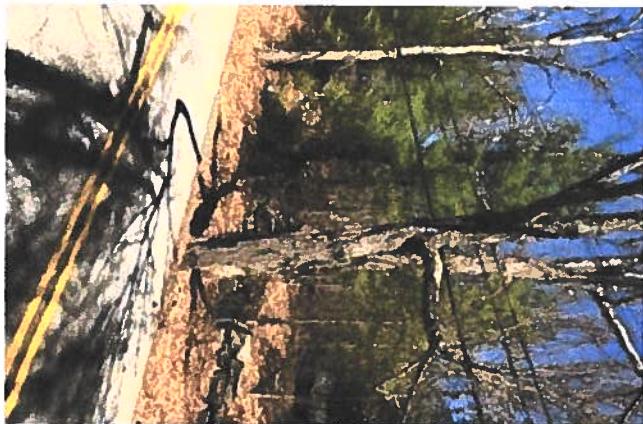
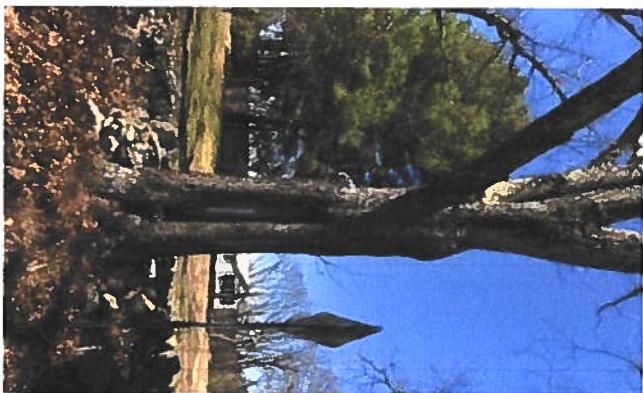
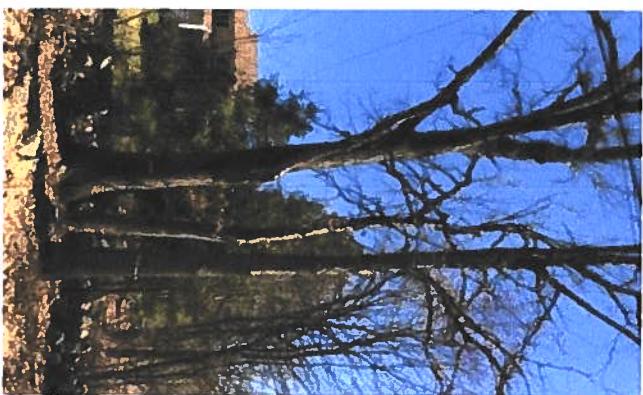
Many dead trees and those with basal trunk cavities are tall and wide enough to pose a danger to utilities located on both sides of the roadway if they failed.
