## **FLAGG ROAD TREE EVALUATION REPORT**

**TOWN OF SOUTHBOROUGH, MA**

**John T Campanini, Jr., Consulting Arborist**

**September 2020**

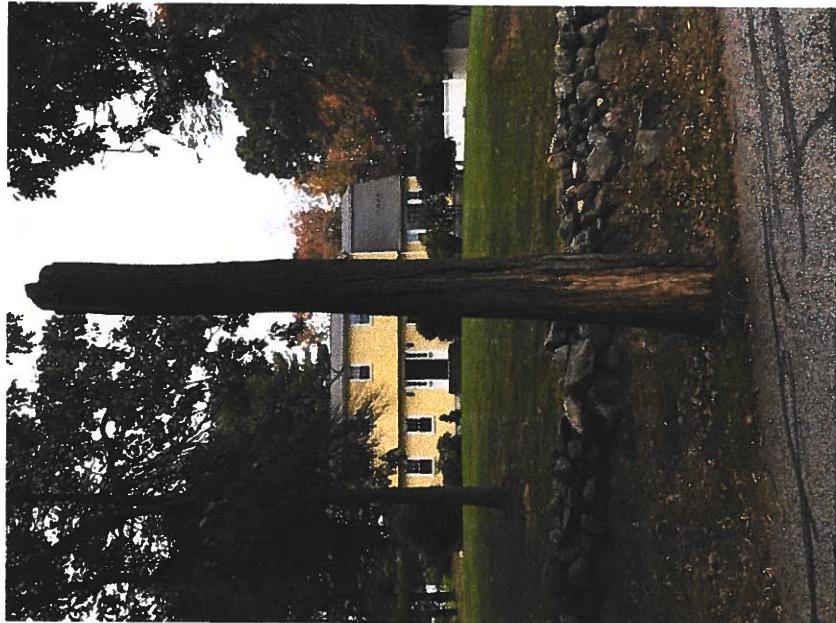
ID8 White Ash (TRC 108"; HT 45'; CR 50')

Comments: This White Ash (east side of road in photo) exhibits several major structural defects. The worse is the loss of nearly 20% of the tree's upper crown. Many stubs exist, showing where the missing branches once stood. There are also cavities and wood decay at the top of the trunk where the crown is broken. The Ash is structural unsound and unsafe. Should the tree fail completely (i.e., at the trunk base), the potential tree fall zone is 2,250 feet. Major at risk targets include the roadway, wall, landscaping and utility transmission wires.

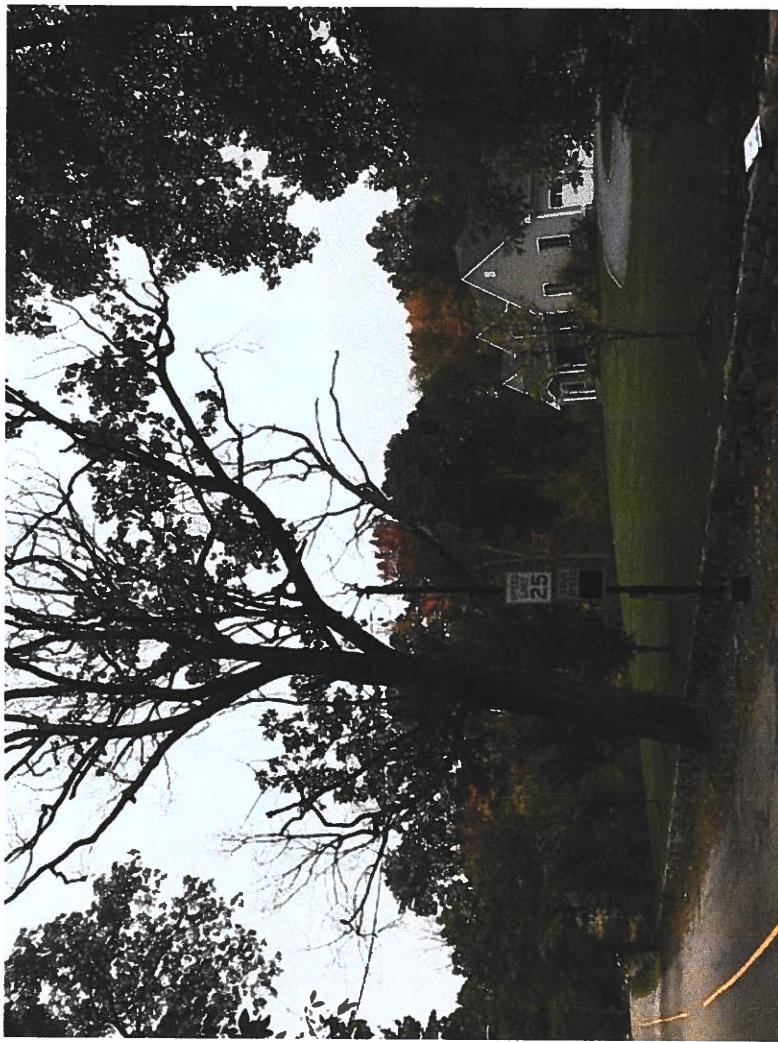
ID10 White Ash (TRC 54"; HT 30'; CR 10')

Comments: This tree was topped in the recent past. All that remains of the ash is the 30' decaying trunk.

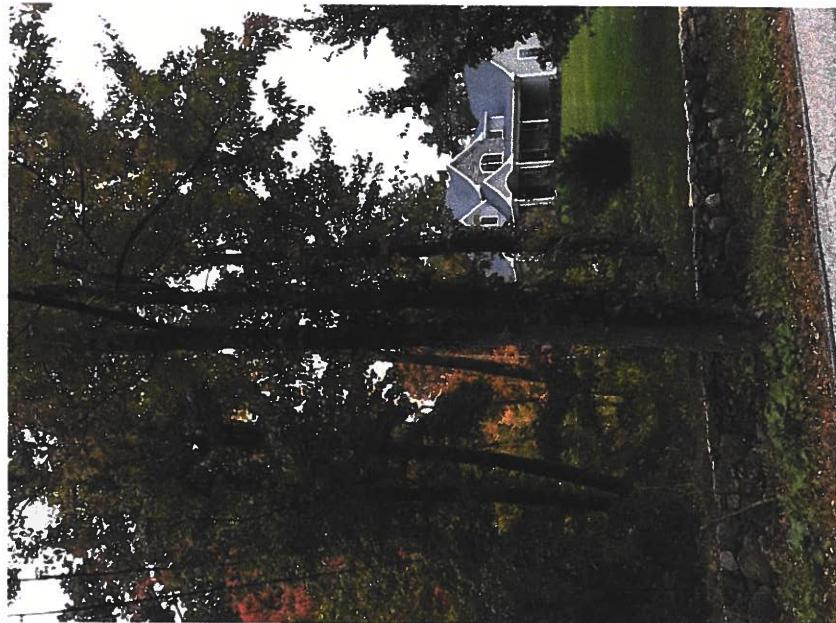
17 SHLane (42.297462 x – 71.546896)  
ID12 Red Oak (TRC 132"; HT 55'; CR 50')

Comments: This Red Oak is showing symptoms of gradual declining health. Most evident is approximately 20% deadwood in the crown. But more troubling is evident of root decay at base of tree trunk. Both are major structural defects associated with mechanically compromised trees. Wall construction in the recent past is probably the cause of this tree's poor health

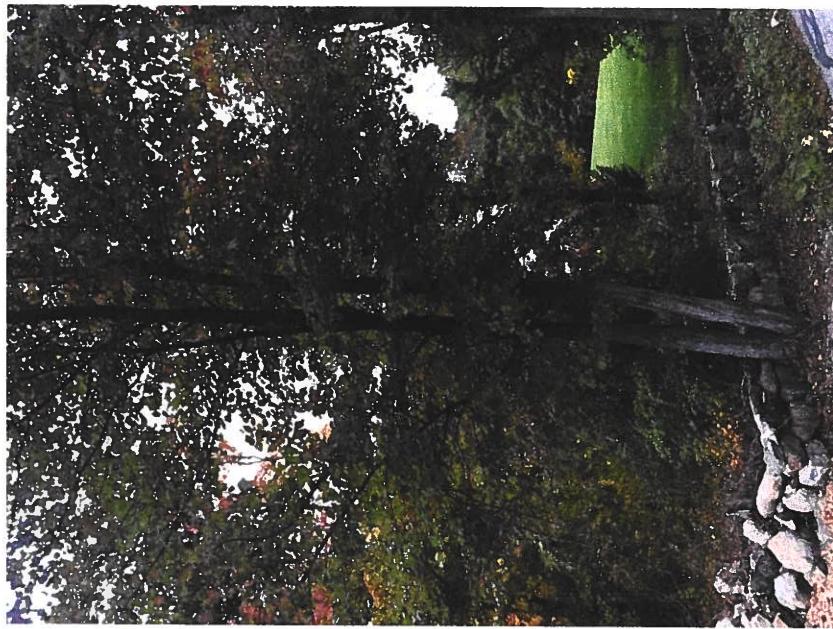
ID14 White Ash (TRC 18" + 16"; HT 35'; CR 20')

Comments: This multi-stemmed Ash is splitting at the base of the trunk. It should be removed before the split gets worse.

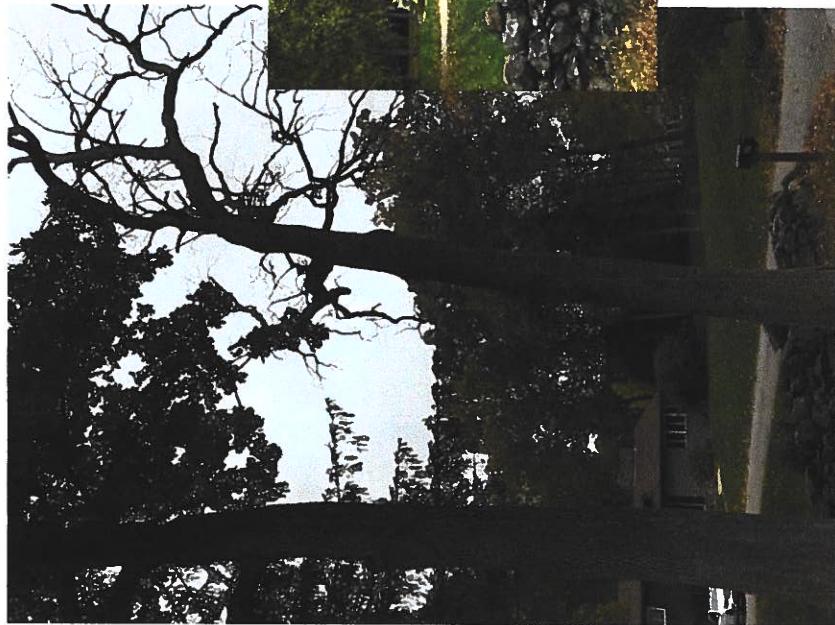
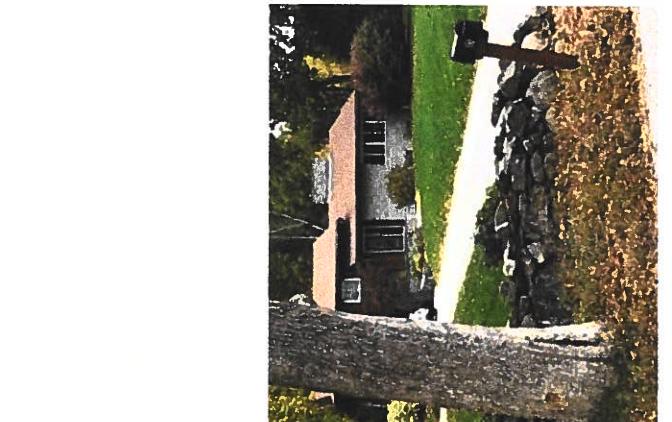
ID19 White Oak (TRC 96"; HT 66'; CR 35')

Comments: This Oak is structurally unsound as the trunk has cracks, cavities (photo right) and wood decay. The crown also has numerous dead branches.

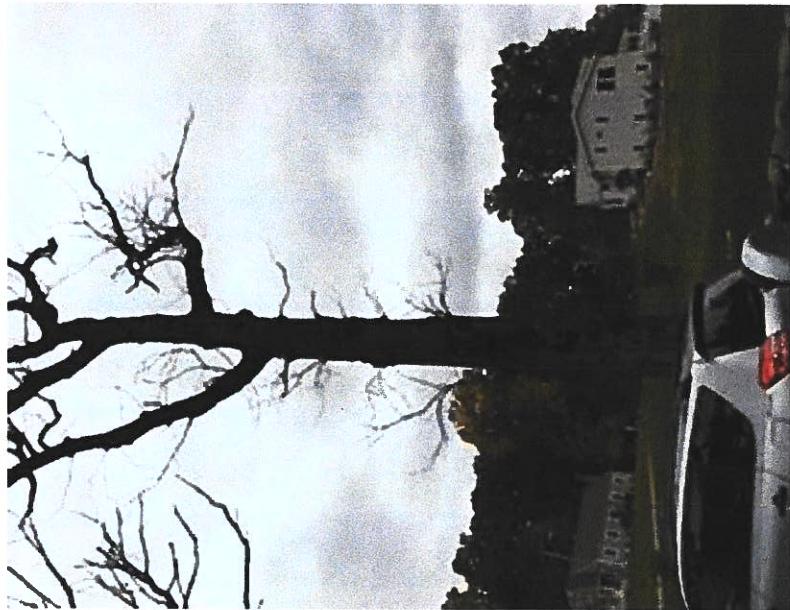
opp 22Flagg Rd (42.296542 x – 71.5550096)  
ID20 White Oak (TRC 84"; HT 50'; CR 40')  
TFZ: 2,000sf; Targets: Multiple

Comments: This is one of two dead Oaks opposite 22 Flagg Road. Both trees may have been compromised by wall construction in past few years; roots may have been damaged by excavation work.

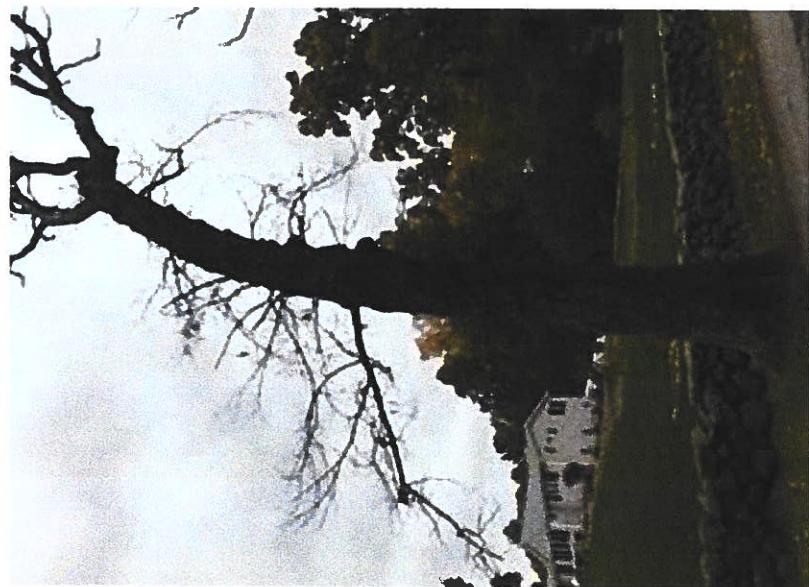
ID21 White Oak (TRC 89"; HT 50'; CR 40')

Comments: This is one of two dead Oaks opposite 22 Flagg Road. Both trees may have been compromised by wall construction in past few years; roots may have been damaged by excavation work.

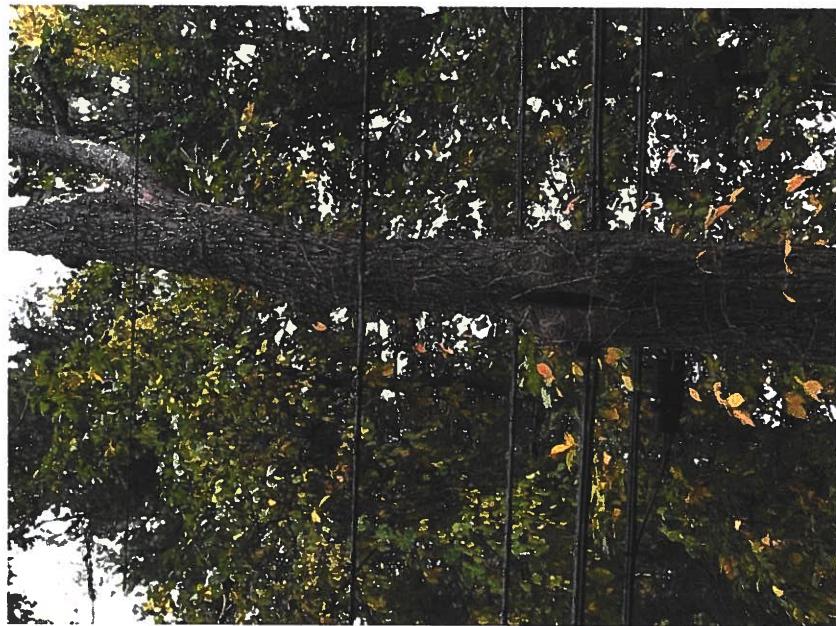
ID24 Pignut Hickory (TRC 90"; HT 40'; CR 40')

Comments: This Hickory is declining rapidly. There is evidence of wood decay behind several cavities on the trunk. The tree is unstable and as several missing branches reveal prone to failing.

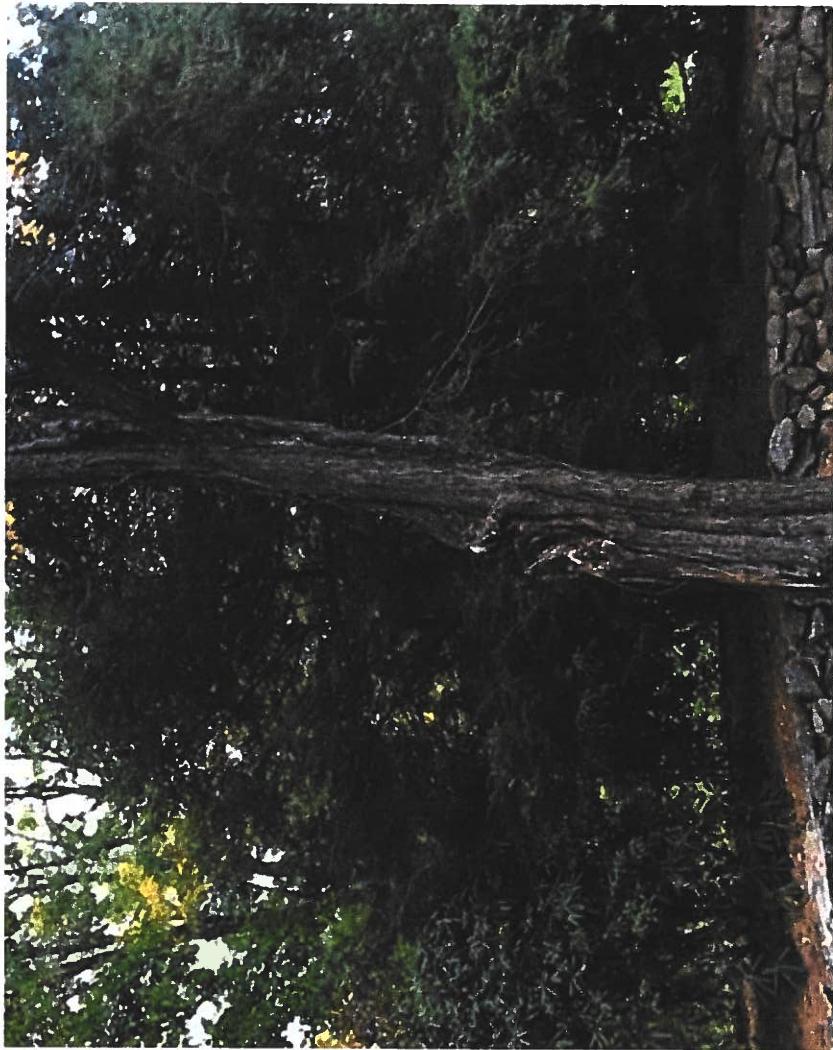
ID31 Red Maple (TRC 95"; HT 30'; CR 25')

Comments: This Red maple has lost half of the crown, has numerous trunk cavities and cankers. It is unstable.

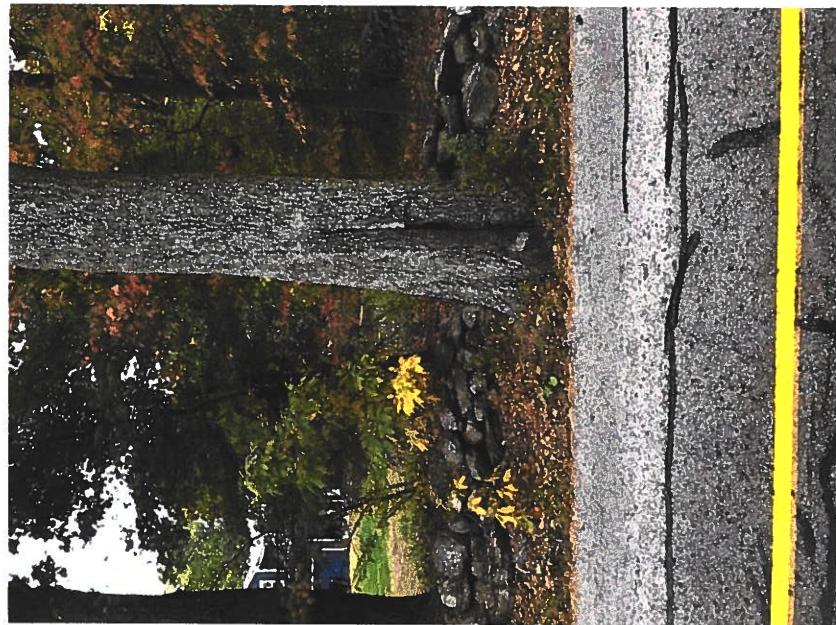
ID41 Red Oak (TRC 80"; HT 30'; CR 20')

Comments: Top of tree is 40% dead; Also, severe vertical crack can be found at base of trunk. The latter is extremely serious and definitely compromises the wood strength of the trunk. The tree should be removed.

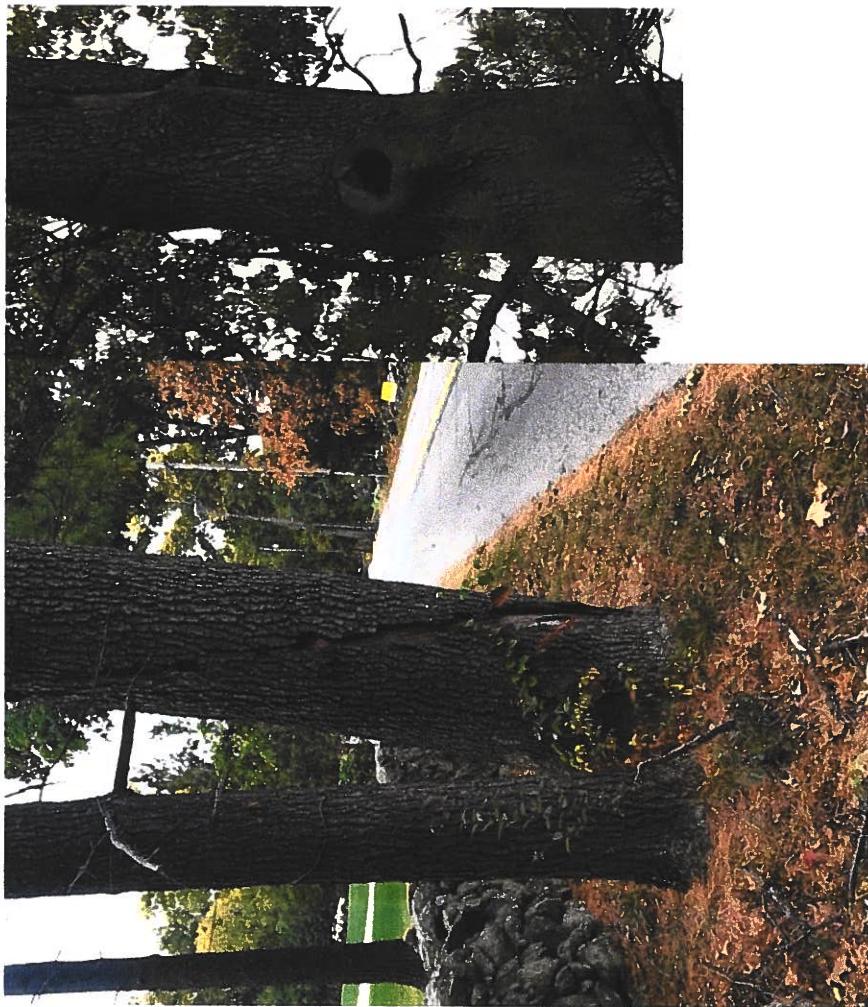
ID35 Red Oak (TRC 116"; HT 55'; CR 40')

Comments: This Red Oak grows next to White Pine ID36 (photo left). The Oak is seriously flawed structural with missing bark, wood decay and cavities from the base to top of trunk (photo right).

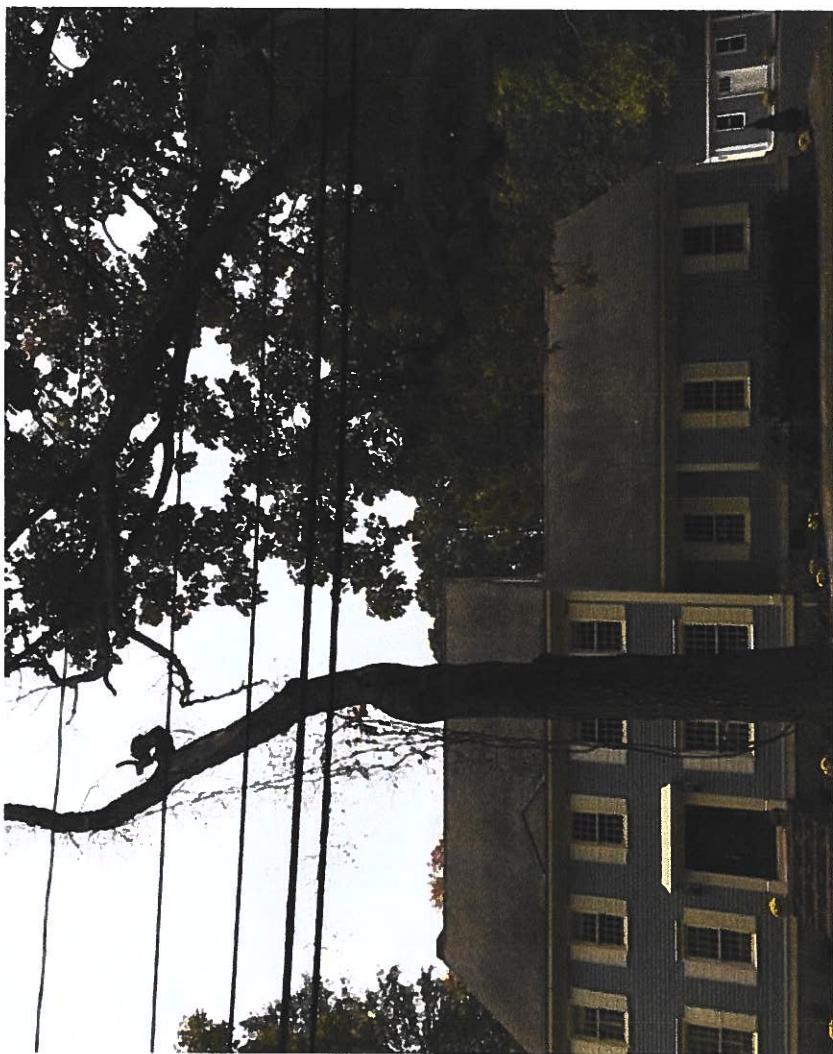
ID38 Red Oak (TRC 62"; HT 35'; CR 5')

Comments: This Red Oak was topped in the recent past. The trunk now remains; it's rotted and unsafe.

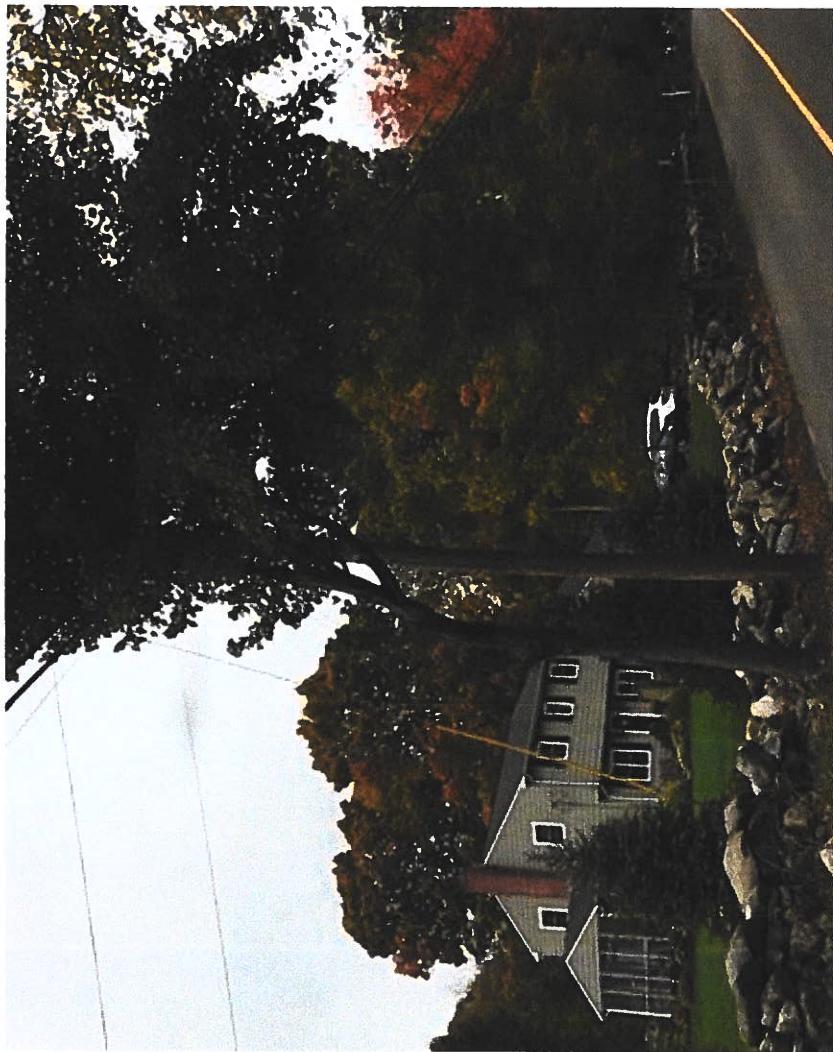
ID45 Red Maple (TRC 20"; HT 25'; CR 20')

Comments: The crown of this Red Maple is one-sided from past utility line clearance. The trunk lean is also a structural defect that make the tree vulnerable to breaking in storms.

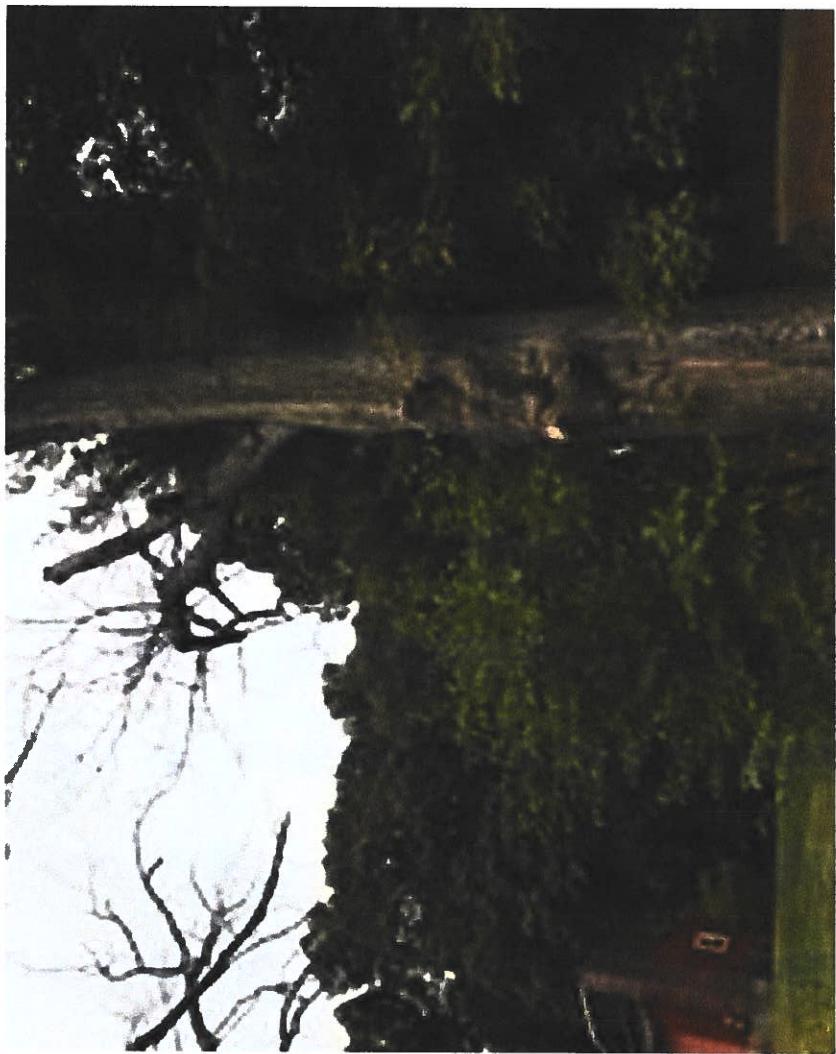
ID48 Red Oak (TRC 156"; HT 35'; CR 20')

Comment: This Oak is located north of 69-71 Flagg Rd driveway. The tree is rotted and seriously flawed. It is unstable and very hazardous.

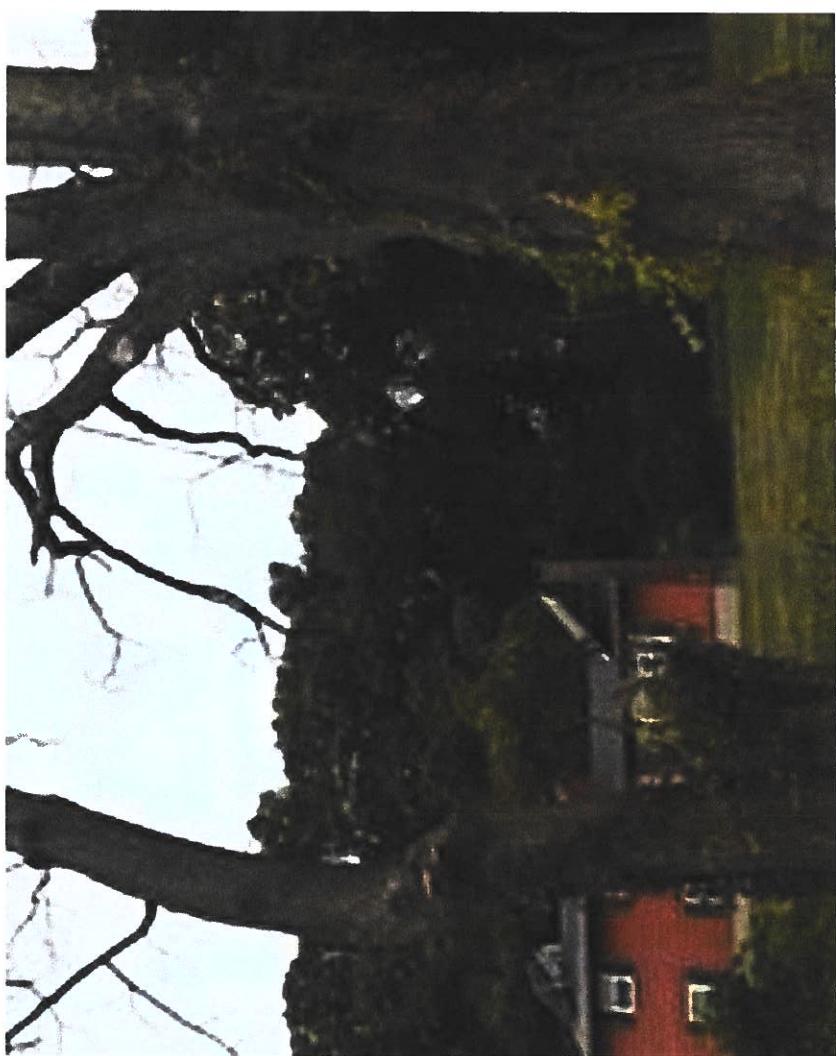
Comments: This Oak ID49 is located on right side of photo. The tree is dead and hazardous.

Comments: This Oak ID50 is located on left side of photo. The tree is dead and hazardous.

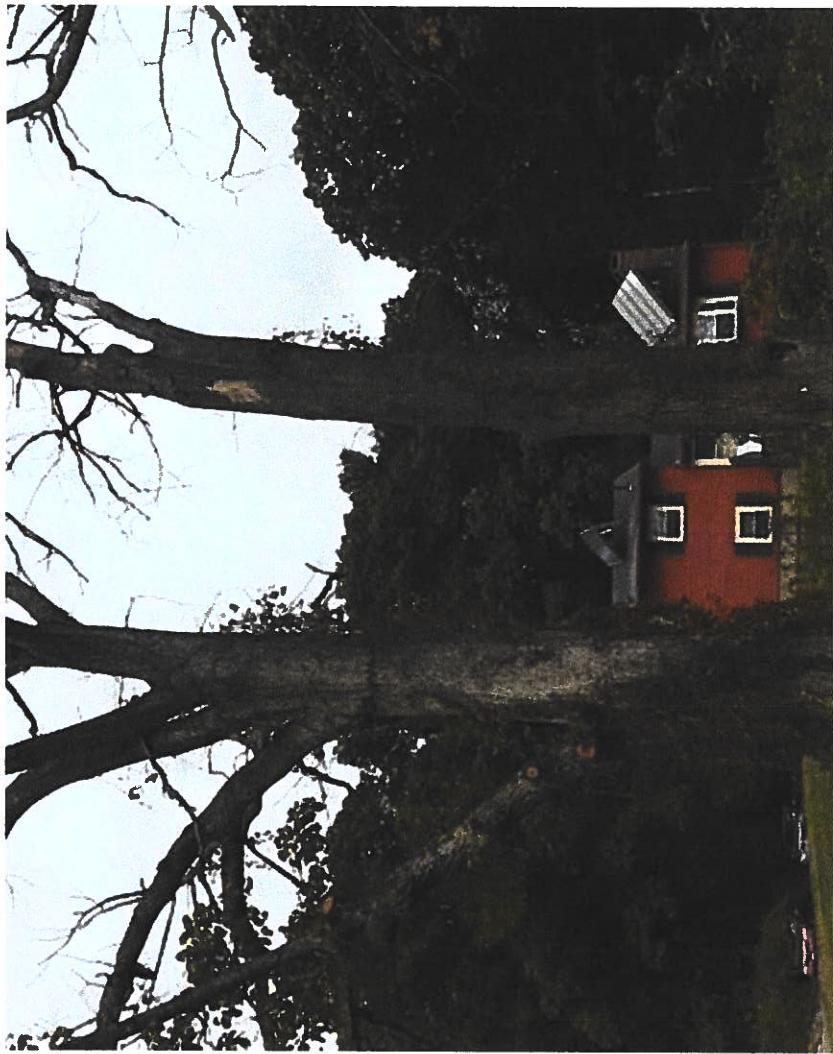
Comments: This Oak ID51 is located on right side of photo. The tree is dead and hazardous.

Comments: This Oak ID52 is located on left side of photo. The tree is dead and hazardous.

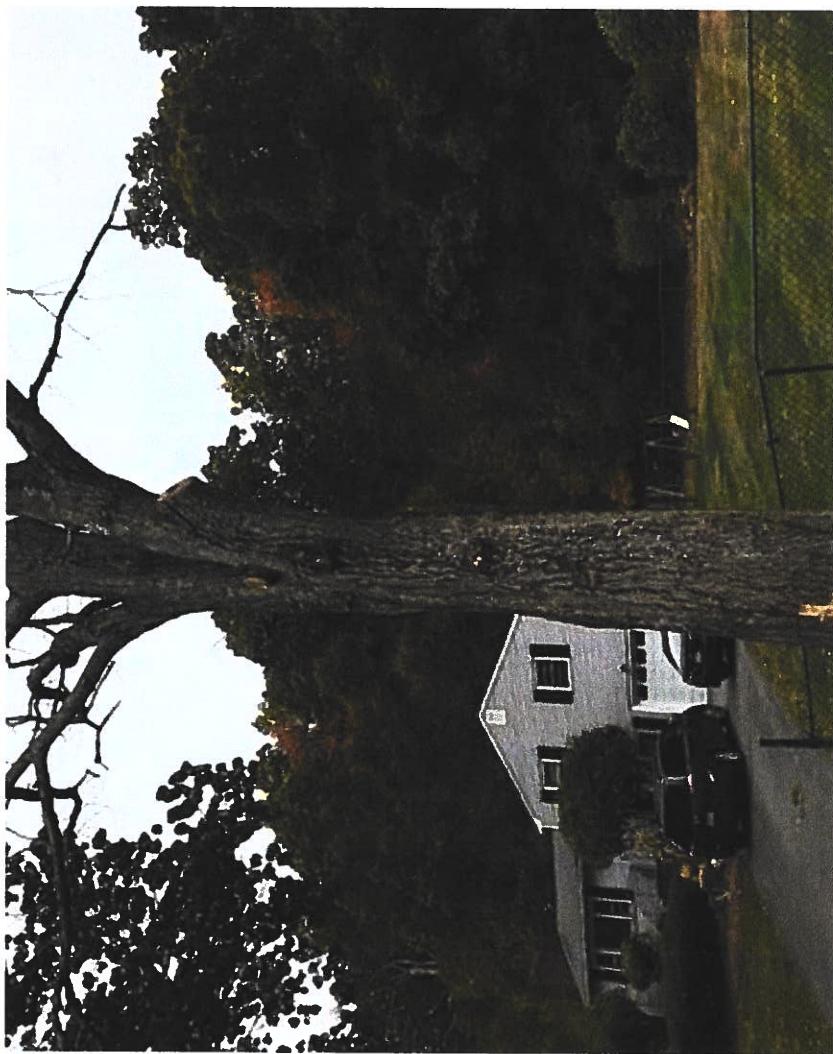
ID53 Red Oak (TRC 116"; HT 48'; CR 20')

Comments: This Oak is dead. The tree has bad cracks at the trunk base and is hazardous.

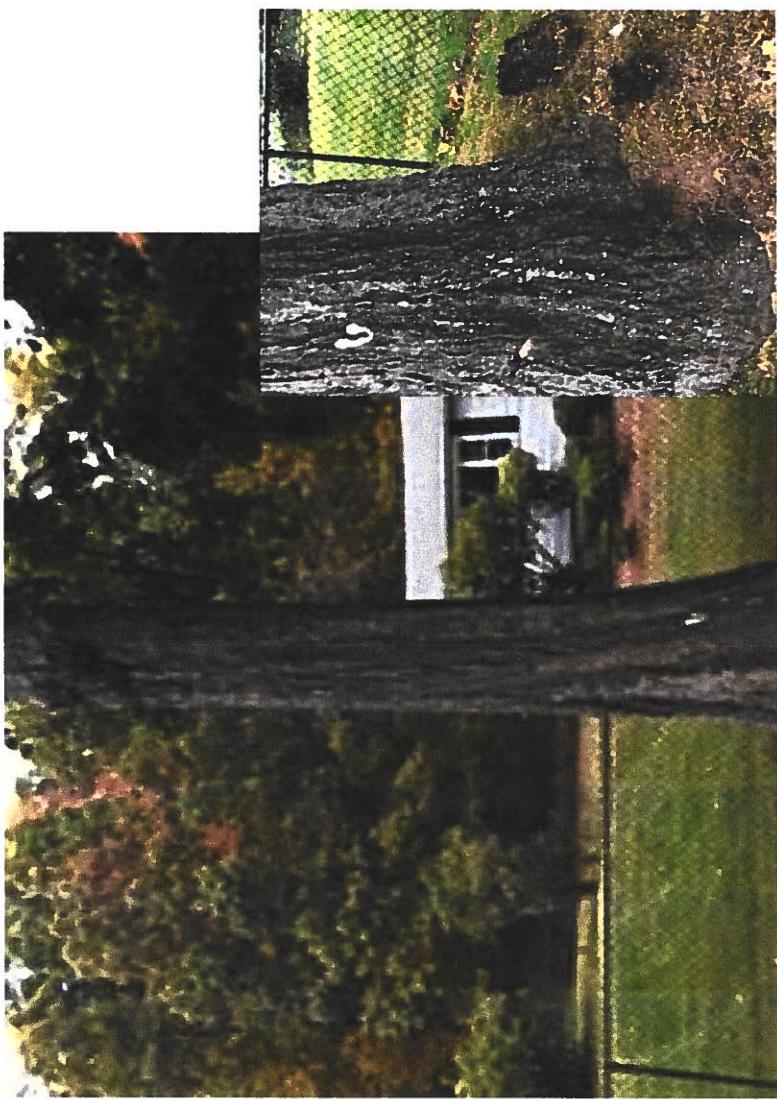
ID56 Red Oak (TRC 115"; HT 68'; CR 20')

Comments: This Oak is dying. The trunk is rotted and there is evidence of fungal root decay at the trunk-root interface (see right photo).

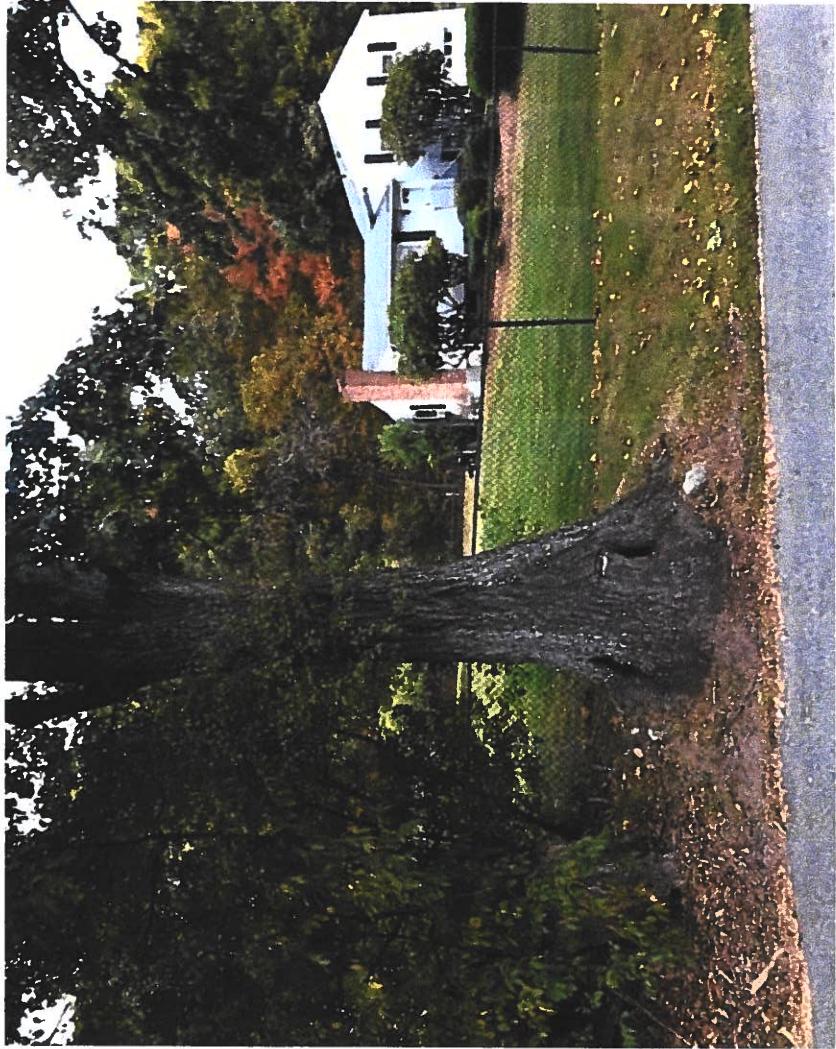
ID57 Red Oak (TRC 115"; HT 68'; CR 20')

Comments: This Oak has numerous dead branches in the crown. But the worse flaw is the presence of deep cavities located at the trunk base. They seriously compromise the stability of this oak. The tree is hazardous and should be removed.

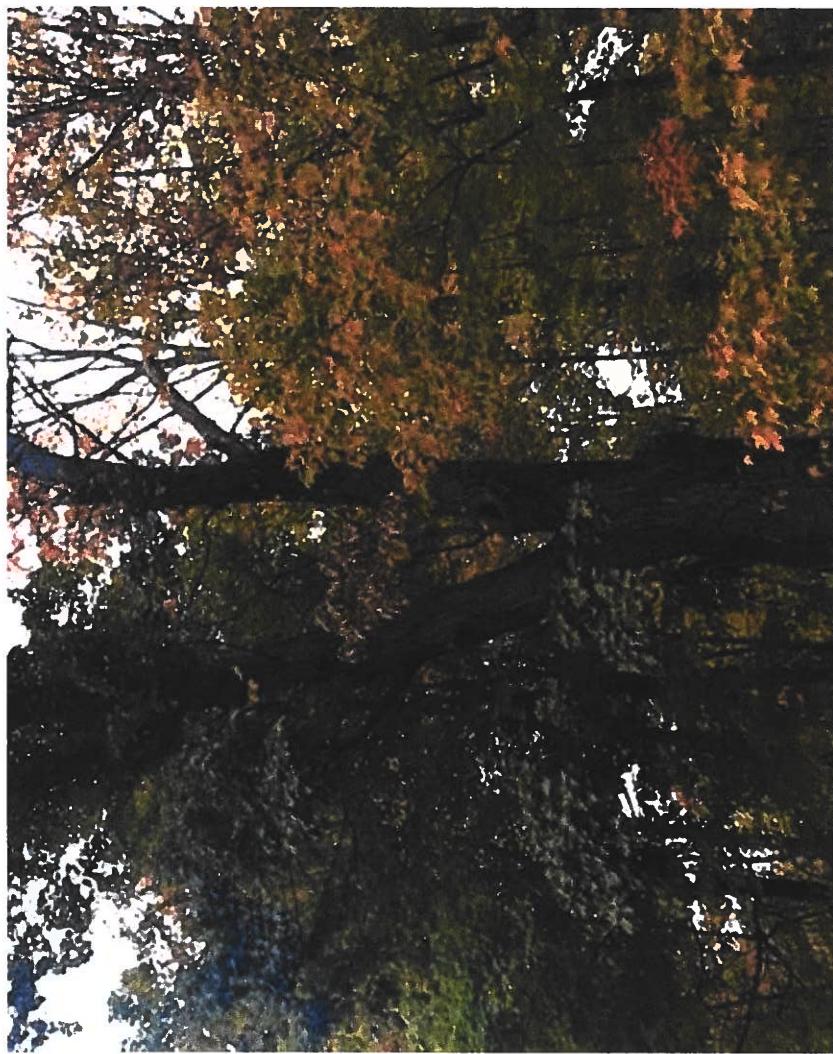
ID58 Red Oak (TRC 119"; HT 55'; CR 50')

Comments: This Oak is on road between 75-77 Flagg Rd. The crown on one-half of the tree is dead. There are several trunk cavities and several places also have missing bark. These flaws are severe and reveal the mechanical stability of the tree has been compromised.

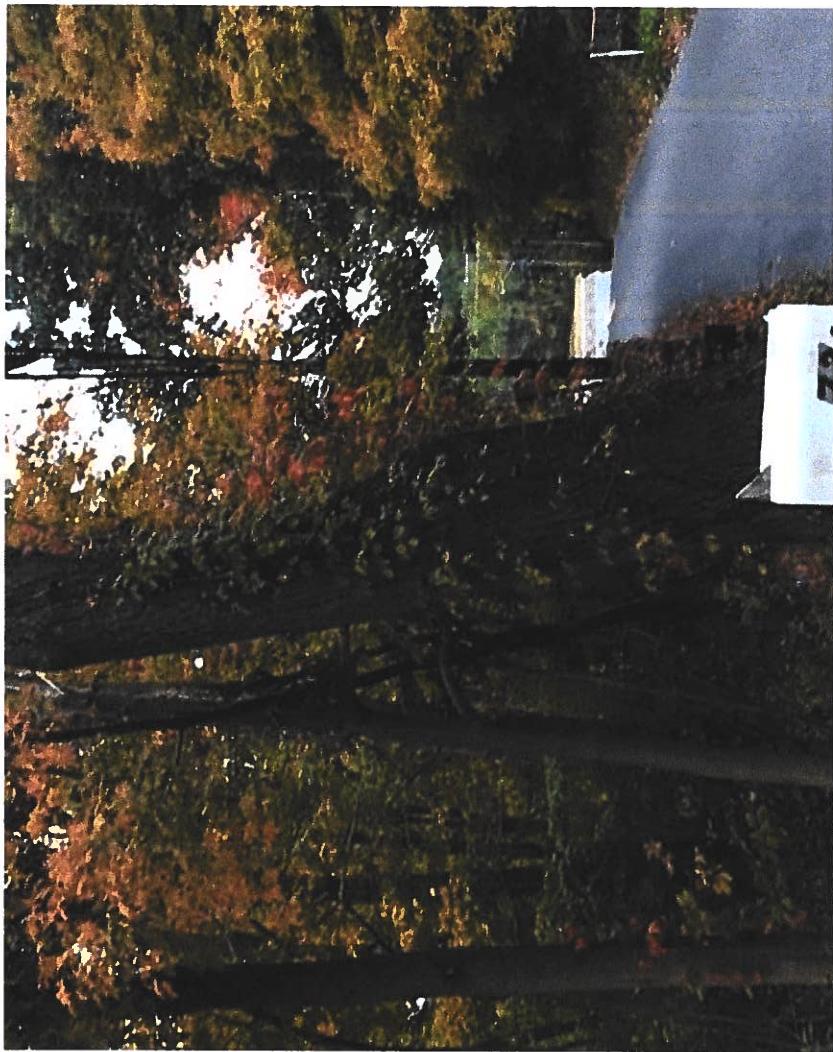
ID59 Red Oak (TRC 106"; HT 25'; CR 05')

Comments: This Oak was topped in the recent past. Only the trunk up to 25' in height remains.
