Excavated Materials Management Plan

Breakneck Hill Farm Dumping Site

**Breakneck Hill Road
Southborough, Massachusetts**

August 2023

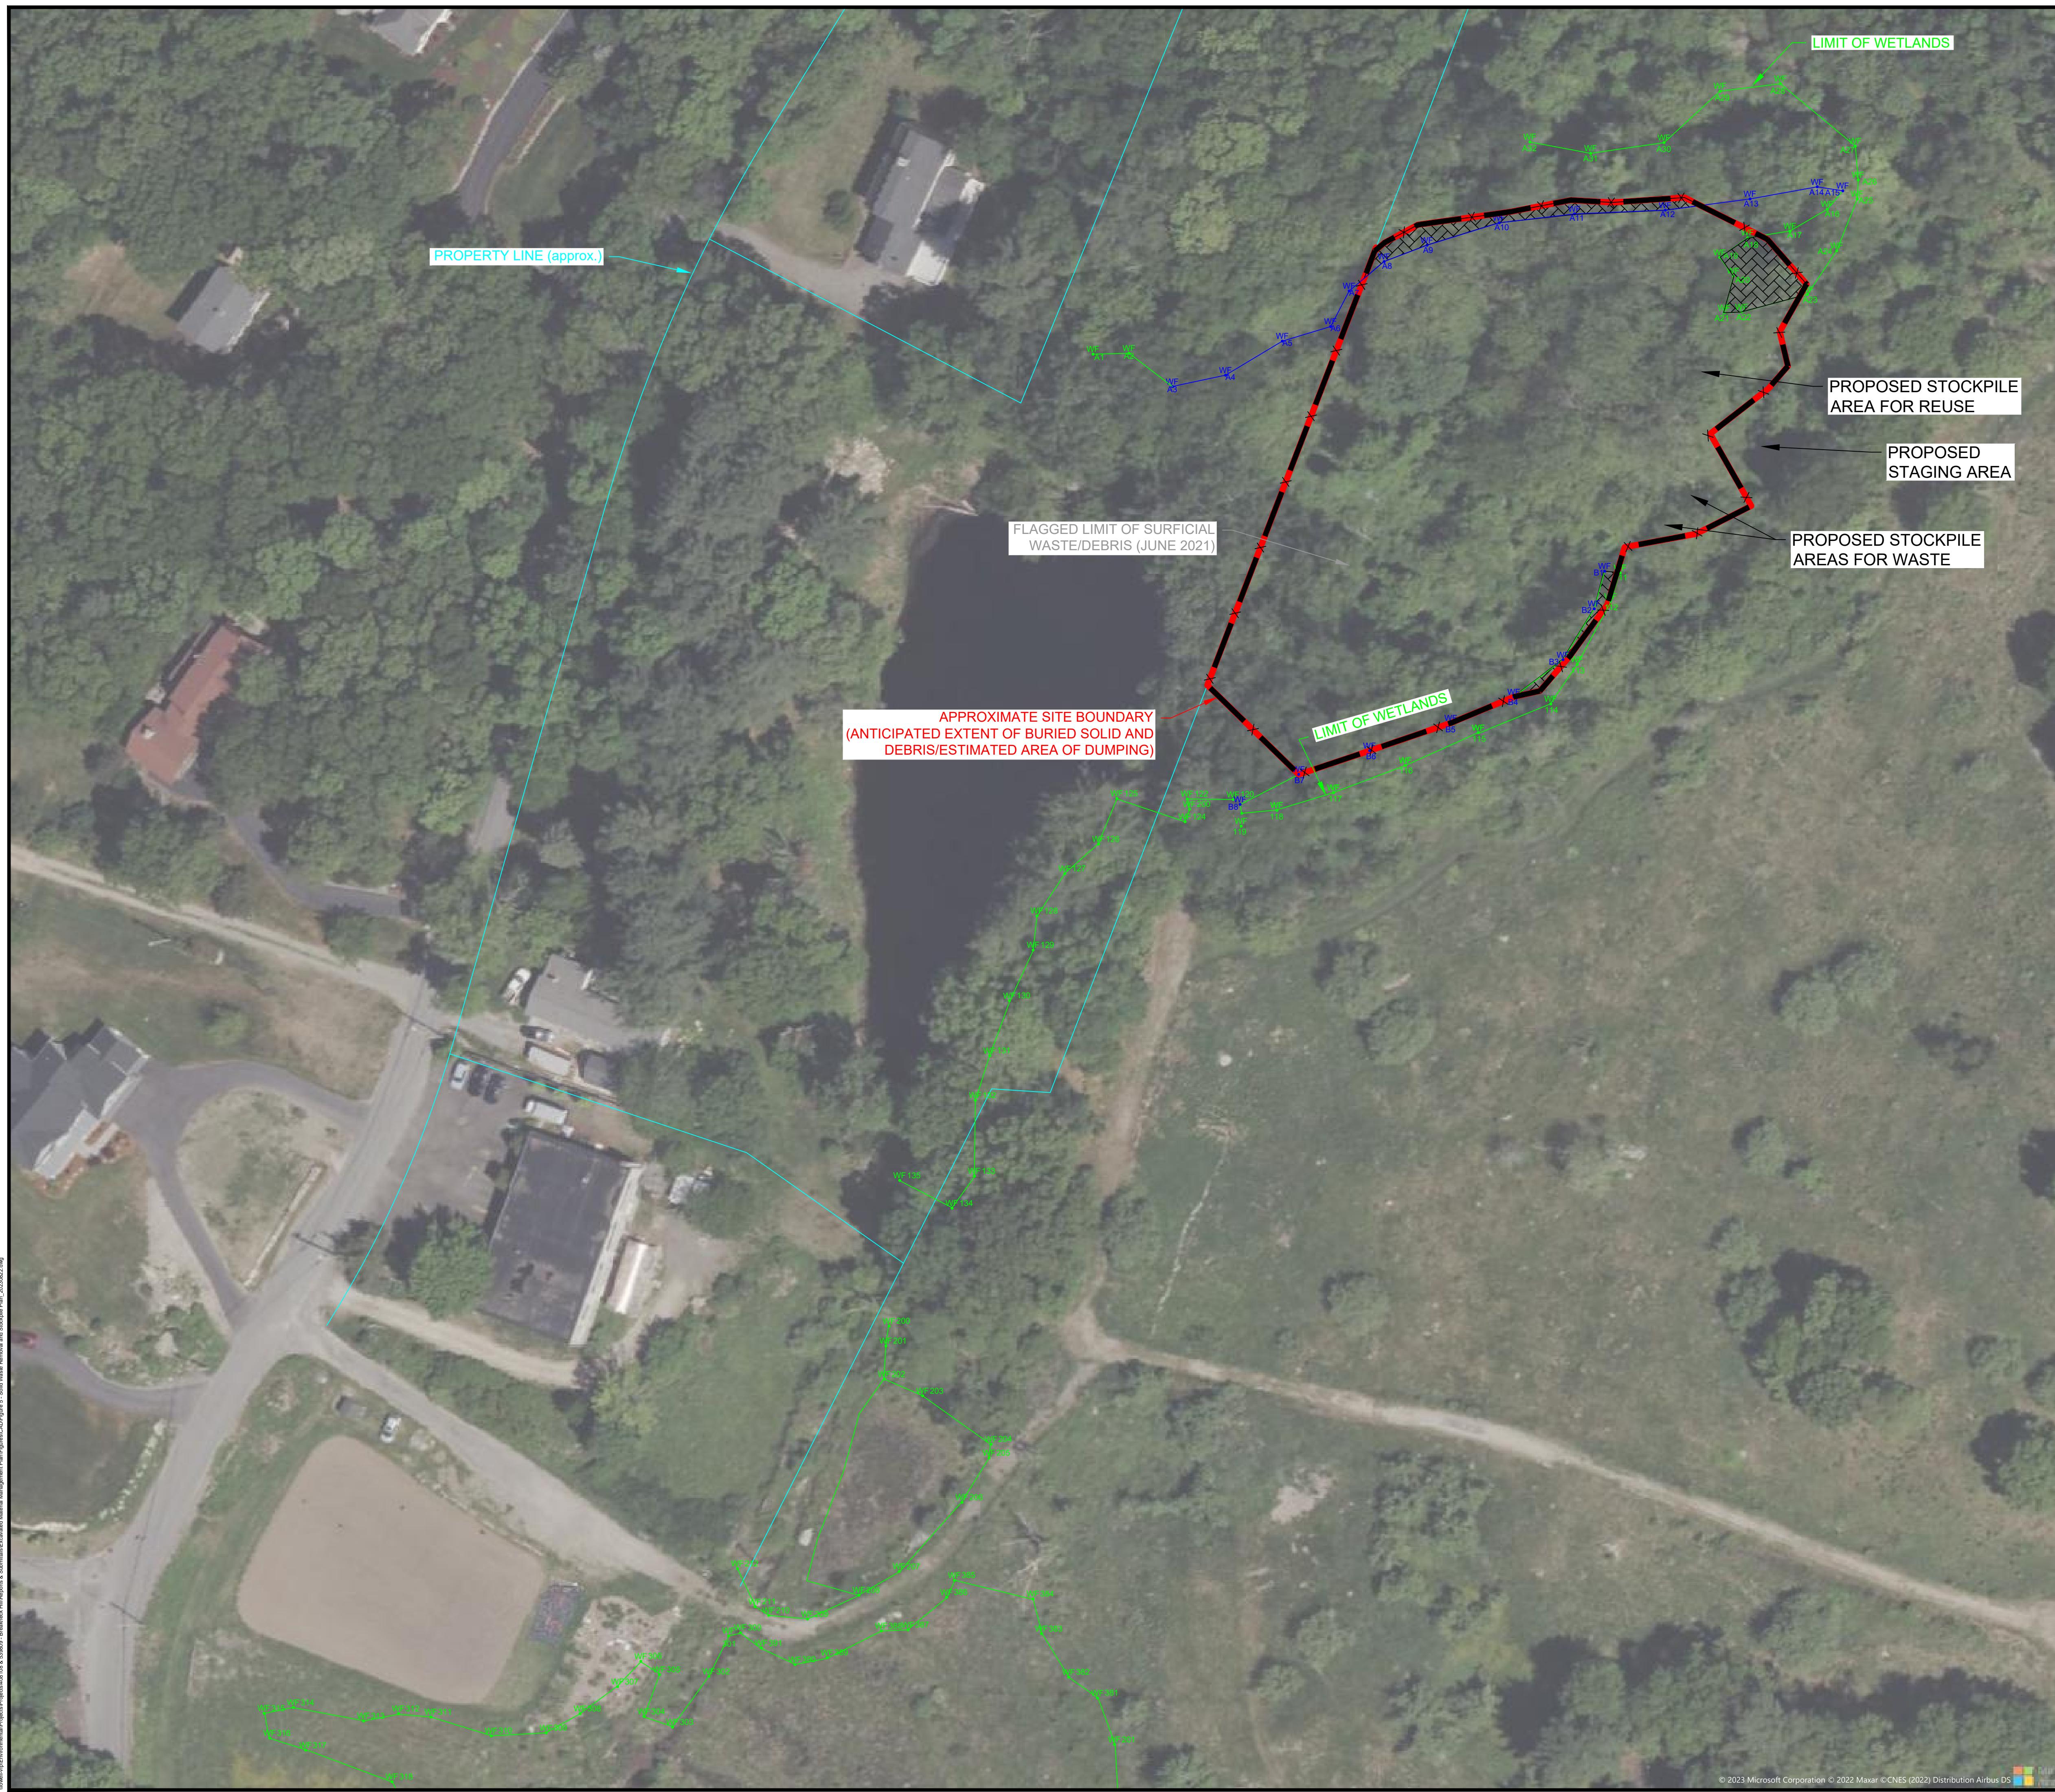
The cleanup contractors will segregate excavated materials in stockpiles based on material classification, field screening activities, and requirements of the anticipated disposal/recycling facilities. Stockpiled materials are anticipated to include solid waste/debris comingled with residual soil, solid waste free of soil, recyclable metals, rubber tires, ACM comingled with soil, and soil and other non-waste materials proposed for on-Site reuse. The cleanup contractors will manage stockpiles to prevent erosion and infiltration and secure the stockpiles to prevent exposure to humans and the surrounding environment. When not in use and at the end of each workday, the cleanup contractors will securely cover the stockpiles with 10 mil (at minimum) polyethylene sheeting and surrounded with adequate erosion and sediment controls. Contaminated soil (or other materials) will be placed on polyethylene sheeting to prevent potential impacts to underlying soil, and erosion and sediment controls will be installed downgradient of the stockpiles. Stockpiles will be weighted to keep the polyethylene sheeting from be entrained by wind. Weights will be tires, sandbags, and similar materials as opposed to boards, concrete with sharp edges, and similar materials that will puncture the sheeting or cause it to shred during windy conditions.

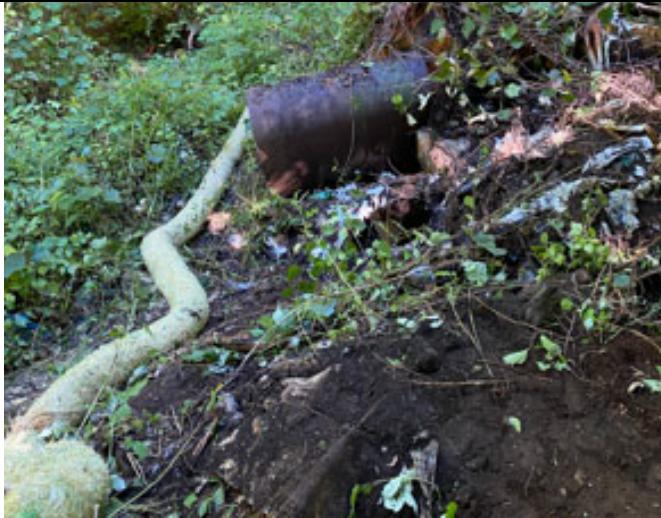
Photo 1: Test Pit TP(100,215); refer to **Figure 4** for location and **Appendix E** for a description of materials encountered

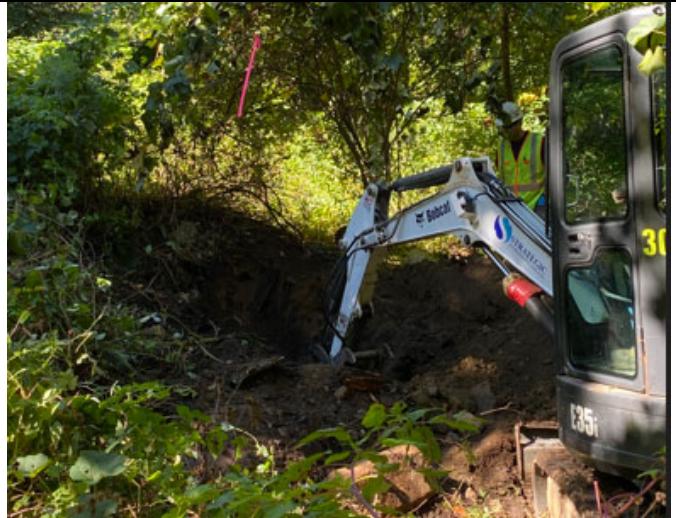
Photo 2: Test Pit TP(55,200); refer to **Figure 4** for location and **Appendix E** for a description of materials encountered

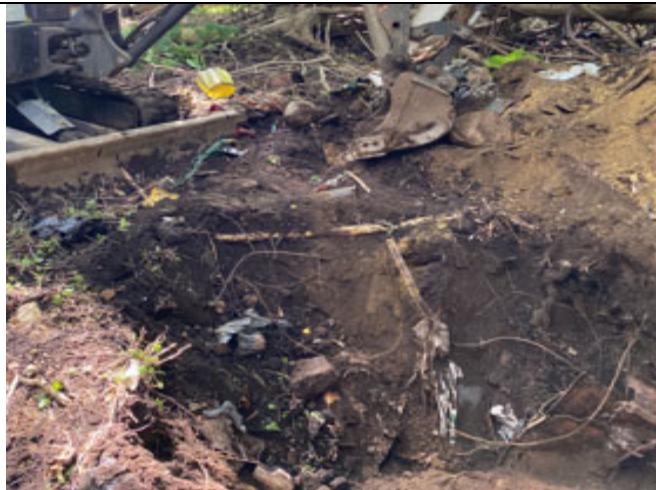
Photo 5: Test Pit TP(193,158); refer to **Figure 4** for location and **Appendix E** for a description of materials encountered

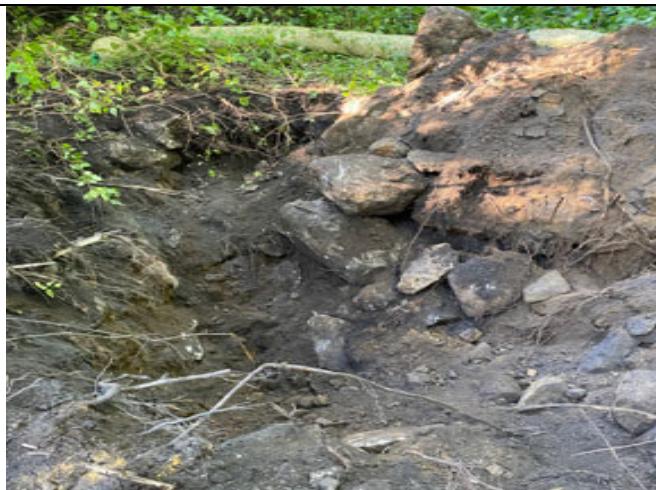
Photo 7: Test Pit TP(200,20); refer to **Figure 4** for location and **Appendix E** for a description of materials encountered

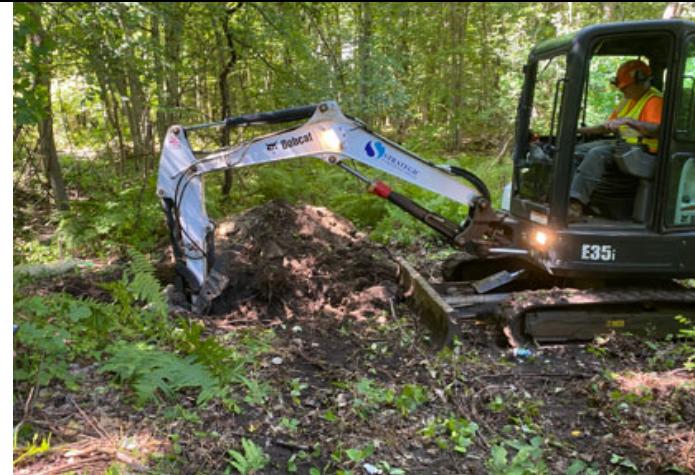
Photo 9: Test Pit TP(255,140); refer to **Figure 4** for location and **Appendix E** for a description of materials encountered

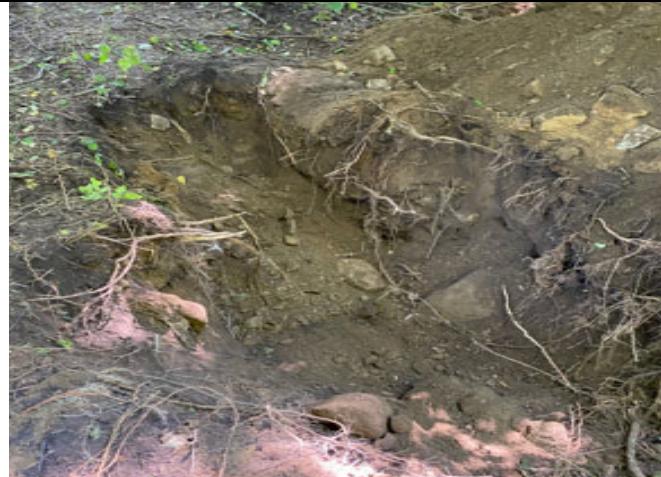
Photo 10: Test Pit TP(100,20); refer to **Figure 4** for location and **Appendix E** for a description of materials encountered

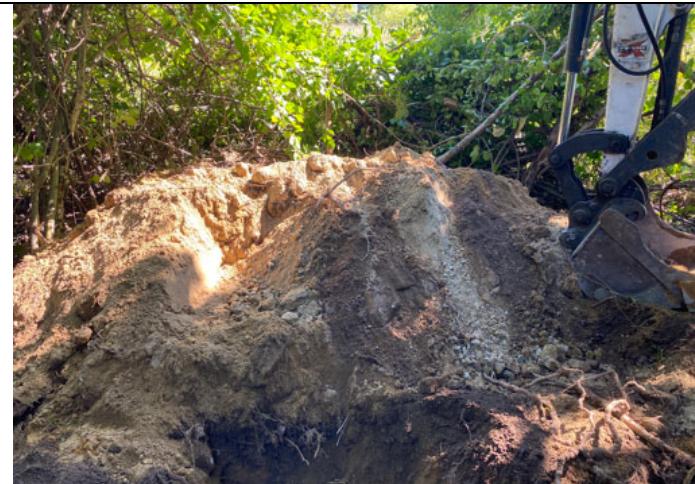
Photo 11: Test Pit TP(0,-8), refer to **Figure 4** for location and **Appendix E** for a description of materials encountered

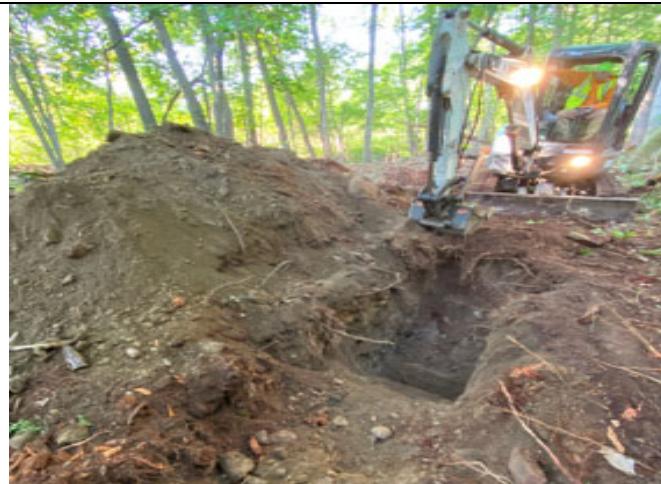
Photo 12: Test Pit TP(-20,100); refer to **Figure 4** for location and **Appendix E** for a description of materials encountered

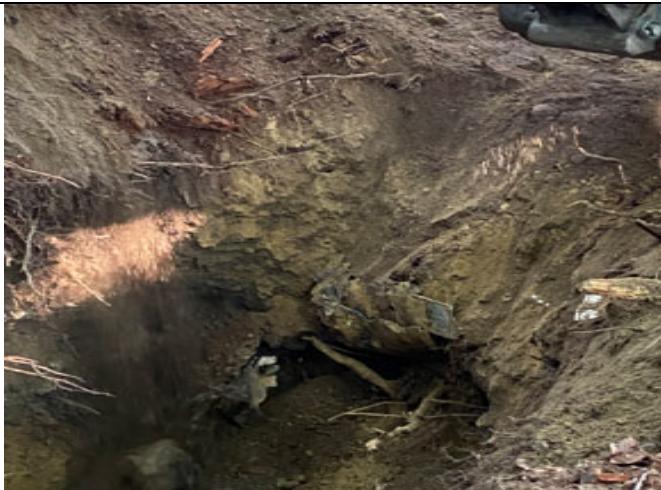
Photo 13: Test Pit TP(-50,100); refer to **Figure 4** for location and **Appendix E** for a description of materials encountered

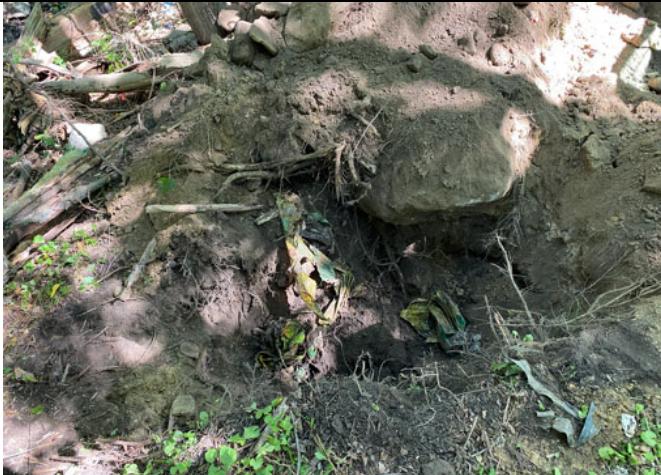
Photo 15: Test Pit TP(255,137); refer to **Figure 4** for location and **Appendix E** for a description of materials encountered

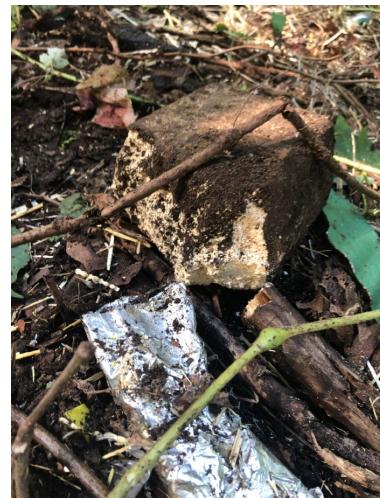
Sample Numbers: 02-A, 02-B, 02-C
Material Description: Boiler Brick
Material Color: Tan
Accessible Material: Accessible
Reason Inaccessible: N/A
Asbestos Detected: Negative
Asbestos Type: No Asbestos Detected
Homogeneous Area:
Total Approximate Quantity: TBD
Condition: N/A
Material Type: N/A
NESHAP Category: N/A
Notes: Not Applicable

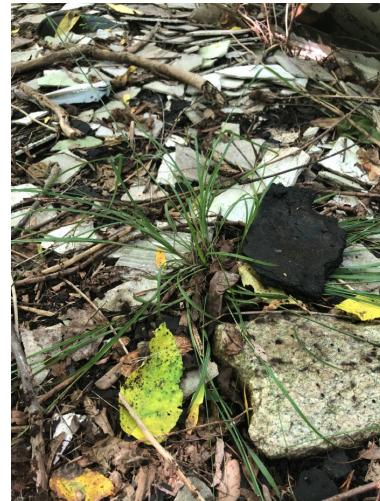
Sample Numbers: 03-A, 03-B, 03-C
Material Description: Roofing Asphalt Based Built-Up
Material Color: Black
Accessible Material: Accessible
Reason Inaccessible: N/A
Asbestos Detected: Positive
Asbestos Type: 5% Chrysotile
Homogeneous Area: 200,150 Surface
Total Approximate Quantity: 200 SF
Condition: N/A
Material Type: N/A
NESHAP Category: N/A
Notes: Not Applicable

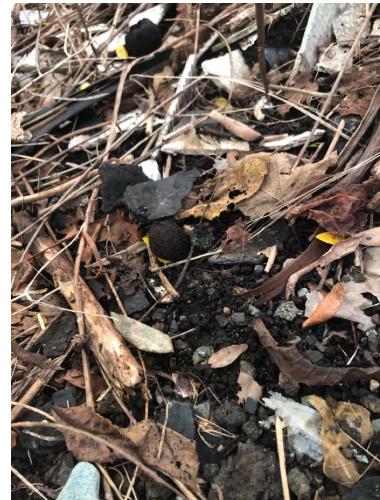
Sample Numbers: 04-A, 04-B, 04-C
Material Description: Roofing Felt Paper
Material Color: Black
Accessible Material: Accessible
Reason Inaccessible: N/A
Asbestos Detected: Negative
Asbestos Type: No Asbestos Detected
Homogeneous Area: 200,150 Surface
Total Approximate Quantity: 200 SF
Condition: N/A
Material Type: N/A
NESHAP Category: N/A
Notes: Not Applicable

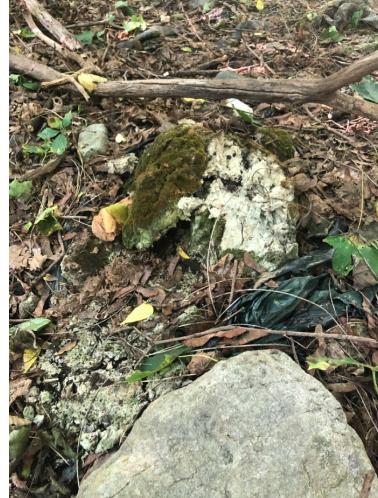
Sample Numbers: 05-A, 05-B, 05-C
Material Description: Insulation Unknown
Material Color: Grey
Accessible Material: Accessible
Reason Inaccessible: N/A
Asbestos Detected: Negative
Asbestos Type: No Asbestos Detected
Homogeneous Area: 100,180 By Truck
Total Approximate Quantity: 10 SF
Condition: N/A
Material Type: N/A
NESHAP Category: N/A
Notes: Not Applicable

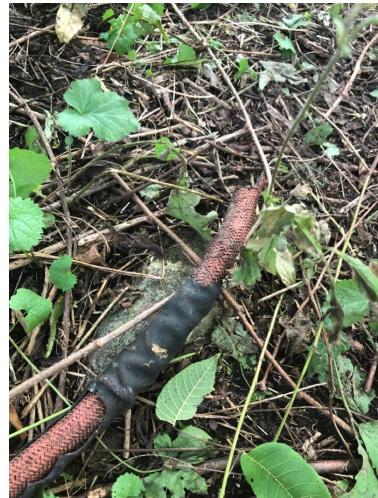
Sample Numbers: 06-A, 06-B, 06-C
Material Description: Wire Insulation
Material Color: Red
Accessible Material: Accessible
Reason Inaccessible: N/A
Asbestos Detected: Negative
Asbestos Type: No Asbestos Detected
Homogeneous Area: 25' SE 100,100
Total Approximate Quantity: 10 LF
Condition: N/A
Material Type: N/A
NESHAP Category: N/A
Notes: Not Applicable

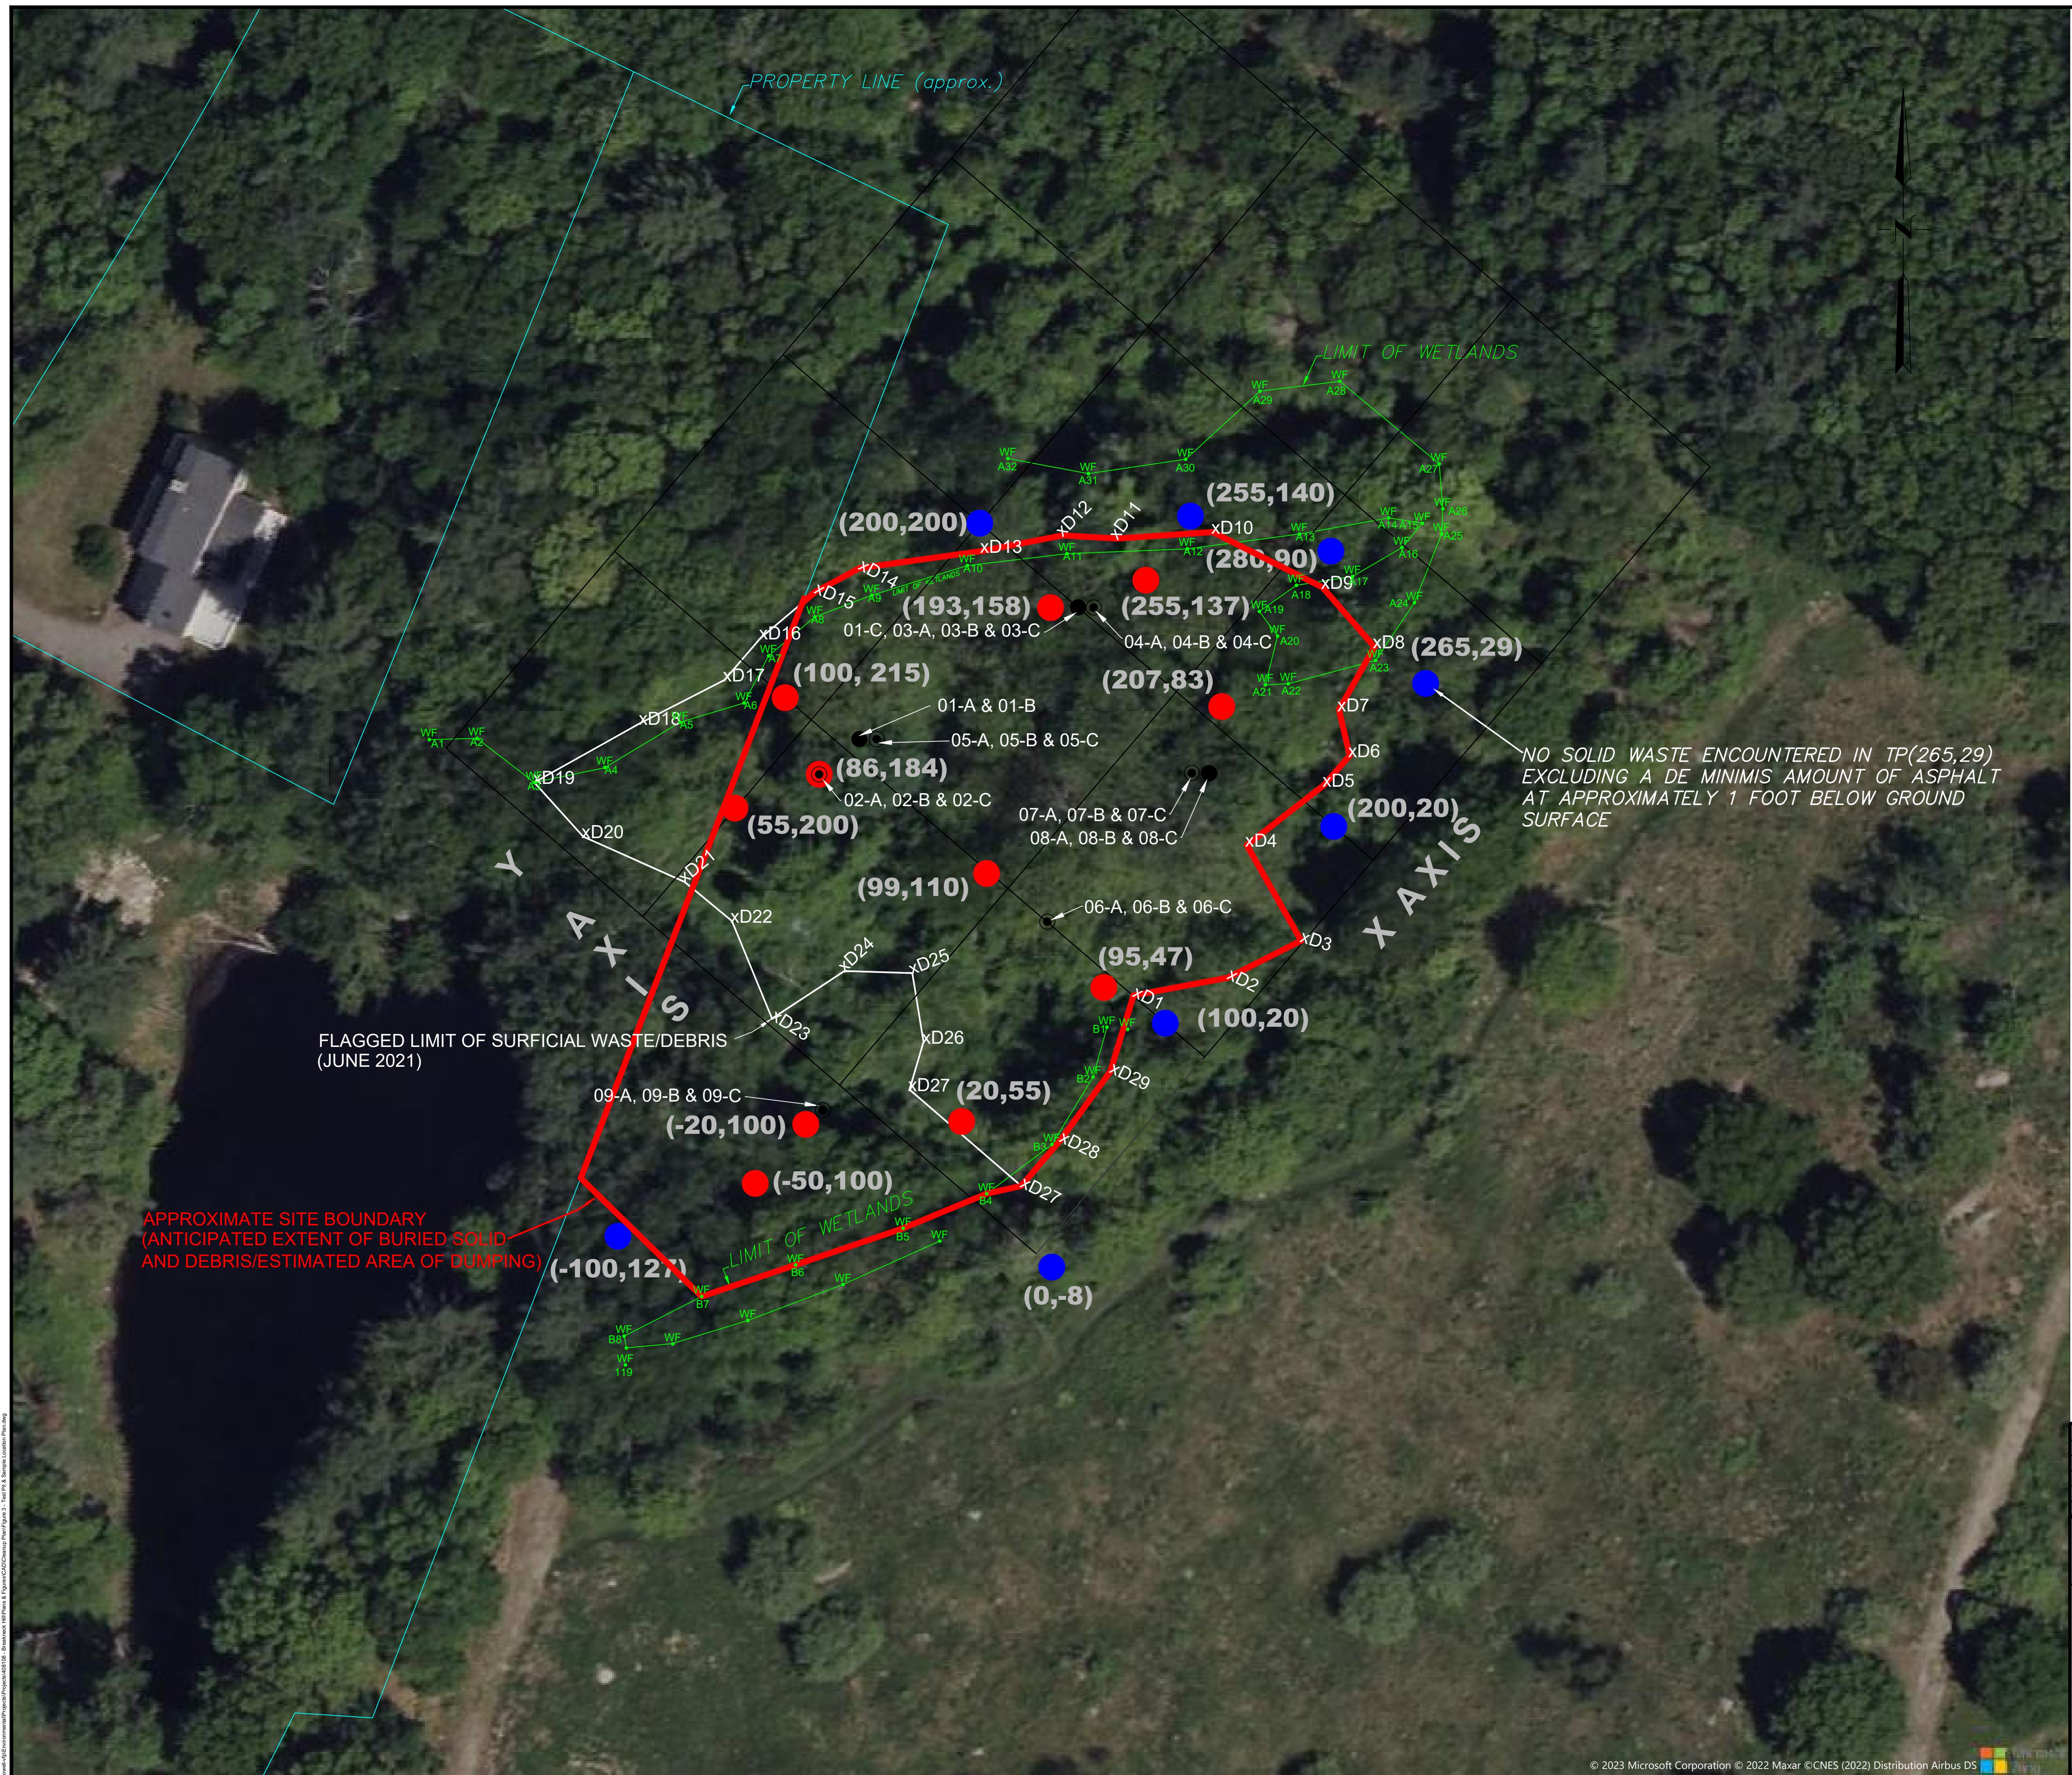
restrictions, the horizontal extent of buried solid waste and debris was not able to be delineated beyond the western property boundary, extending towards the abutting residential property. The test pits installed at the Site generally encountered light-brown to dark-brown silt with varying amount of sand, cobbles, and solid waste. Groundwater was not encountered during the test pitting program to a maximum explored depth of approximately 8.5 feet bgs. No drums, tanks, or other containers housing hazardous waste or materials were encountered at the Site during the September 2022 test pitting program. However, several corroded drums, tanks, and/or other discarded containers were encountered during the test pitting program; these containers were empty, and evidence of releases stemming from the empty containers was not observed. Leachate, sheens and/or OHM seeps were not encountered at the Site during the test pitting program. Test pit locations are depicted on **Figure 3**, and the test pit logs are included as **Appendix A**. In addition, a photographic log is also provided as **Appendix B**.

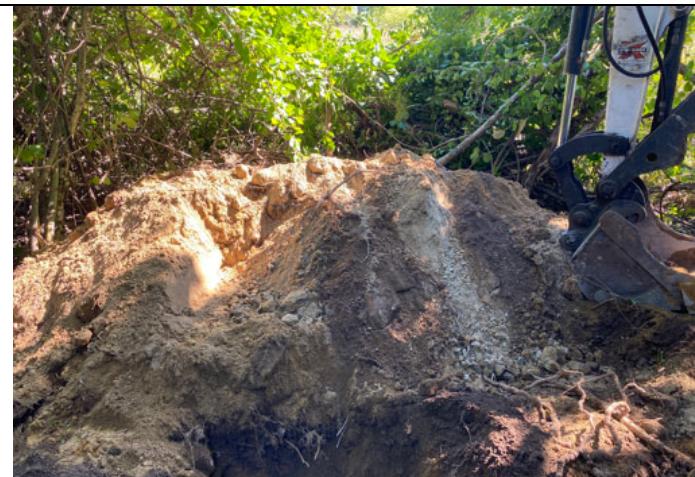
Photo 11: Test Pit TP(0,-8), refer to **Figure 4** for location and **Appendix E** for a description of materials encountered

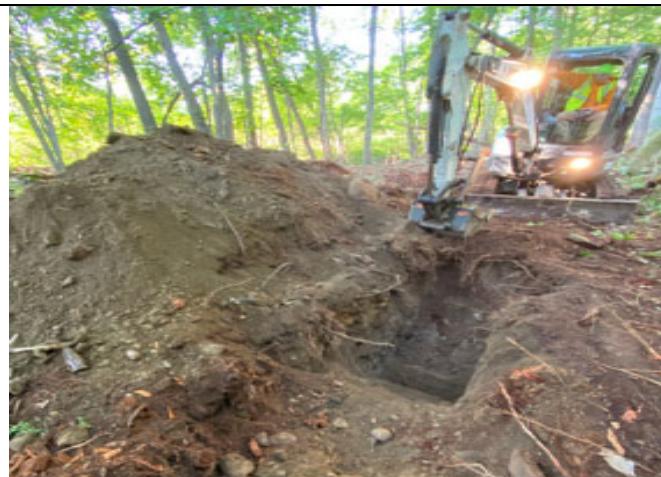
Photo 12: Test Pit TP(-20,100); refer to **Figure 4** for location and **Appendix E** for a description of materials encountered

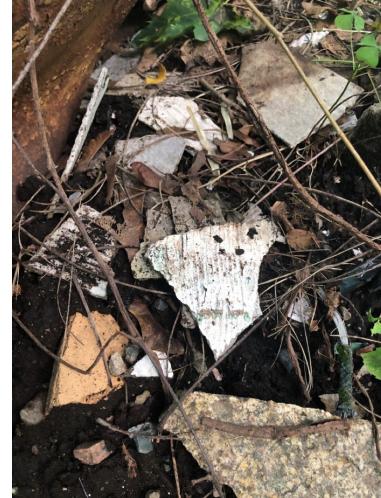
Sample Numbers: 01-A, 01-B, 01-C
Material Description: Cement Board
Material Color: Grey
Accessible Material: Accessible
Reason Inaccessible: N/A
Asbestos Detected: Positive
Asbestos Type: 20% Chrysotile
Homogeneous Area: 200,150 Surface , 100,180 Truck
Total Approximate Quantity: 300 SF
Condition: N/A
Material Type: N/A
NESHAP Category: N/A
Notes: Not Applicable

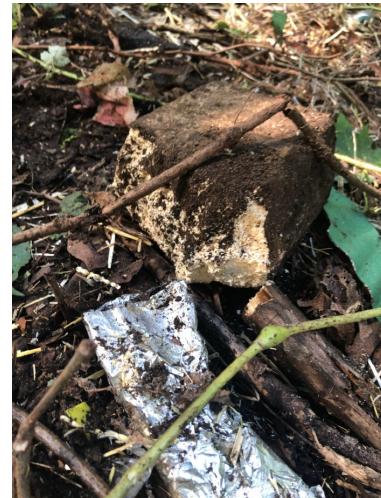
Sample Numbers: 02-A, 02-B, 02-C
Material Description: Boiler Brick
Material Color: Tan
Accessible Material: Accessible
Reason Inaccessible: N/A
Asbestos Detected: Negative
Asbestos Type: No Asbestos Detected
Homogeneous Area:
Total Approximate Quantity: TBD
Condition: N/A
Material Type: N/A
NESHAP Category: N/A
Notes: Not Applicable

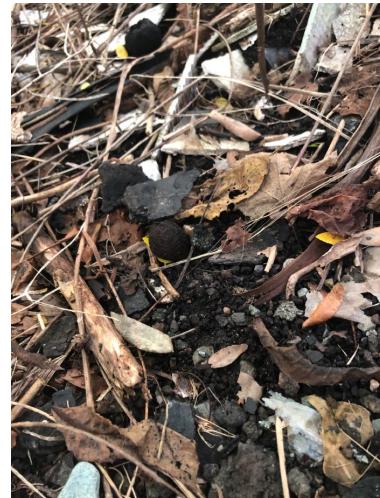
Sample Numbers: 04-A, 04-B, 04-C
Material Description: Roofing Felt Paper
Material Color: Black
Accessible Material: Accessible
Reason Inaccessible: N/A
Asbestos Detected: Negative
Asbestos Type: No Asbestos Detected
Homogeneous Area: 200,150 Surface
Total Approximate Quantity: 200 SF
Condition: N/A
Material Type: N/A
NESHAP Category: N/A
Notes: Not Applicable
