Environmental Monitoring & Mitigation Plan

Breakneck Hill Farm Dumping Site

**Breakneck Hill Road
Southborough, Massachusetts**

August 2023

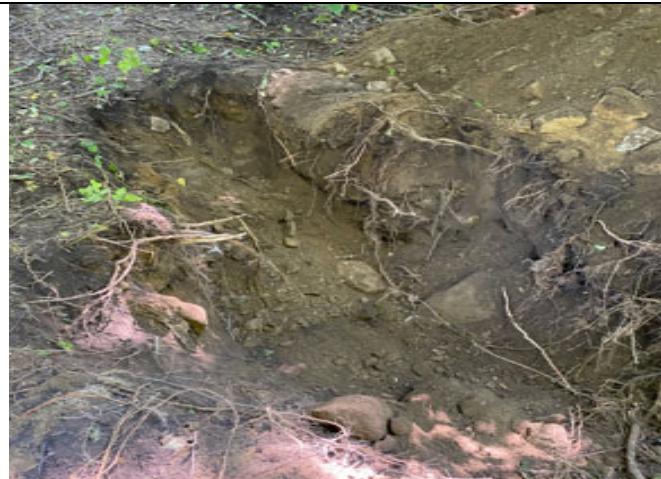
Photo 10: Test Pit TP(100,20); refer to **Figure 4** for location and **Appendix E** for a description of materials encountered

DEPTH (ft. BGL)	SAMPLE ID.	GRAPHIC LOG	LITHOLOGIC DESCRIPTION	PID (ppm)	NOTES
-			Dark-brown SILT, some sand, trace organics (no odor/staining, dry).		Solid waste was not encountered in test pit TP(100,20).
- 1			Dark-brown SILT, some sand, boulders and cobbles (no odor/staining, dry).	0.1	
- 2				0.1	
- 3				0.1	
- 4				0.0	
- 5			Test pit terminated at 5 feet below ground surface.	0.0

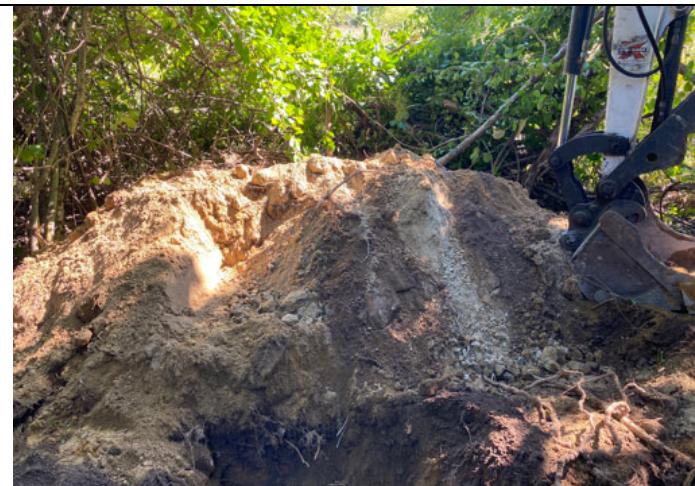
Photo 11: Test Pit TP(0,-8), refer to **Figure 4** for location and **Appendix E** for a description of materials encountered

DEPTH (ft. BGL)	SAMPLE ID.	GRAPHIC LOG	LITHOLOGIC DESCRIPTION	PID (ppm)	NOTES
-			Dark-brown SILT, some sand, trace organics (no odor/staining, dry).		Solid waste was not encountered in test pit TP(0,-8).
- 1			Brown SILT, some sand (no odor/staining, dry).		
- 2			Light-brown SILT, some sand, boulders and cobbles (no odor/staining, dry).		
- 3				0.6	
- 4					
- 5			Test pit terminated at 5 feet below ground surface.	0.1

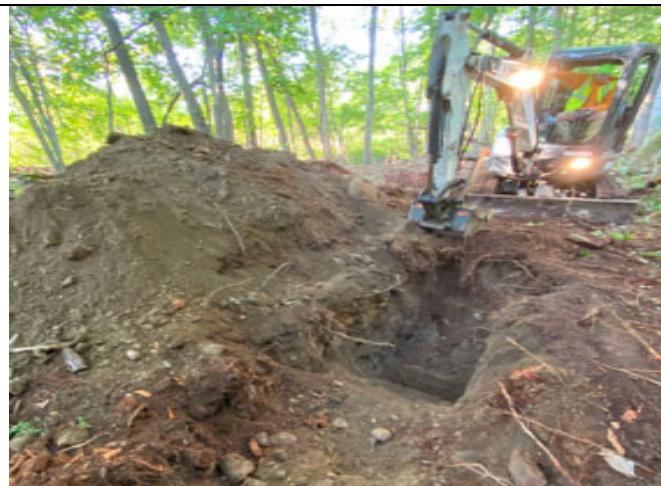
Photo 12: Test Pit TP(-20,100); refer to **Figure 4** for location and **Appendix E** for a description of materials encountered

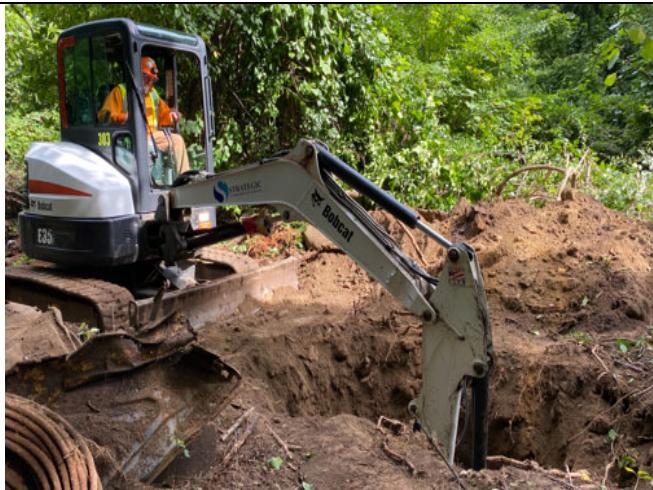
Photo 14: Test Pit TP(20,55); refer to **Figure 4** for location and **Appendix E** for a description of materials encountered

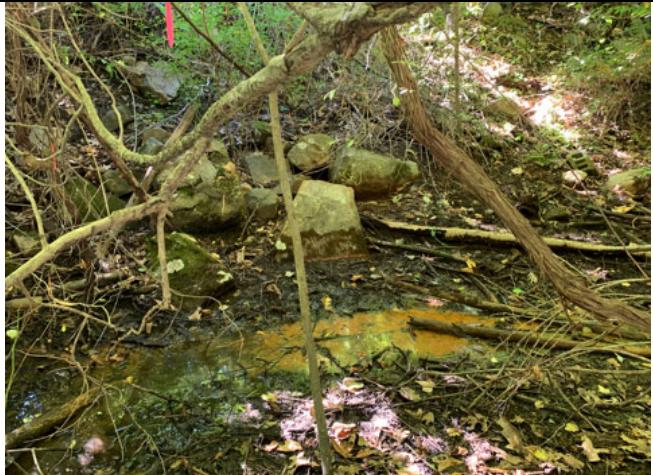
Photo 16: Orange discolored surface water located in intermittent stream downgradient of dumping area to northwest of Test Pit TP(100,215)

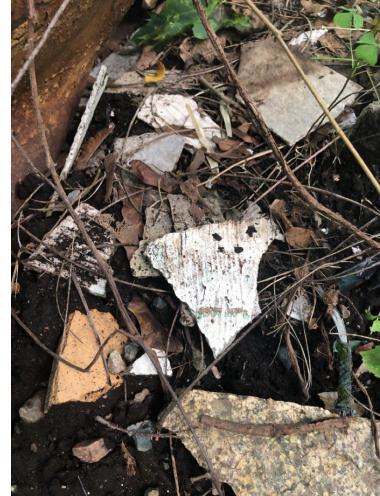
Results of laboratory analysis confirmed asbestos was identified within three of the suspect materials, as summarized in Section 4.1. The ACM were found to be in poor condition at the time of the inspection. The identified ACM should be securely covered with polyethylene sheeting to restrict access.

Sample Numbers: 01-A, 01-B, 01-C
Material Description: Cement Board
Material Color: Grey
Accessible Material: Accessible
Reason Inaccessible: N/A
Asbestos Detected: Positive
Asbestos Type: 20% Chrysotile
Homogeneous Area: 200,150 Surface , 100,180 Truck
Total Approximate Quantity: 300 SF
Condition: N/A
Material Type: N/A
NESHAP Category: N/A
Notes: Not Applicable

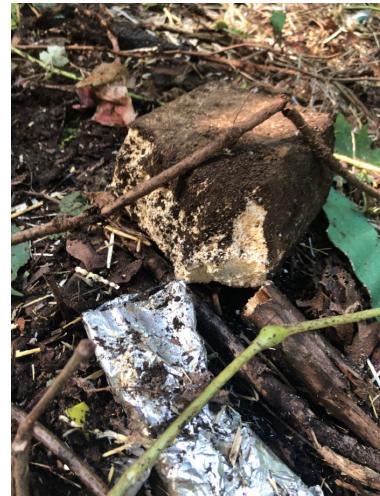
Sample Numbers: 02-A, 02-B, 02-C
Material Description: Boiler Brick
Material Color: Tan
Accessible Material: Accessible
Reason Inaccessible: N/A
Asbestos Detected: Negative
Asbestos Type: No Asbestos Detected
Homogeneous Area:
Total Approximate Quantity: TBD
Condition: N/A
Material Type: N/A
NESHAP Category: N/A
Notes: Not Applicable
