# Revised Solid Waste Assessment Summary Report

## Breakneck Hill Farm Dumping Site

**Breakneck Hill Road  
Southborough, Massachusetts**

October 2022 (Revised February 2023)

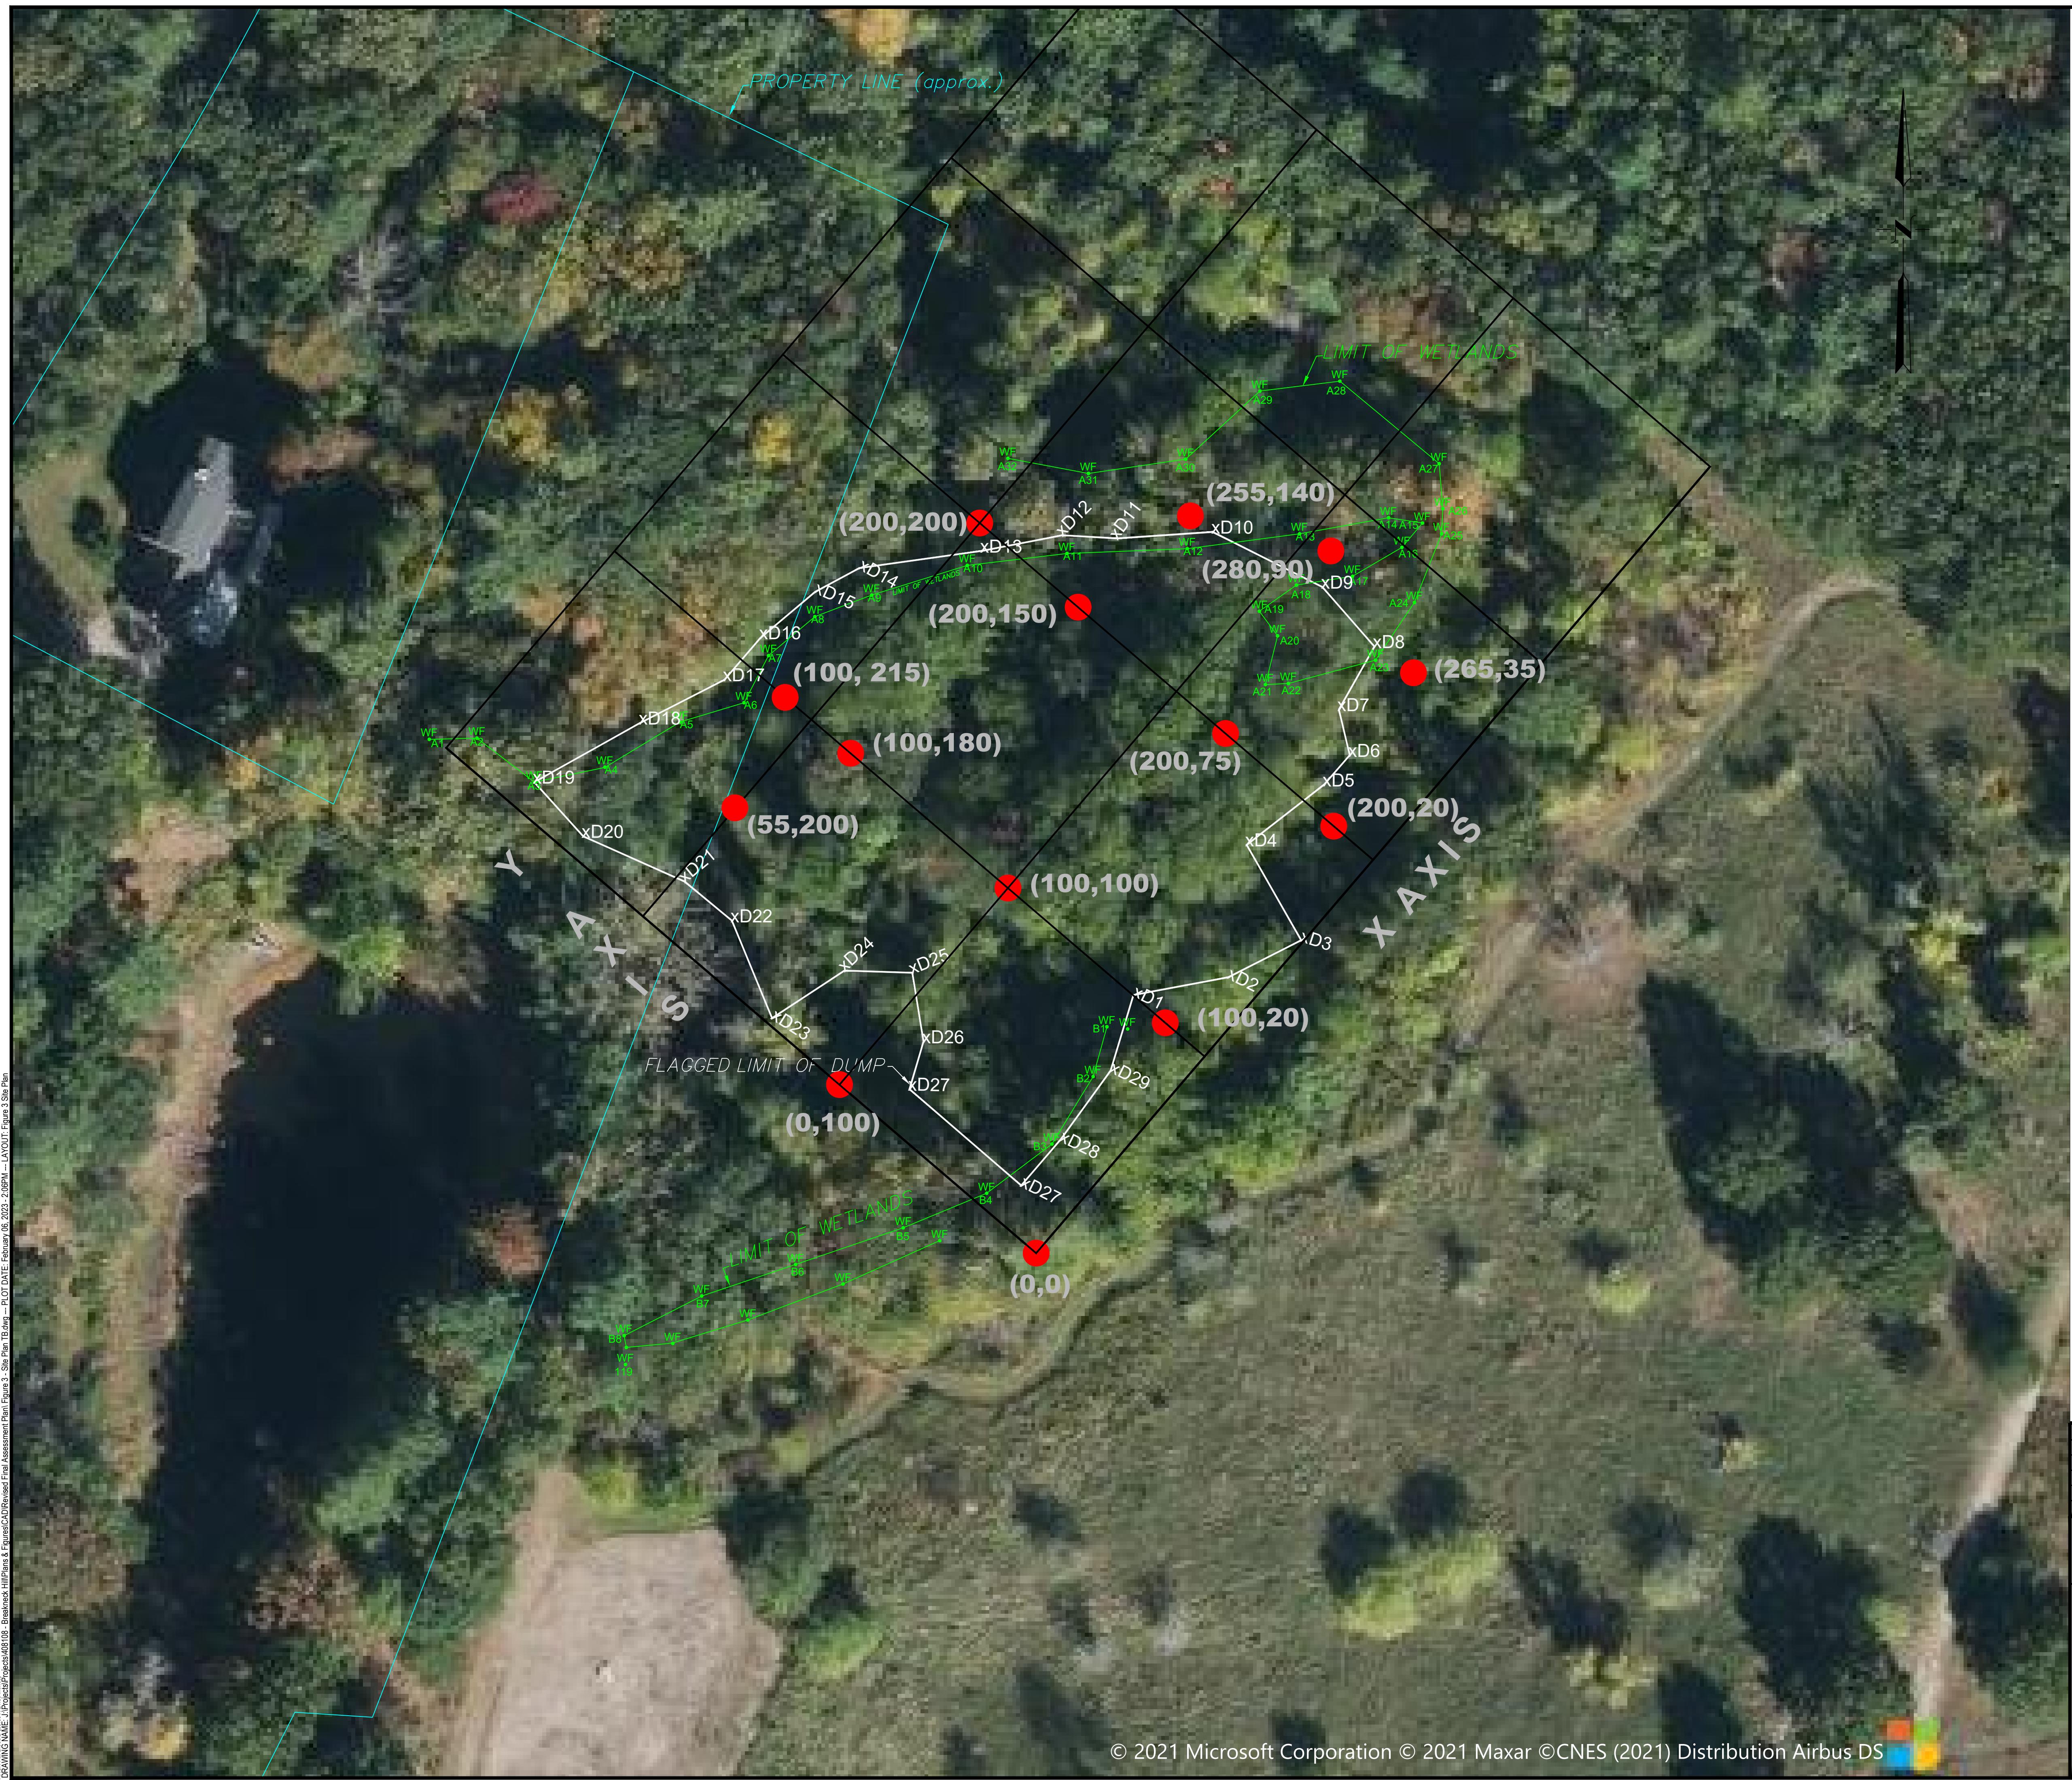
FILE NO.: Figure 3 - Site Plan TB.dwg

On September 13, 2022, Land Planning returned to the Site to stake out the 14 test pit locations depicted on **Figure 3** (the *Site Plan* included in the February 2023 *Revised Final Assessment Plan*), which depicts the initially proposed test pit locations on Town-owned land. TRC and MassDEP personnel observed surveying activities performed by Land Planning, reviewed proposed test pit locations, and discussed adjusting the locations of certain test pits in the field, as necessary.

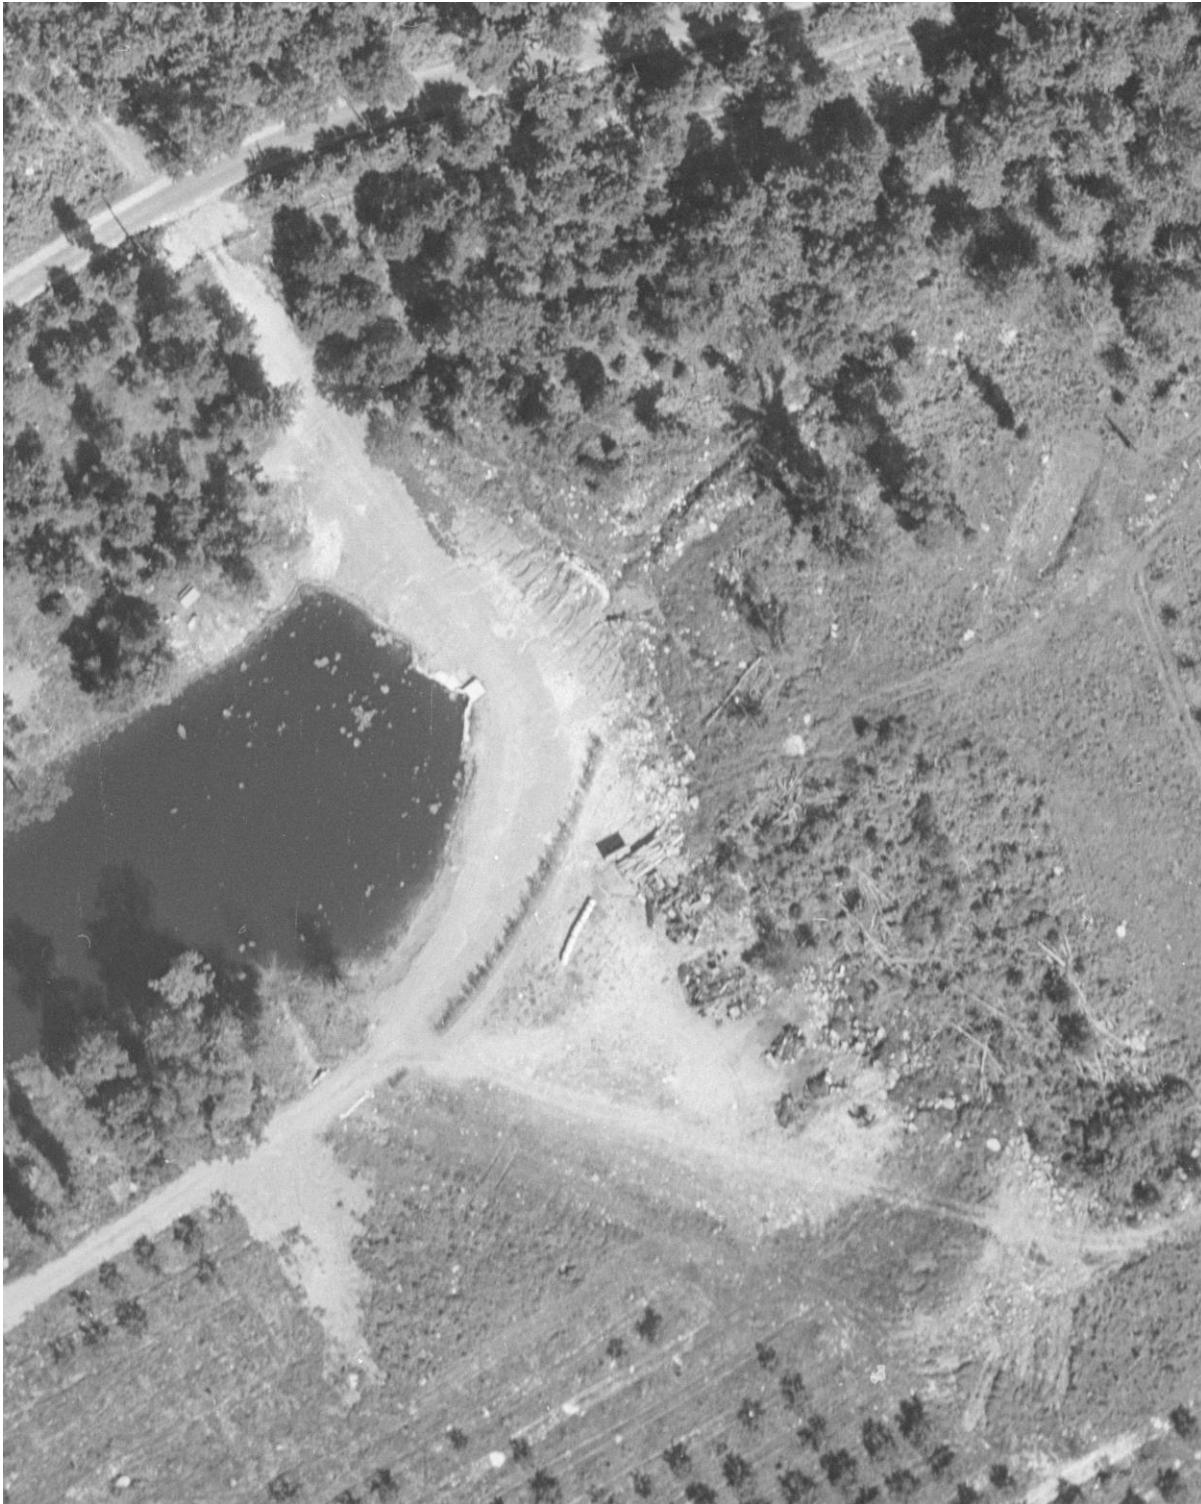
**Figure 1. 1959 Image of Study Area**

The 1959 image shows the Study Area within two years of the construction of the pond and provides good detail (see Figure 1). This image appears to show that the dam was still somewhat under construction at this time and the area contained significant open soil areas. The 1959 photo also appears to show in progress clearing of trees within the Study Area and possibly the placement (or exposure) of the boulders that are currently observable where soil has eroded. The eastern intermittent channel is not obvious in the 1959 photo, although it appears the culvert beneath the cart path may have existed at that time. LE theorizes that the channel would have been constructed between 1959 and 1966, as the channel appears to be visible in the 1966 photos.

The stereoscopic images obtained from 1966 provide a three-dimensional stereoscopic view of the Study Area at that time. These images depict a clearly defined limit of the top of the constructed dam. Having been built in only nine years previous, it is reasonable to expect that the top of the dam was being well maintained at this time and no significant mature vegetation had become established. Unfortunately, the remaining photos were not of sufficient resolution to determine when exactly the man-made debris (forming the dump) began to be deposited. A review of additional photographs may provide greater detail on the timeline, although the end result of the current condition would not be changed.

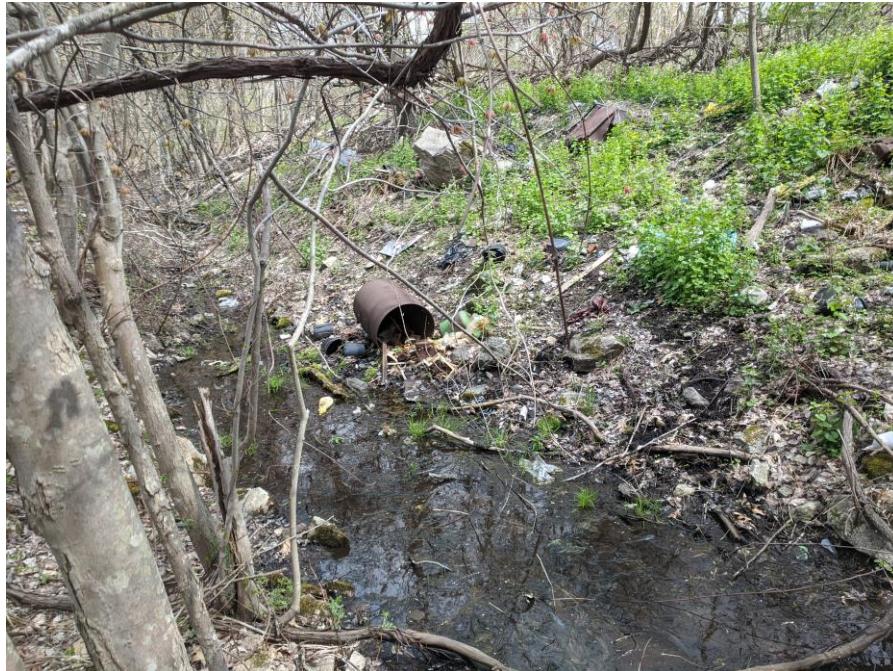
Photograph 1: Bank of A-Series wetland delineation.

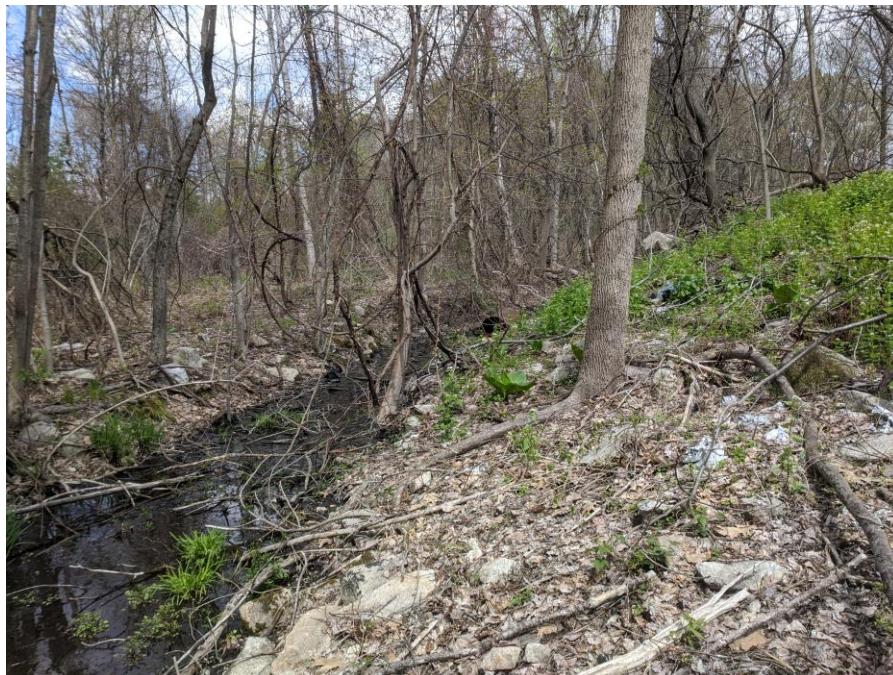
Photograph 2: Bank of A-Series wetland delineation.

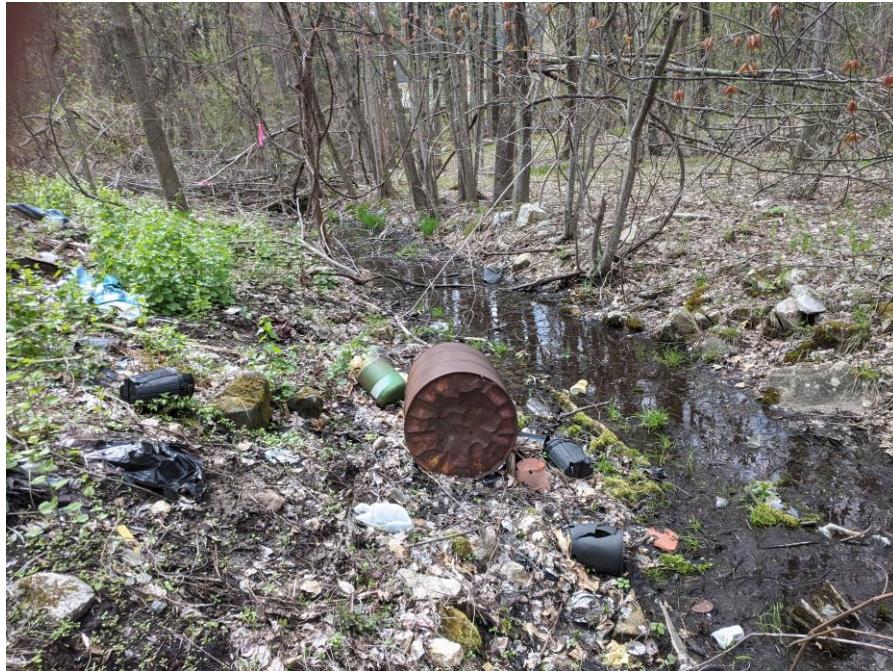
Photograph 3: Bank of A-Series wetland delineation.

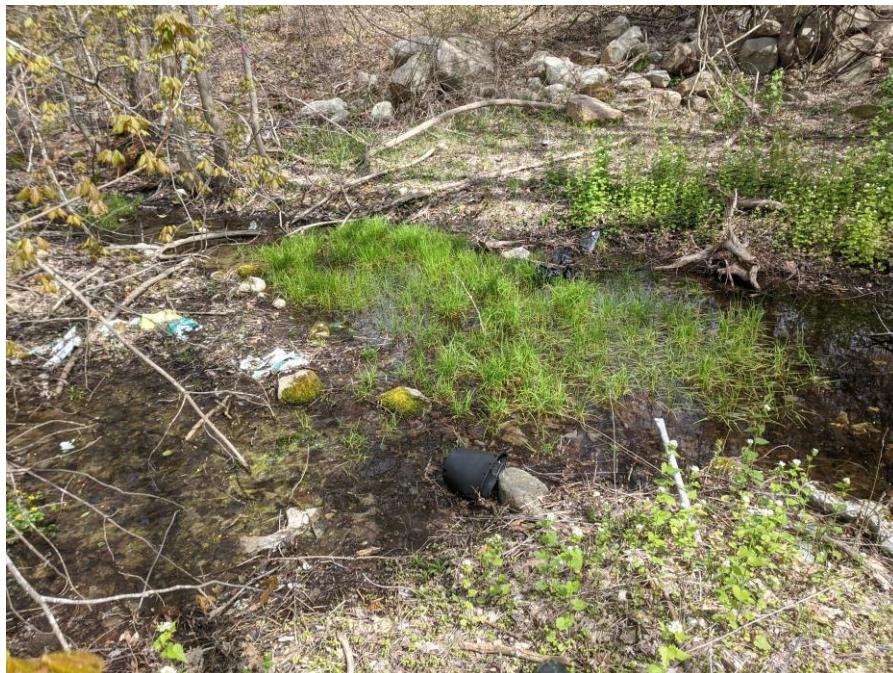
Photograph 4: BVW of A-Series wetland delineation.

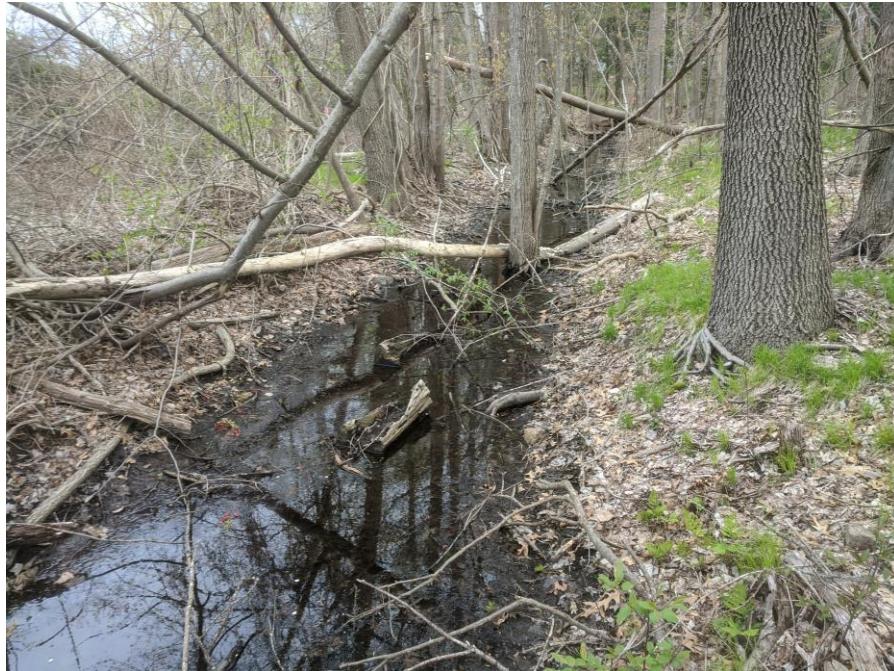
Photograph 5: Bank of B-Series wetland delineation.

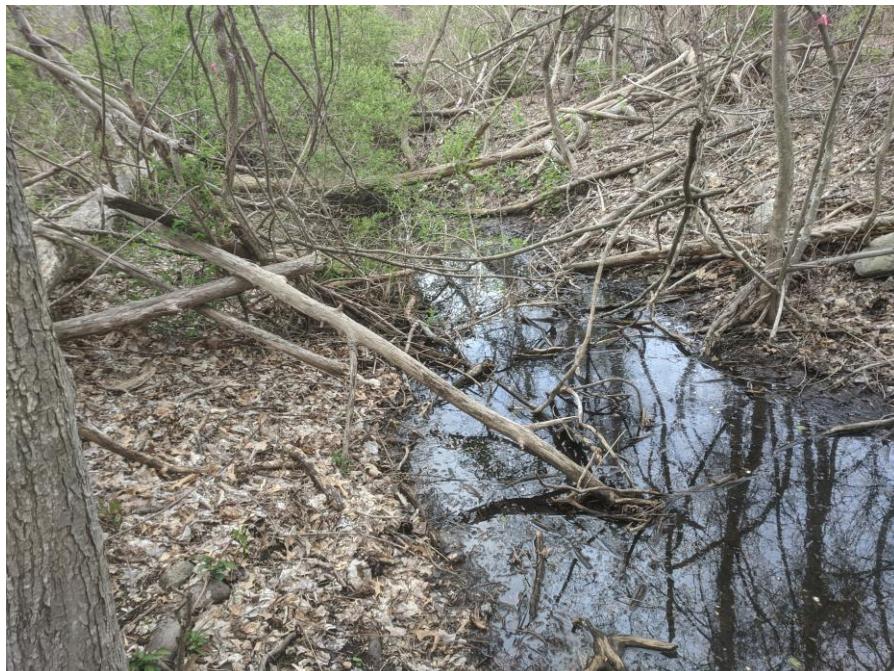
Photograph 6: Bank of B-Series wetland delineation.

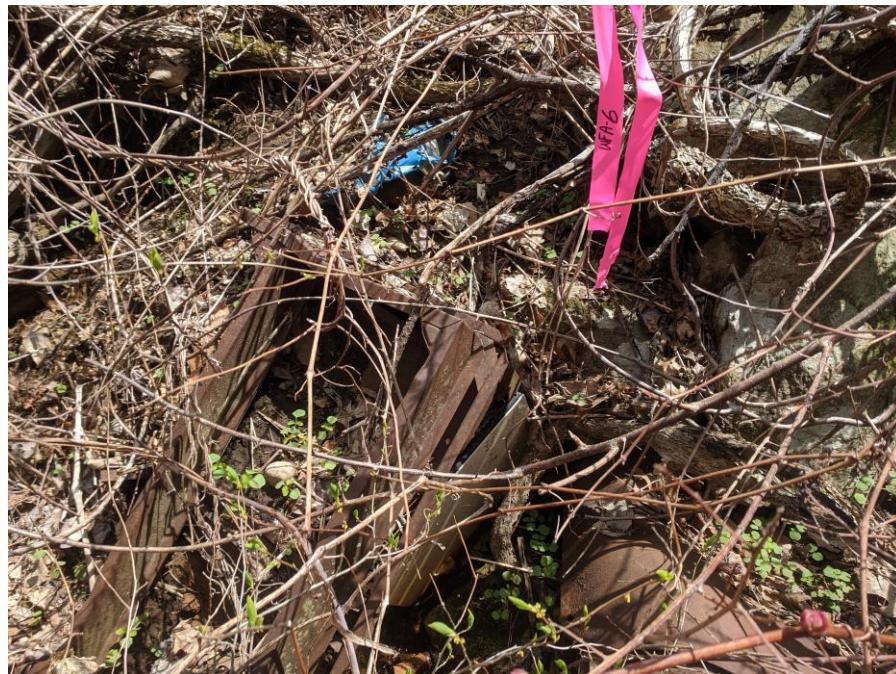
Photograph 9: Debris within wetland resource area (Bank).

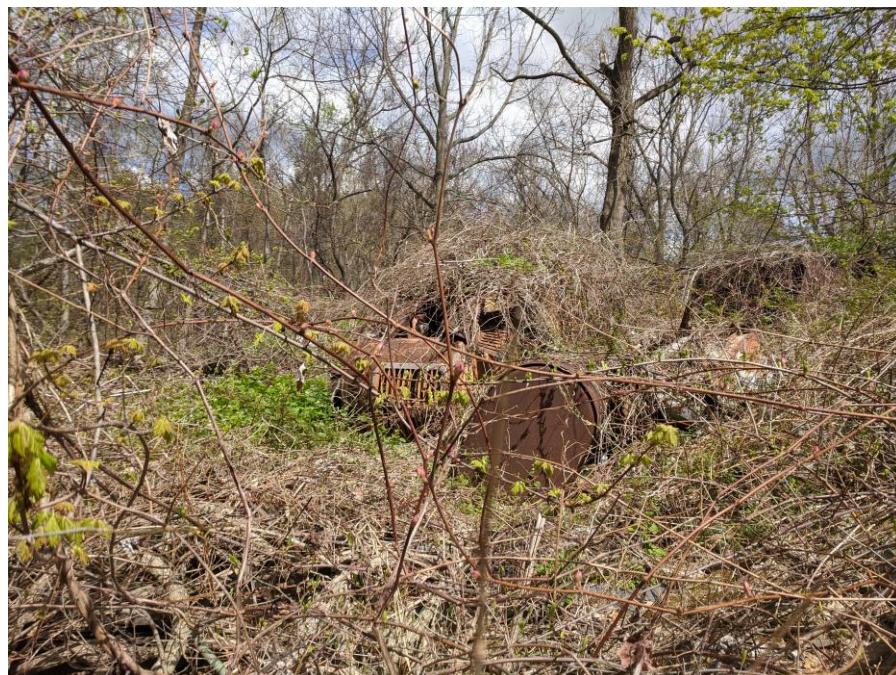
Photograph 10: Debris within wetland resource area Buffer Zone.

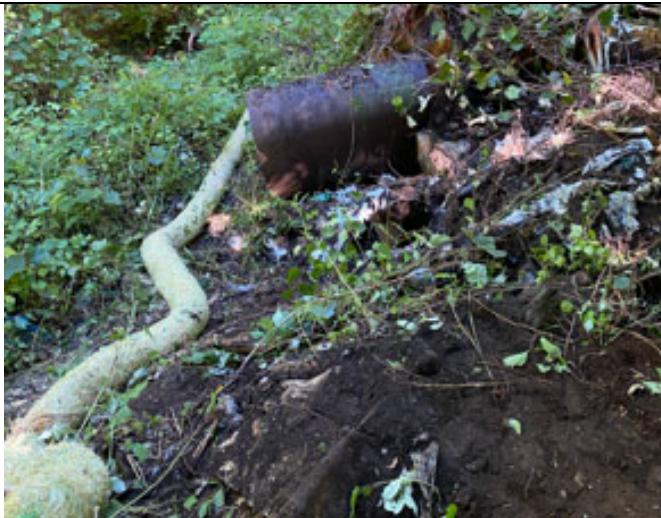
Photo 1: Test Pit TP(100,215); refer to **Figure 4** for location and **Appendix E** for a description of materials encountered

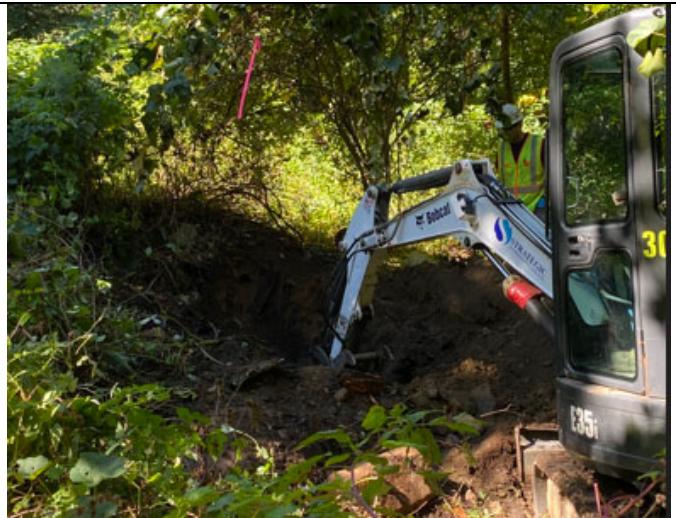
Photo 2: Test Pit TP(55,200); refer to **Figure 4** for location and **Appendix E** for a description of materials encountered

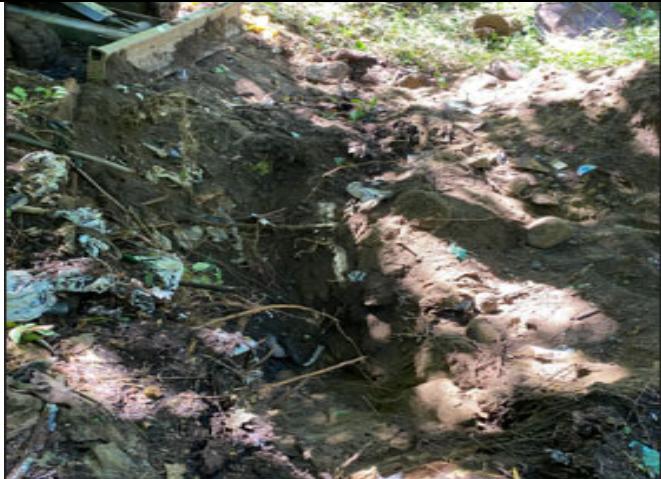
Photo 3: Test Pit TP(86,184); refer to **Figure 4** for location and **Appendix E** for a description of materials encountered

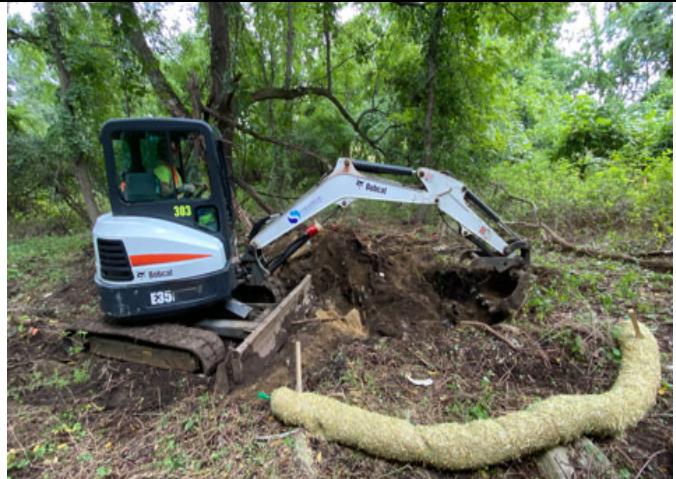
Photo 4: Test Pit TP(99,110); refer to **Figure 4** for location and **Appendix E** for a description of materials encountered

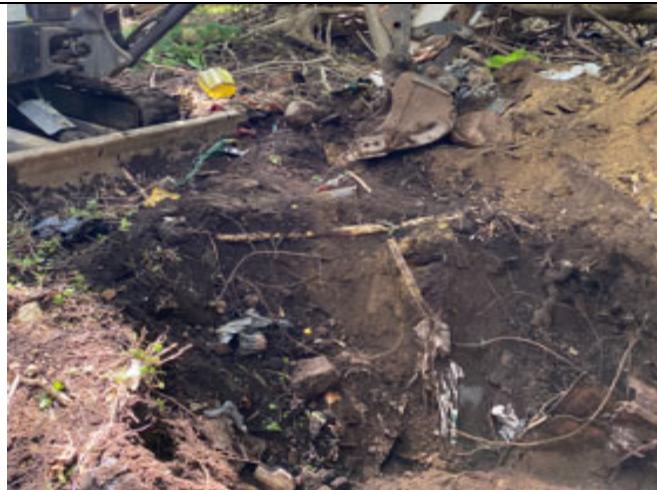
Photo 5: Test Pit TP(193,158); refer to **Figure 4** for location and **Appendix E** for a description of materials encountered

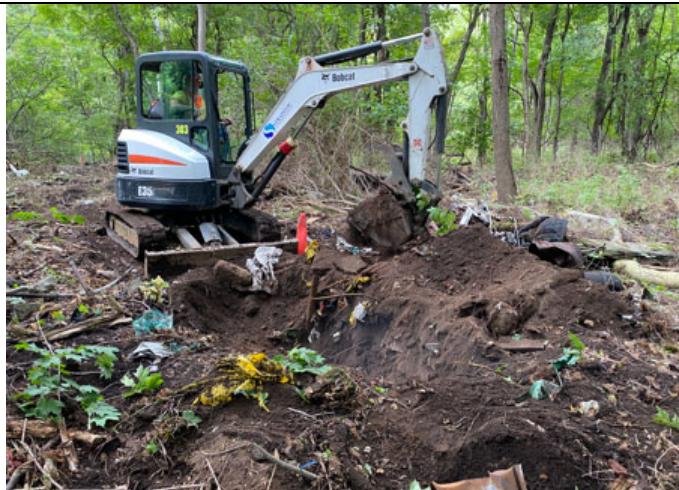
Photo 6: Test Pit TP(207,83); refer to **Figure 4** for location and **Appendix E** for a description of materials encountered

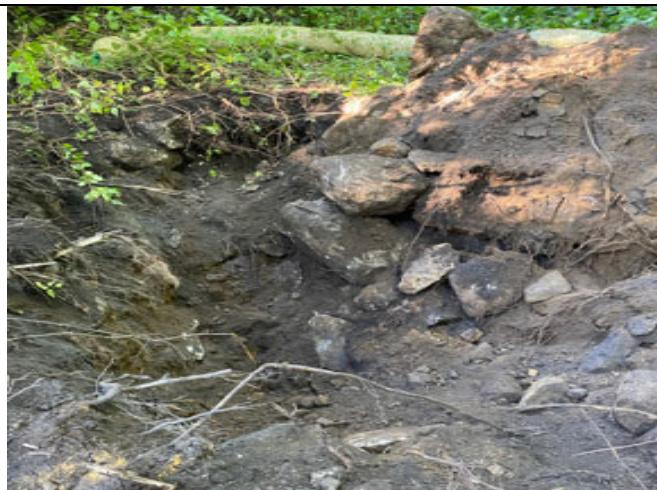
Photo 7: Test Pit TP(200,20); refer to **Figure 4** for location and **Appendix E** for a description of materials encountered

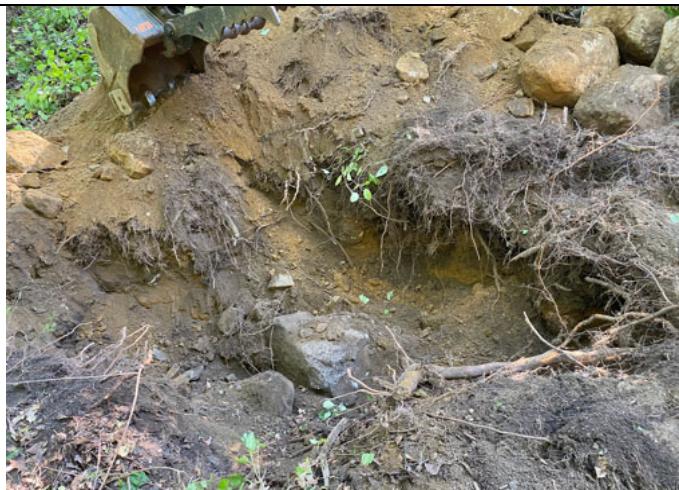
Photo 8: Test Pit TP(265,29); refer to **Figure 4** for location and **Appendix E** for a description of materials encountered

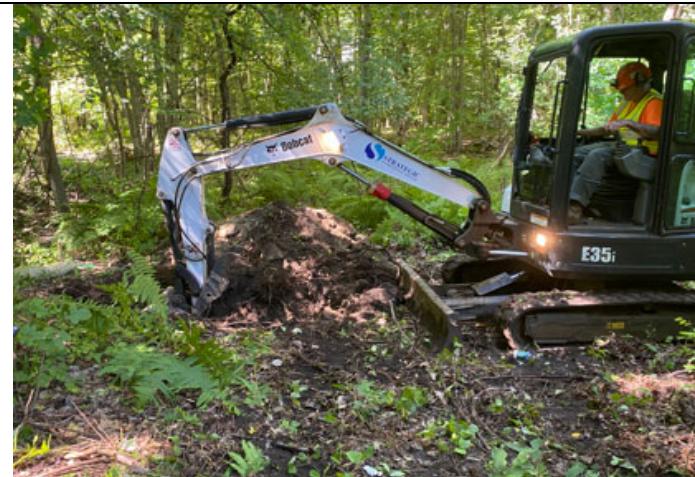
Photo 9: Test Pit TP(255,140); refer to **Figure 4** for location and **Appendix E** for a description of materials encountered

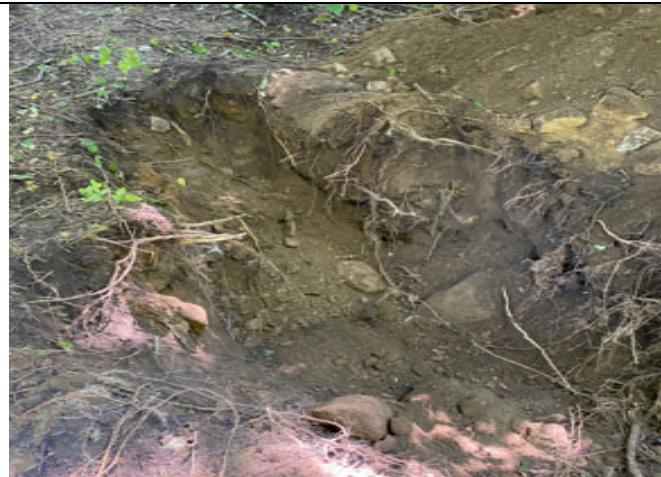
Photo 10: Test Pit TP(100,20); refer to **Figure 4** for location and **Appendix E** for a description of materials encountered

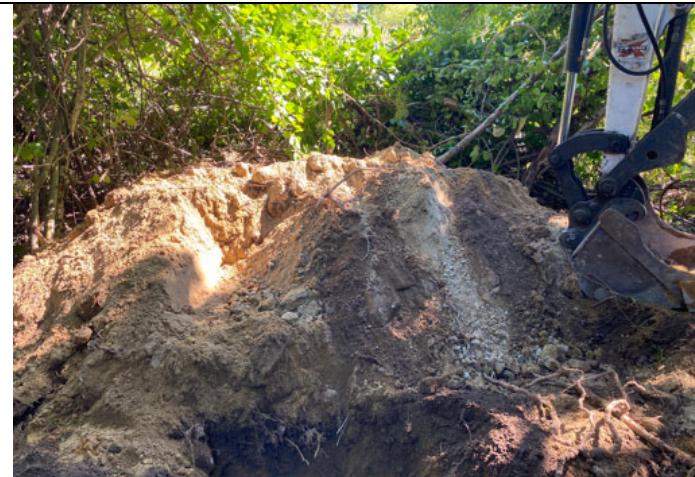
Photo 11: Test Pit TP(0,-8), refer to **Figure 4** for location and **Appendix E** for a description of materials encountered

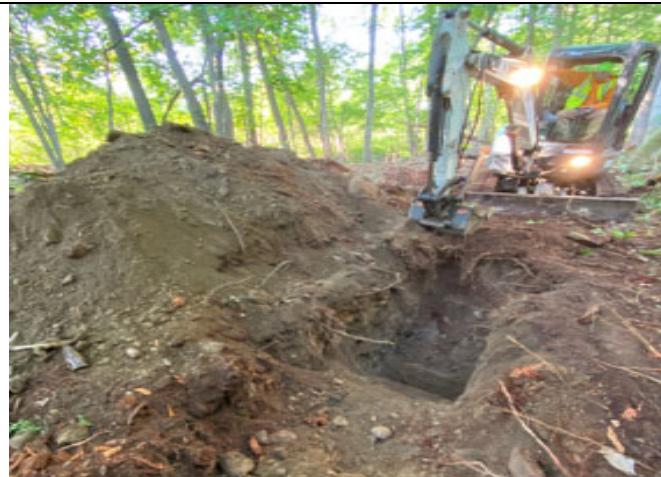
Photo 12: Test Pit TP(-20,100); refer to **Figure 4** for location and **Appendix E** for a description of materials encountered

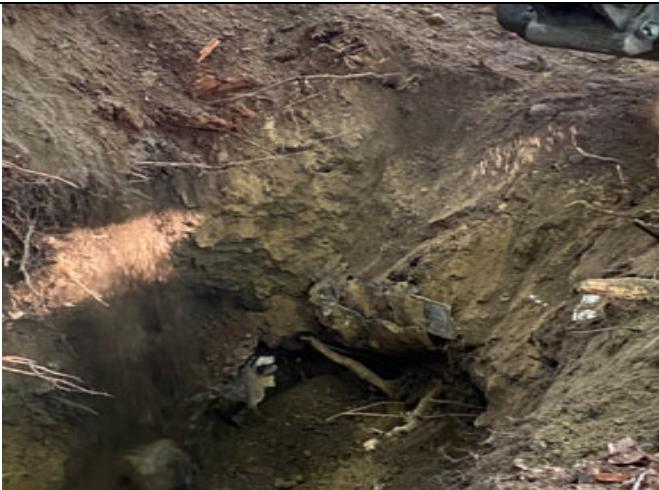
Photo 13: Test Pit TP(-50,100); refer to **Figure 4** for location and **Appendix E** for a description of materials encountered

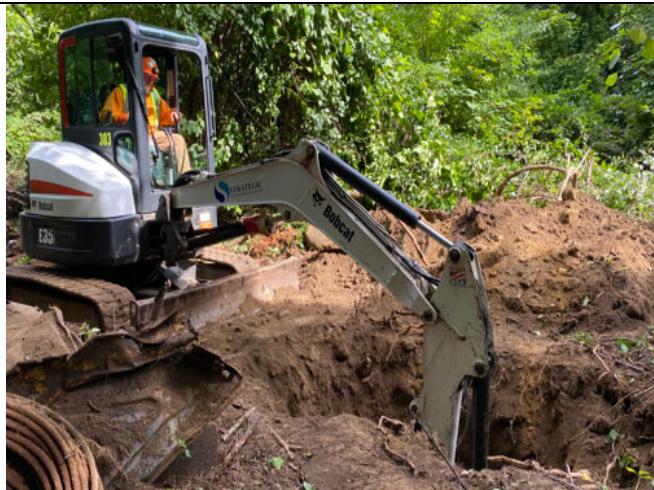
Photo 14: Test Pit TP(20,55); refer to **Figure 4** for location and **Appendix E** for a description of materials encountered

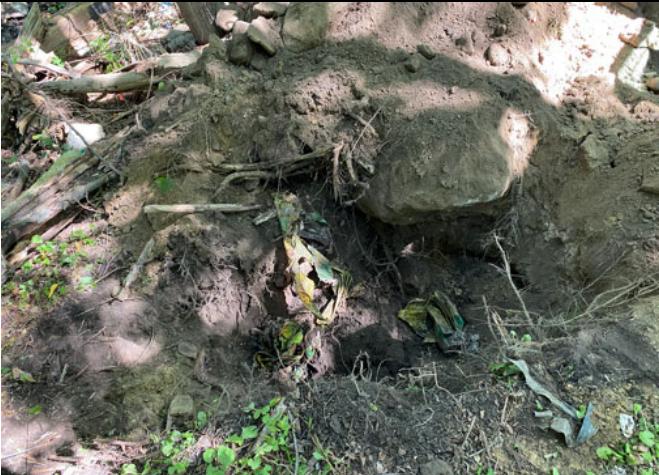
Photo 15: Test Pit TP(255,137); refer to **Figure 4** for location and **Appendix E** for a description of materials encountered

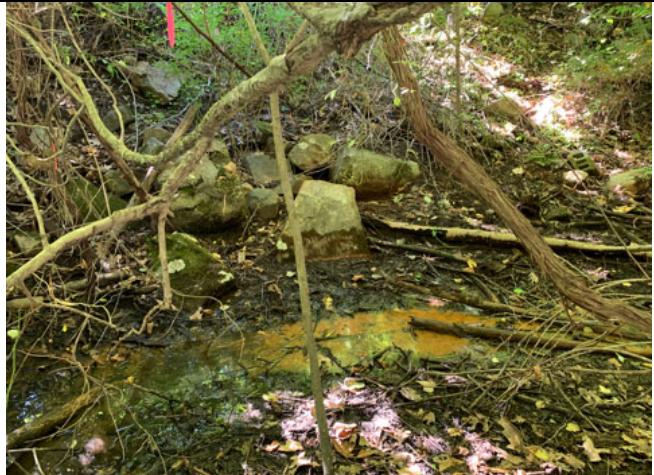
Photo 16: Orange discolored surface water located in intermittent stream downgradient of dumping area to northwest of Test Pit TP(100,215)

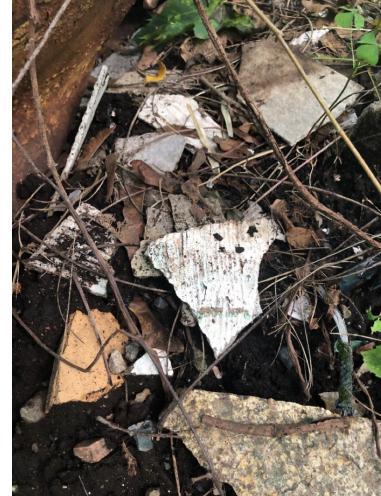
**Sample Numbers:** 01-A, 01-B, 01-C  
**Material Description:** Cement Board  
**Material Color:** Grey  
**Accessible Material:** Accessible  
**Reason Inaccessible:** N/A  
**Asbestos Detected:** Positive  
**Asbestos Type:** 20% Chrysotile  
**Homogeneous Area:** 200,150 Surface , 100,180 Truck  
**Total Approximate Quantity:** 300 SF  
**Condition:** N/A  
**Material Type:** N/A  
**NESHAP Category:** N/A  
**Notes:** Not Applicable

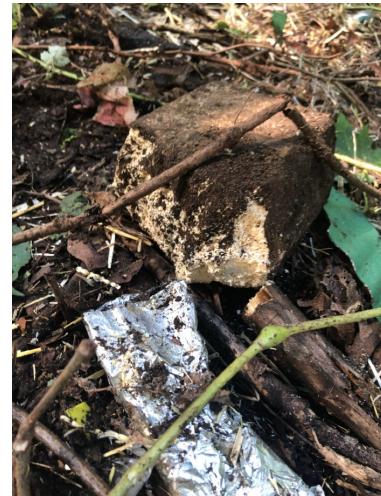
**Sample Numbers:** 02-A, 02-B, 02-C  
**Material Description:** Boiler Brick  
**Material Color:** Tan  
**Accessible Material:** Accessible  
**Reason Inaccessible:** N/A  
**Asbestos Detected:** Negative  
**Asbestos Type:** No Asbestos Detected  
**Homogeneous Area:**  
**Total Approximate Quantity:** TBD  
**Condition:** N/A  
**Material Type:** N/A  
**NESHAP Category:** N/A  
**Notes:** Not Applicable
