Revised Final Assessment Plan Breakneck Hill Farm Dumping Site

**Breakneck Hill Road
Southborough, Massachusetts**

May 2022 (Revised February 2023)

TRC Environmental Corporation
650 Suffolk Street
Lowell, Massachusetts 01854
(978) 970-5600

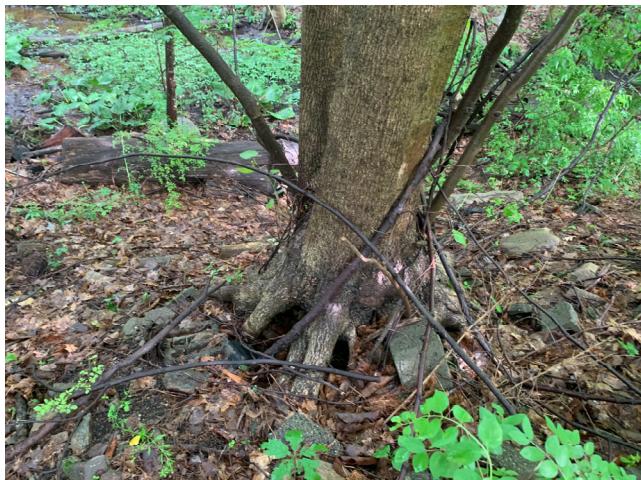
Photo 11: Partially buried cinder block and brick observed along the steep slope at the southwestern portion of the site; view to the west

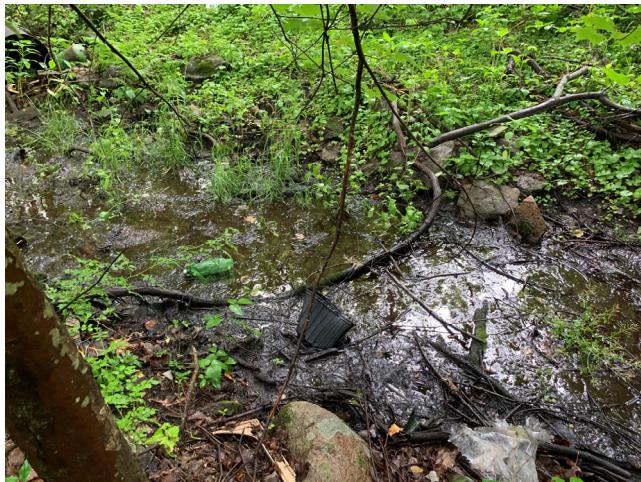
Photo 13: Debris including plastic pots and bottles observed along the wetland area at the western portion of the site; view to the east

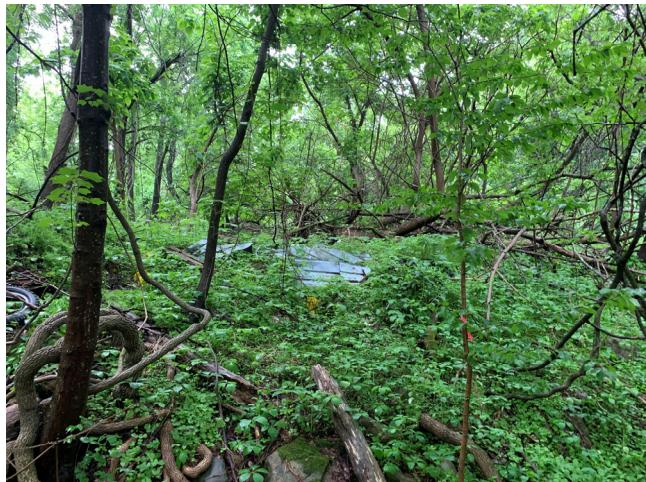
Photo 14: Metal siding and rubber tires observed at the western portion of the site; view to the east

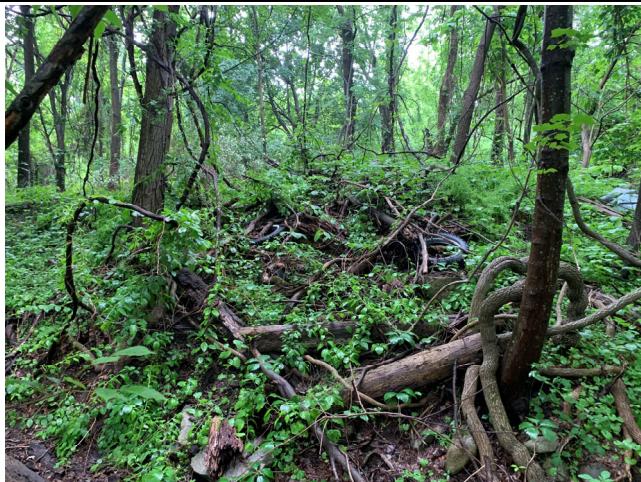
Photo 15: Rubber tires and miscellaneous debris observed throughout the western portion of the site; view to the northeast

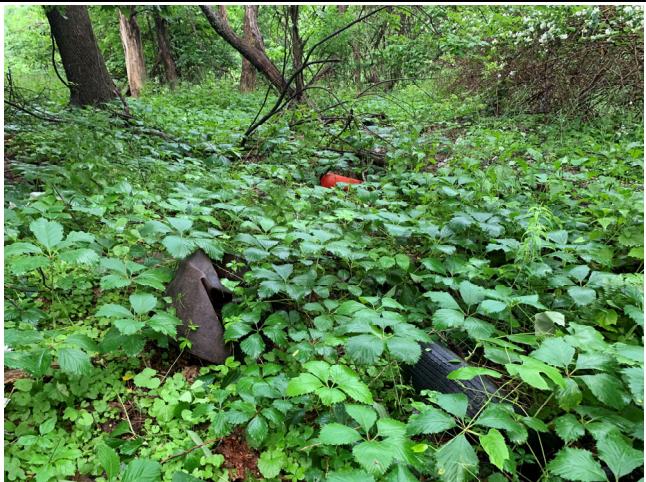
Photo 16: Debris including a plastic cone, a rubber tire, and metal waste located at the northern portion of the site; view to the northeast

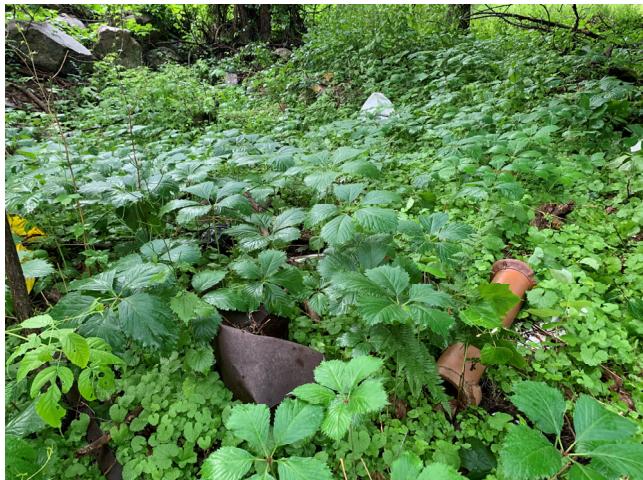
Photo 17: Debris including plastic waste, a pipe, and scrap metal located at the northern portion of the site; view to the east

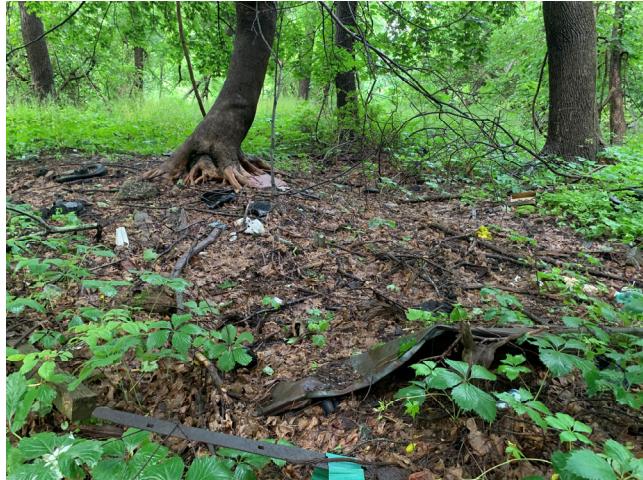
Photo 18: Sparsely vegetated area and debris including brick, concrete, tires, plastic waste, and scrap metal observed at the eastern-central portion of the site; view to the southwest

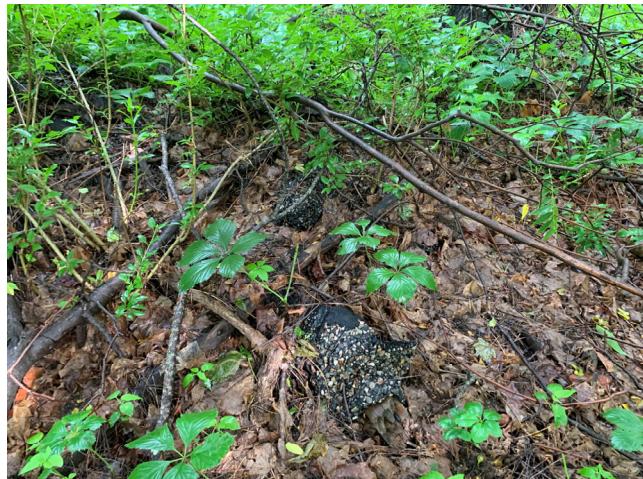
Photo 19: Asphalt debris observed at the southeastern portion of the site; view to the west

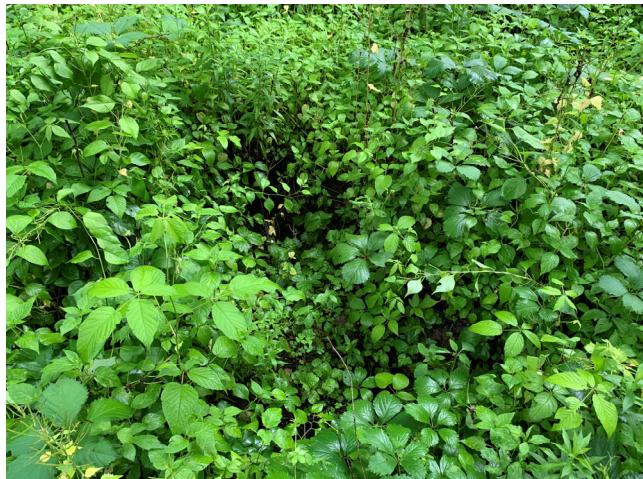
Photo 20: A hole observed in the densely vegetated area located at the northeastern portion of the site; view to the west
