# Wildlife Habitat Evaluation & Vernal Pool Migration Study Report

for  
250 Turnpike Road  
(Map: 27, Lots: 46 & 2A)  
Southborough, MA 01772

**DATE:**  
May 15, 2025

**PREPARED BY:**  
Goddard Consulting LLC  
291 Main Street, Suite 8  
Northborough, MA 01532

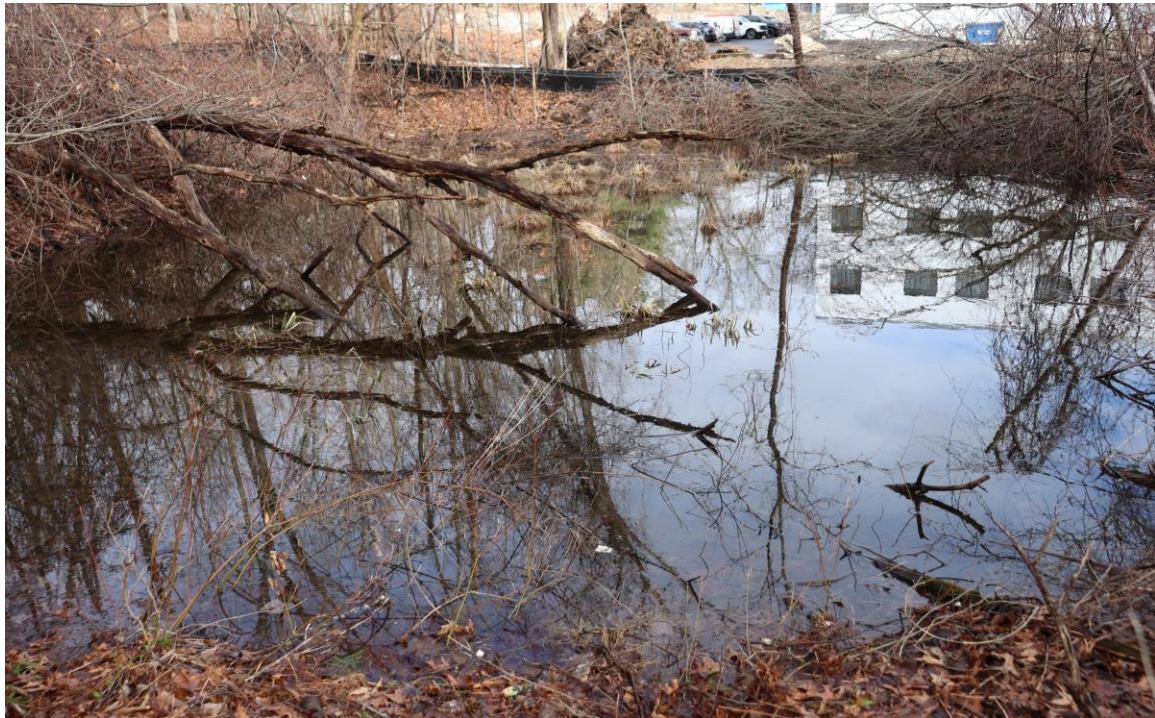
**Photo 1.** View of potential vernal pool (facing north) on March 21<sup>st</sup>, 2025.

According to the Guidelines for the Certification of Vernal Pool Habitat prepared by the Natural Heritage & Endangered Species Program, a potential vernal pool must meet both the biological and physical criteria to qualify as jurisdictional vernal pool habitat. Biologically, the potential vernal pool does support both obligate and facultative species (Reference Section 2.2). Physically, the pool does not have a permanently flowing outlet and there is no established, reproducing fish population (Reference Photo 1). There are various attachment sites for egg masses, including woody debris and vegetation. The average depth of the pool is approximately 10-12 inches with a maximum depth of approximately 16 inches. There is an outlet located at the northeastern edge of the pool. The water within the basin discharges into the adjacent wetland, potentially limiting the depth of the pool.

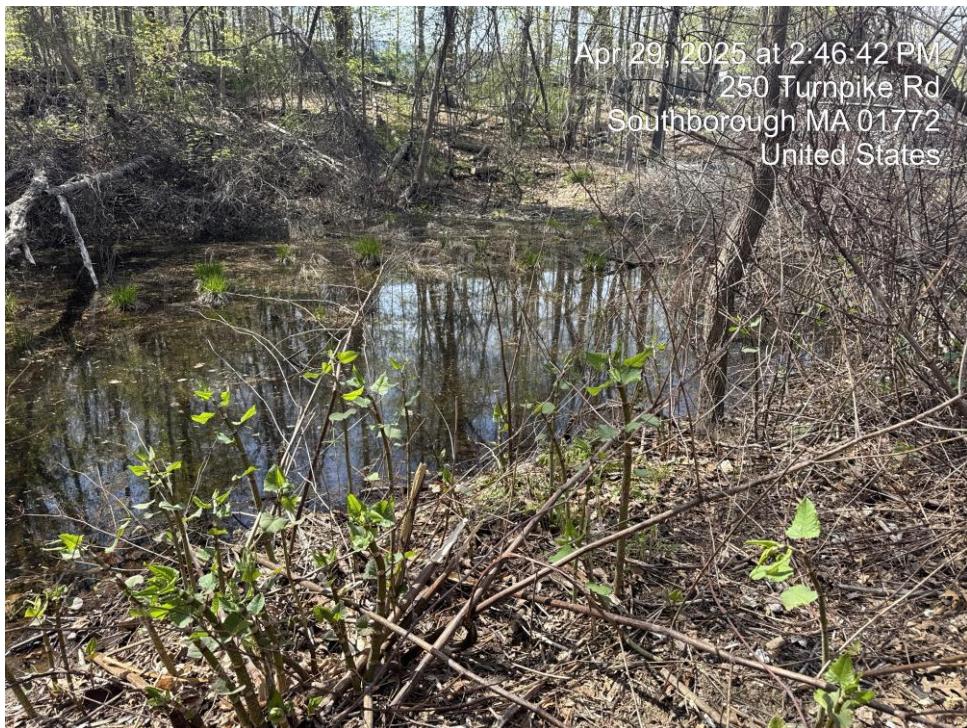
View of western stormwater detention basin, or the potential vernal pool.

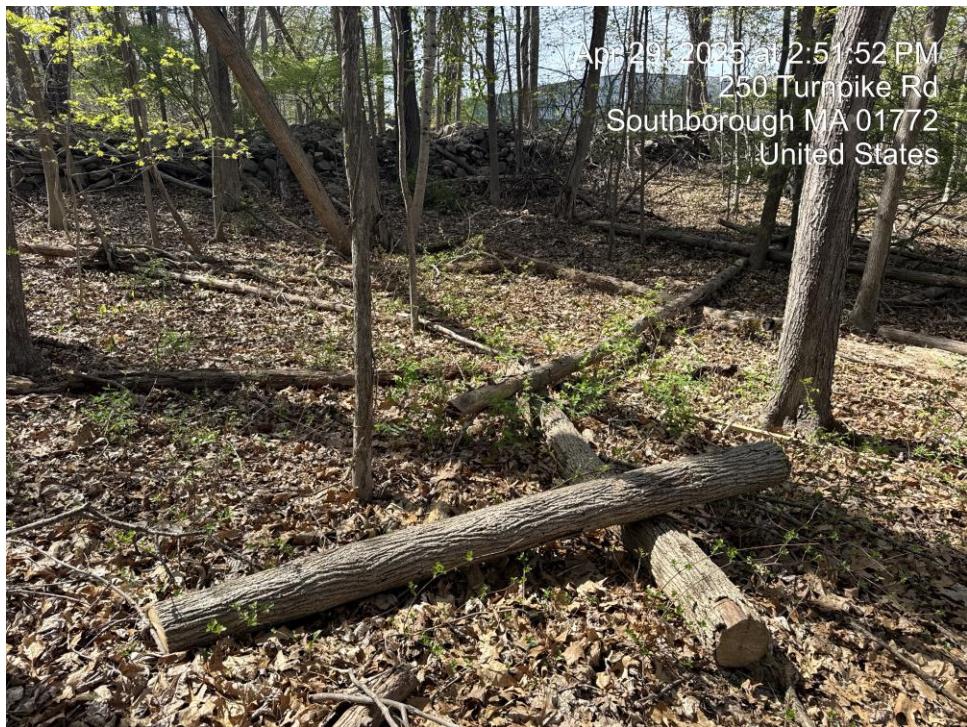
View of the forested upland west of the western detention basin.

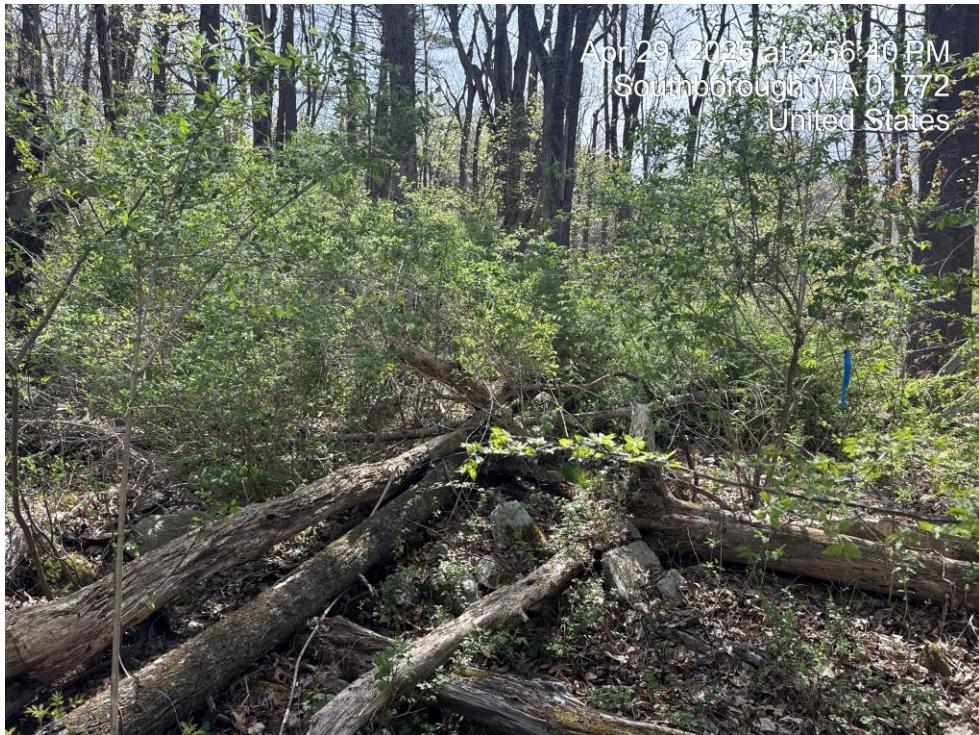
View of the forested wetland located south of the western detention basin.

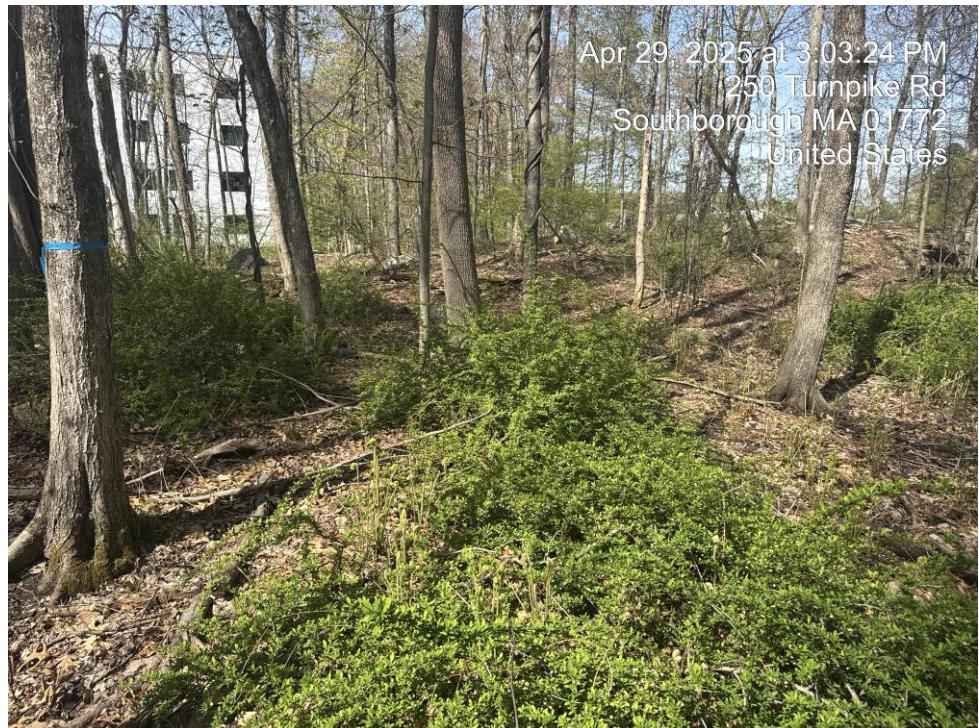
View of the forested wetland located east of the western detention basin.

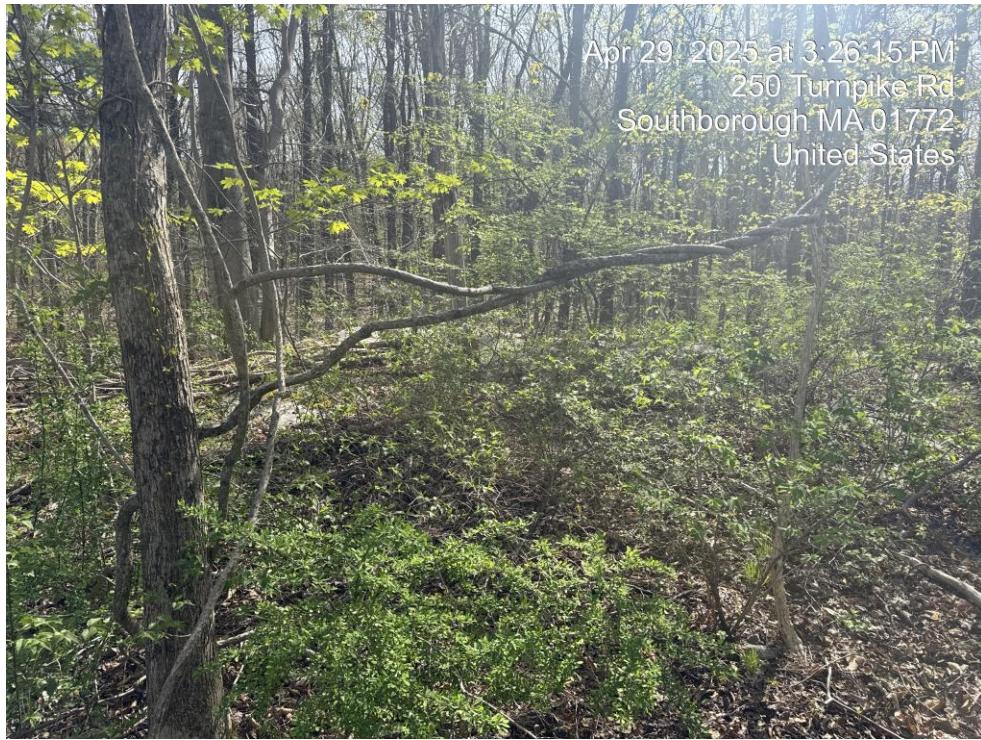
View of the forested uplands between the wetland systems, within the area of the proposed roadway.

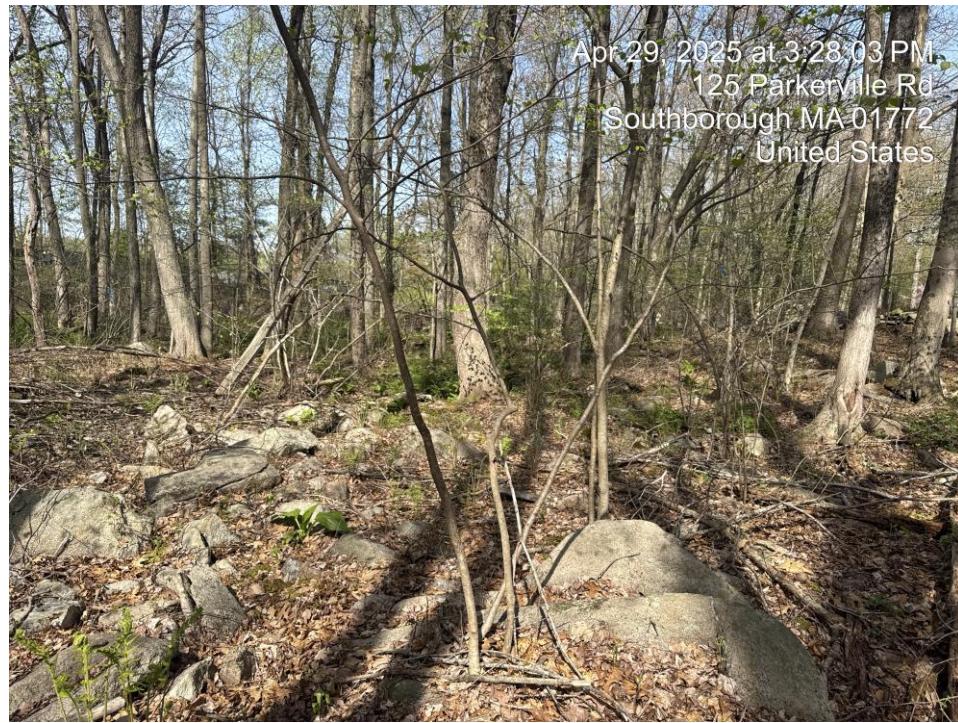
View of the forested wetlands south of the eastern detention basin, or east of the proposed roadway.

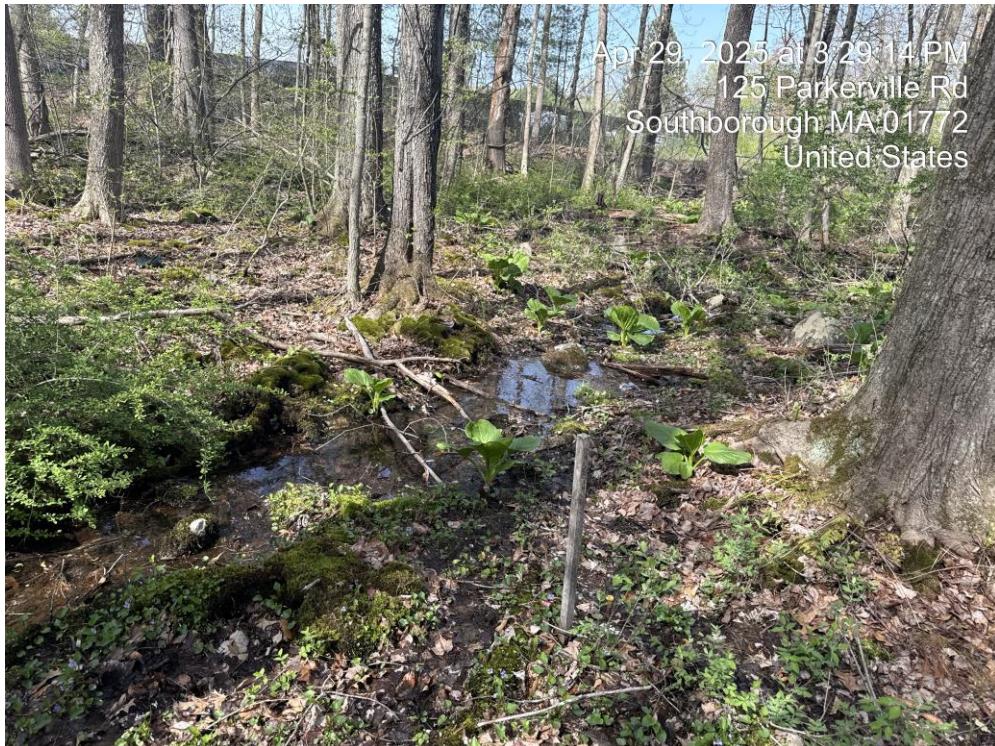
View of the forested wetland and the internal intermittent stream located on the eastern portion of the site.

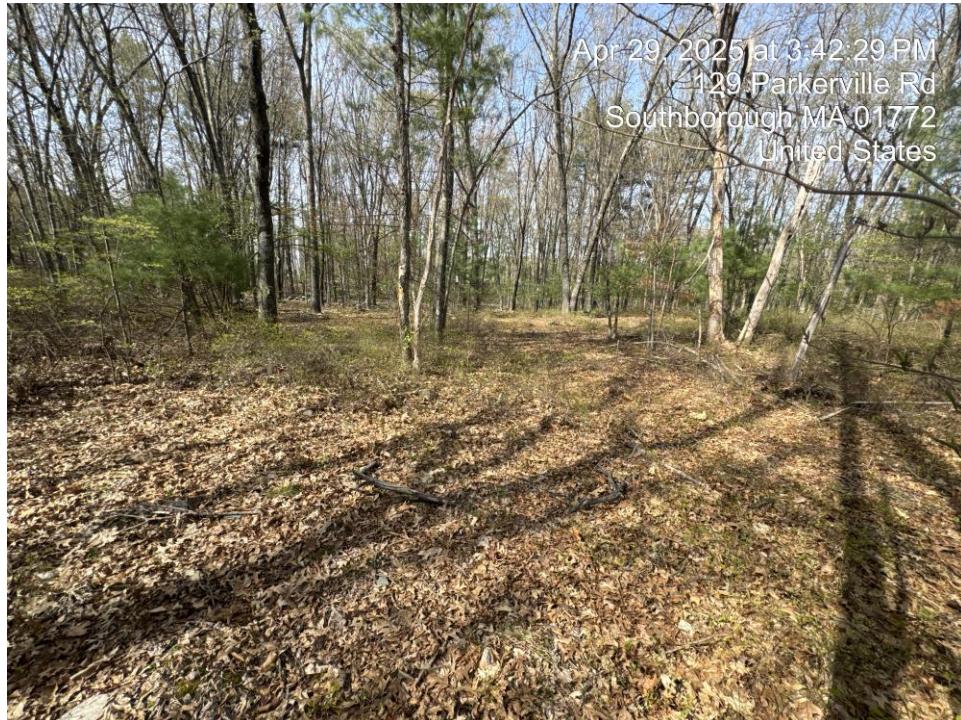
View of the forested uplands south of the western BVWs.

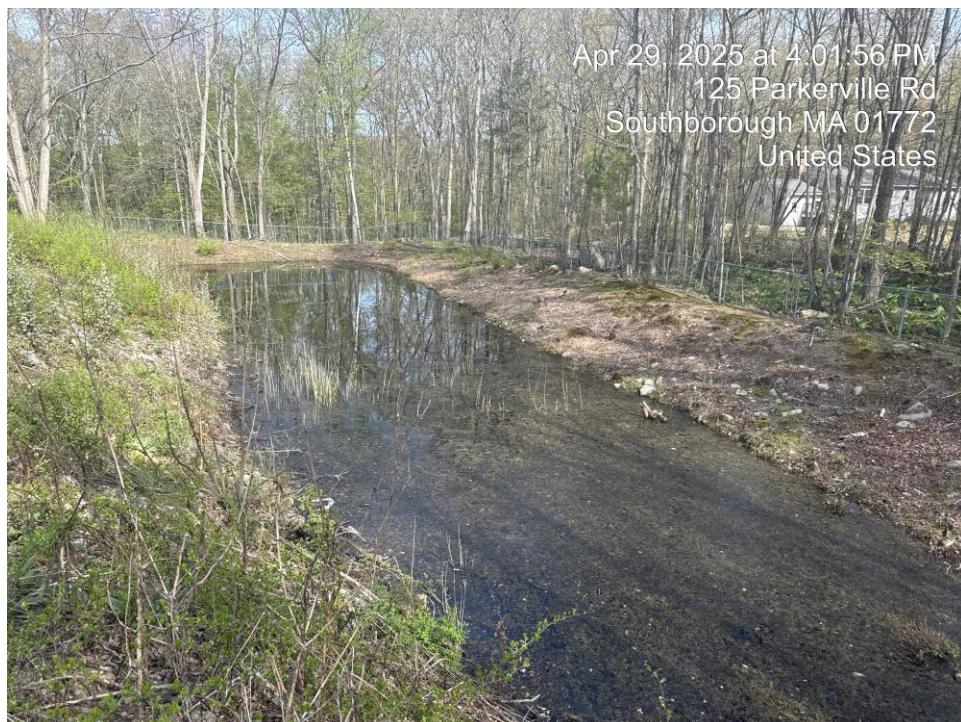
View of the eastern stormwater detention basin.

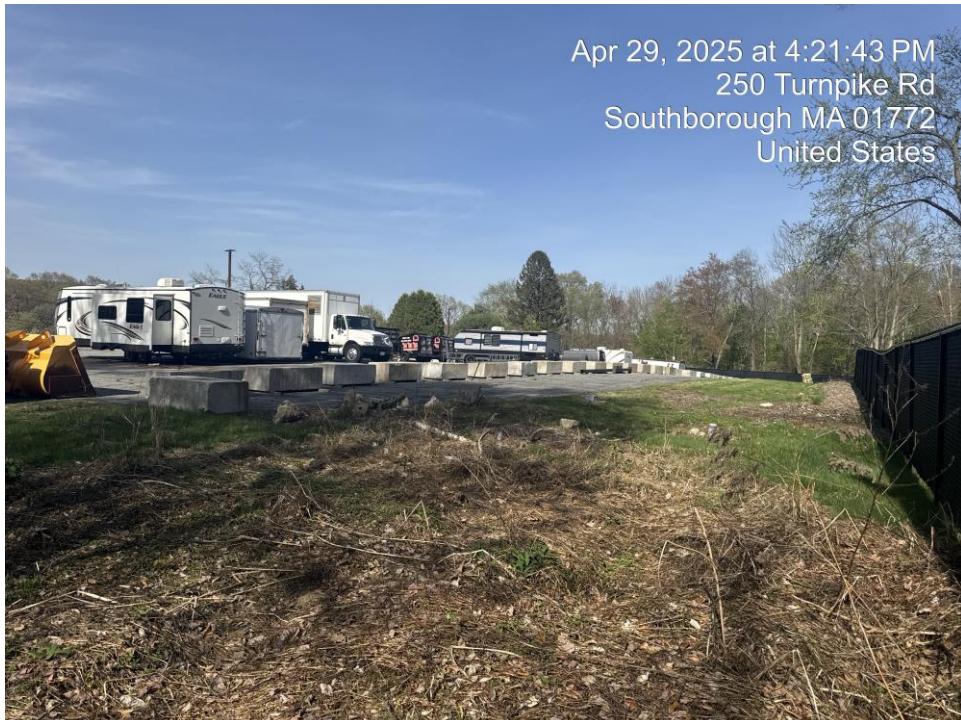
View of the developed area north of the eastern detention basin.
