# **Town of Southborough**

## **Self-Evaluation and Transition Plan**

### **June 2021**

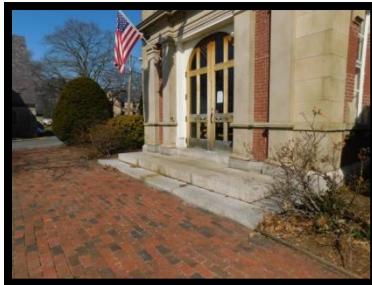
### Front Entrance Stairs

A variance should be sought to keep the front entrance as “egress only” with proper directional signage and to maintain its current historical appearance with no further modifications. *See photo below.*

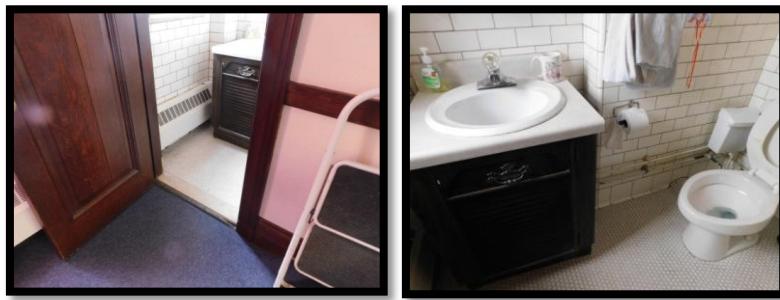
The Level 2 Library Director's office private bathroom has only 25" of clear width to gain access. The bathroom is only 3 feet wide and is wholly non-compliant due to lack of maneuverability, clearance, and accessible components. *See Photos Below*. As this is an employee only space and not open to the public, modifications would only be required as a reasonable accommodation request. No other action is required at the present time.

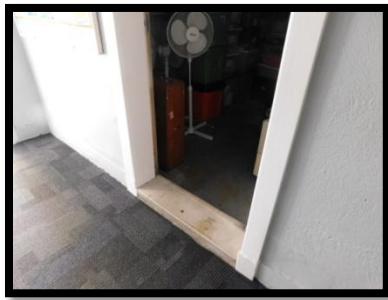
The Level 1 storage room near the Teen Room has 3" abrupt change in level surface to access the storage area. As this is not open to the public and restricted to employees only, modifications would only be required as a result of a reasonable accommodation request. No other action is required at the present time. *See Photo Below*.

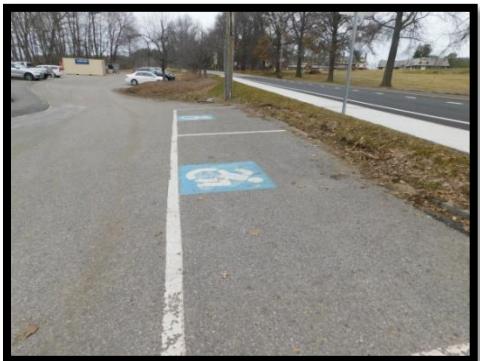
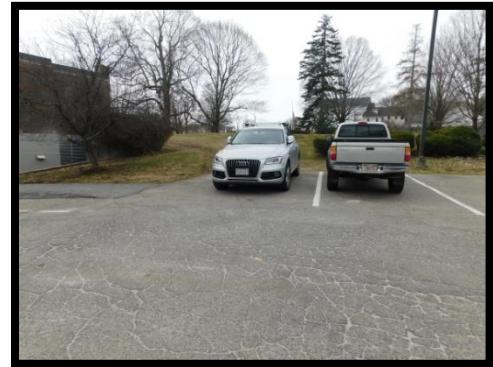
General Description of Obstacle	2010 ADAAG	MAAB 521 CMR	Type of Action to be Taken	P	E	TF	Cost Estimate
<b>Parking</b> None of 2 designated accessible parking spaces have signage or access aisles. There is no van designated accessible space.  <b>See Photos Library 1 and 2.</b>	502	23	<p><u>Option 1:</u> Reconstruct the accessible parking spaces as follows: stripe and designate a van accessible parking space with van accessible signage at a width of either 11' with a 5' access aisle or 8' with an 8' access aisle (2010 ADA Standards); stripe and designate the passenger vehicle accessible parking spaces at a width of 8' with 5' access aisles; signage must be set such that the signage height should be a minimum of 60" high at the bottom (2010 ADAAG Standards) and a maximum of 96" at the top (MAAB 521 CMR) and located in front of the space; slopes should not exceed 2% in any direction. <i>Note: Reconstruction of the accessible parking with compliant access aisles will severely restrict driveway access and pass-through.</i></p> <p><u>Option 2:</u> Leave the current parking spaces without access aisles to be used by non-wheelchair users but for persons with other ambulatory or non-ambulatory disabilities. A variance should be sought to allow the designated spaces without access aisles to remain "as is". Construct 2 new accessible parking spaces (one van accessible) in the side parking lot closest to the accessible route to the library entrance.</p>	1	2	N	Up to \$350

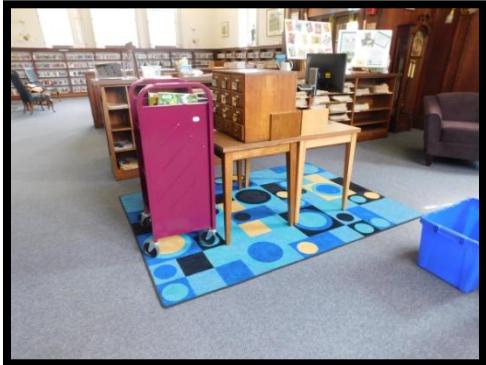
Photo Library 13

<b>Carpets and Rugs</b> The rug in the Reading room under the card catalogue is not secured and serves as a tripping hazard.  <a href="#">See Photo Library 13.</a>	302.2	29.3	Remove the rug/carpet.	4	1	I	\$0
<b>Children's Check-out Counter</b> Although the check-out counter meets accessibility height requirements, the plexiglass does not allow for pass-through access to fully serve as a counter.  <a href="#">See Photo Library 14.</a>	227 902	12.2	Modify the plexiglass to provide a pass-through at the accessible counter.	2	2	I	\$0

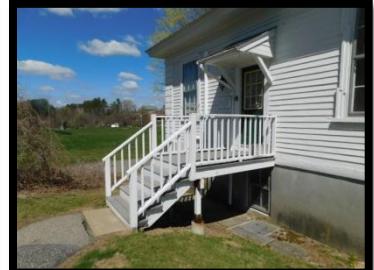
Photo Museum 3

<b>Egress Stairs</b> The stairs have non-compliant rectangular railings that lack bottom extensions.  <b>See Photo Museum 3.</b>	505	27	The railings must be replaced so that they are circular or oval in x-section with an outside diameter of $1\frac{1}{4}$ " to 2". The railings must extend 12" parallel to the floor at the top and the slope distance of one tread then 12" parallel to the ground at the bottom with a height of 34" – 38" a.f.f. to the top of the handrail.	4	2	N	Up to \$350
<b>Signage</b> Three interior doors (including the bathroom) lack tactile designation signage.	703	41.1	Install accessible compliant signage on the latch side of each door (where allowable) with appropriate finish and contrast and character height and proportions, raised and brailled characters should also be included. Under 521 CMR, signage s/b 60" a.f.f. to the centerline of the sign. Tactile characters on signs s/b 48" min. a.f.f. from baseline of lowest character and 60" max. a.f.f. to baseline of highest character. Characters must meet the ADA Standards for character height, finish and contrast, accompanied by Grade 2 Braille (703 ADA Standards).	2, 3	2	I	Up to \$300

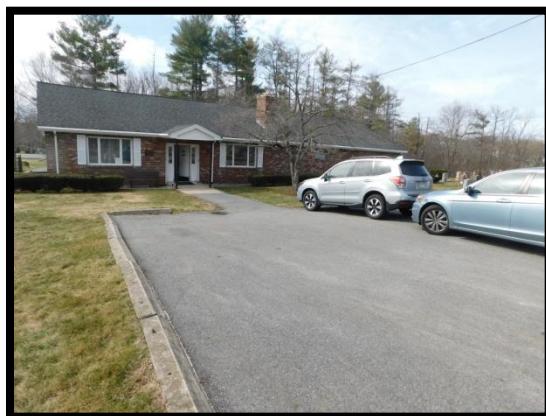
Photo Cemetery 1

General Description of Obstacle	2010 ADAAG	MAAB 521 CMR	Type of Action to be Taken	P	E	TF	Cost Estimate
<b>Parking</b> There is no designated accessible parking space inclusive of access aisle and signage. The designated accessible parking space must also be van accessible.  <color>See Photo Cemetery 1.</color>	502 703.7.2	23	Stripe and designate a van accessible parking space with van accessible signage at a width of either 11' with a 5' access aisle or 8' with an 8' access aisle (2010 ADA Standards). Signage must be set such that the signage height should be a minimum of 60" high at the bottom (2010 ADAAG Standards) and a maximum of 96" at the top (MAAB 521 CMR) and located no more than 10' in front of the space.	1	3	N	Up to \$3,500

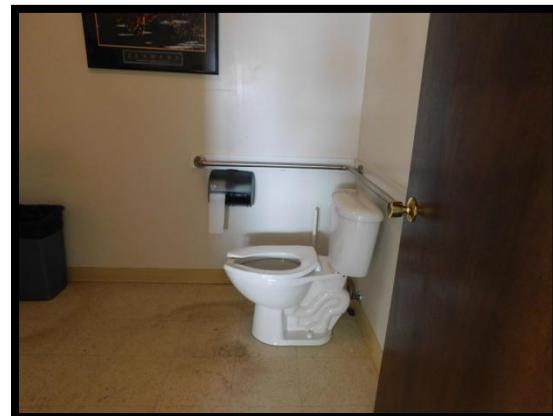
Photo Cemetery 4

The water closest flush control is on the near side and not the far or approach side.	604.6	30.7.5	Replace the water closet or the tank of the water closet with one that has a flush control on the approach or wide side.	3	3	N	\$125 to \$350
The side grab bar is 6" too short	604.5	30.8	Replace the grabs so that both are 42" in length.	3	2	N	\$700
The toilet paper dispenser is too close to the water closet.	604.7	30.7.6	Relocate the toilet paper dispenser so it is a minimum of 7" and a maximum of 9" in front of the water closet measured to the centerline of the dispenser and at least 24" a.f.f. <i>Note: There also must be at least 1½" clearance below the grab bar to the nearest object or fixture.</i>	3	2	I	\$0
The water closet is 22" o.c. to the near side wall, which is 4" too far.	604.2	30.7.2	Relocate the water closet so that it is 18" o.c. to the near side wall.	3	3	N	Up to \$500
<b>See Photo Cemetery 4.</b>							Total \$11,970+

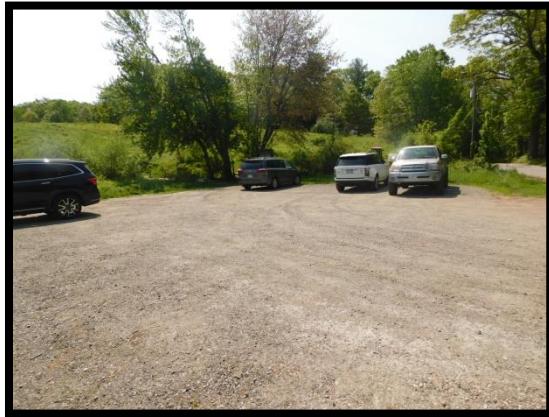
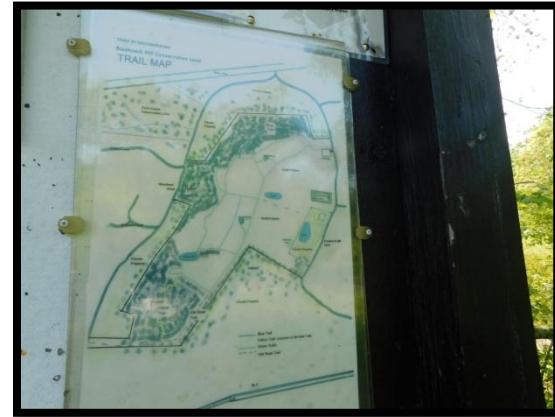
Trails. There are roughly 3 miles of trails on the site, but none are formally maintained to a standard that would be considered to be an accessible route of travel. The parking for the facility is an unimproved compacted stone dust surface. No signage or striping is provided.

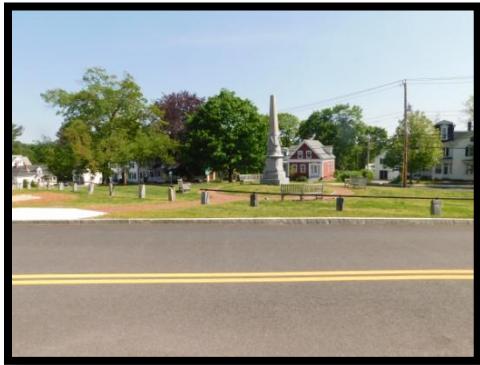
Photo Town Common 1

**General Description or Obstacle Which Limits Mobility or Access:** There is no accessible route of travel to the cannon and adjacent bench. The accessible route of travel to the 1866 monument has a running slope that varies from 5.0% to 14.4%. The initial 5 to 6 feet of the brick walkway to the Veteran's Memorial from the concrete sidewalk has a running slope of up to 6.4%. The stairs from Main Street to the Town Common lack railings.

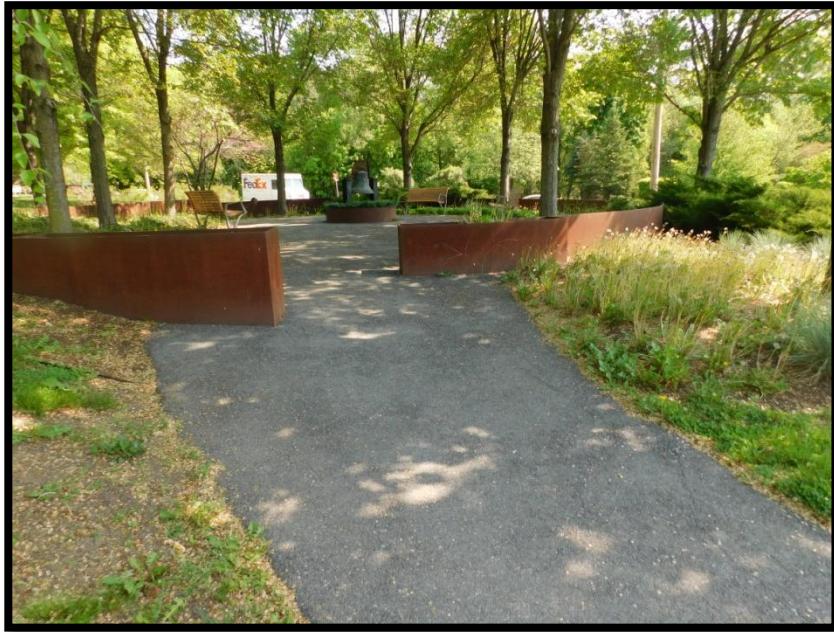
Photo Triangle Park 1

**General Description or Obstacle Which Limits Mobility or Access:** A section of the paved accessible route in the northern end of the park has significant sinking creating a 6+ inch change in level surface and a running slope of up to 27.8%. A roughly 6 foot segment of the walkway from Southville Road has a running slope that varies up to 6.6%.

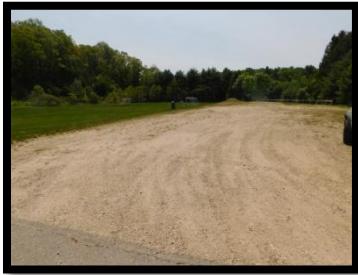
Photo Kallander 1

**General Description or Obstacle Which Limits Mobility or Access:** There is no designated accessible parking. The portable toilet is not on an accessible route of travel and is not fully "ADA compliant". There is no accessible route of travel to and around the field.

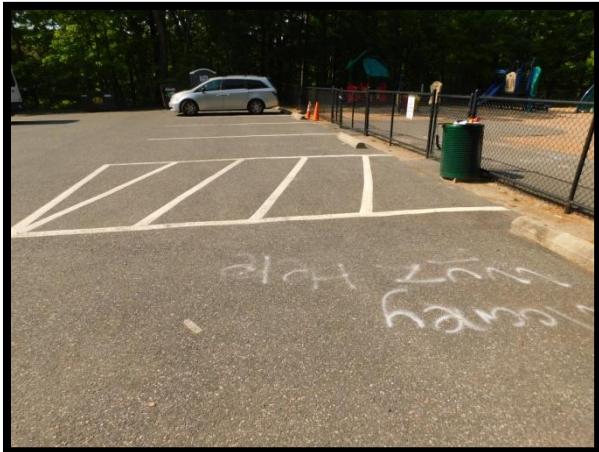
Photo South Union 1

**General Description or Obstacle Which Limits Mobility or Access:** Although there is accessible parking adjacent to the South Union Street building and an apparent striped access aisle at the playground entrance, there is no designated accessible parking and signage for the playground area. There is a paved accessible route into the playground area and to the picnic tables, however, no accessible route of travel exists fully around the playground area or the play equipment. Non-compliant wood chips are the primary surface throughout the playground. Although one of the 3 picnic tables is accessible, it is positioned so that the accessible side has insufficient clear width to access on the pavement side and can only be reached by going through woodchips. The chain link gate to enter the playground is not flush at the base. The portable toilet is not on an accessible route of travel and is not fully “ADA compliant”.

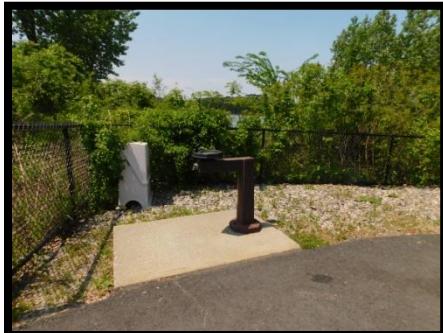
Photo Fayville 1

<b>Drinking Fountain</b> The drinking fountain is not "high-low".  <span style="color: red;">See Photo Fayville 1.</span>	211 602	36	Option #1: Discontinue the use of the drinking fountain and place out of service.  Option #2: Remove the existing drinking fountain and replace with a "high-low" drinking fountain or add a "high fountain". The drinking fountain must comply as follows:  Protruding objects compliance of no > 4" protrusion between 27" and 80" a.f.f. (307); 30"x48" clear space requirement (305), and knee/toe clearance (306). Knee clearance is 9" to 27" a.f.f; 25" deep max. at 9" a.f.f. or 11" deep min at 9" a.f.f. and 8" deep min at 27" a.f.f. Width of knee clearance s/b 30" wide min (306.3). Toe clearance as part of c.f.s. 17" min - 25" max, 9" high a.f.f., 30" wide (306.2). The spout s/b 5" max from the front edge of the unit (602.5). Flow of water 4" high min and spout located max 5" from front (602.6). The spout height s/b 36" max. a.f.f. for "low" and 38" min a.f.f. to 43" max a.f.f. for "high". The controls s/b operable w/one fist; no > 5 lbs force (309.4).	2	3	L	Up to \$1,500

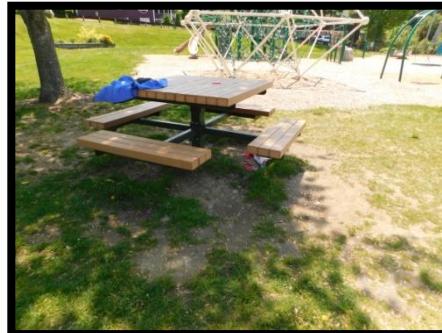
Photo Fayville 2

**General Description or Obstacle Which Limits Mobility or Access:** One of the designated accessible parking spaces and the shared access aisle has excessive running slopes. In addition, the signage for that space is too low. The portable toilet is not fully "ADA compliant". The drinking fountain is not "high-low". The picnic tables near Central Street lack sufficient clear width. The stairs from Central Street to the park lack extensions at the top and bottom. There are no accessible routes of travel to and around the ball fields, basketball court, little free library, and other amenities. There is no accessible route of travel fully around the playground and to and between play components. Non-compliant wood chips are the primary surface throughout the playground. Although there is one accessible swing and the larger playscape has a ramped approach, the ramp is only 44" wide, lacks compliant railings, and has a running slope up to 9.2%.

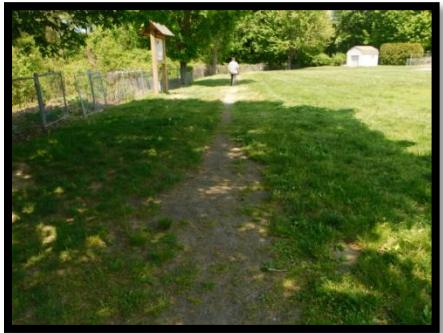
Photo Fayville 5

There appears to be the remnant of a stone dust walking trail around the field area of the park. There are areas along the entirety of this walking trail that is getting overgrown with grass and weeds and becoming deteriorated and uneven. This accessible route of travel around the recreation area perimeter needs to be routinely maintained including weeding, providing additional stone dust, and compacting to ensure full compliance with the standard of "*firm, stable, and slip resistant*".

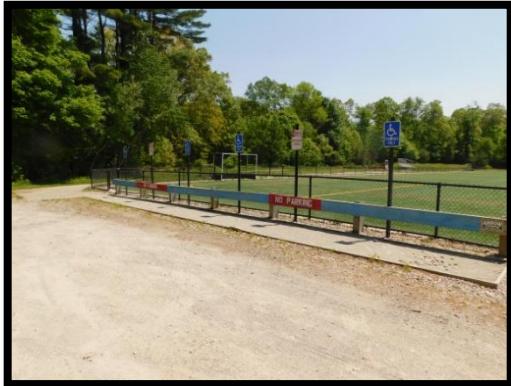
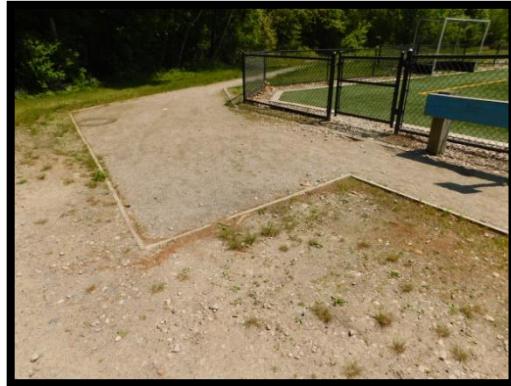
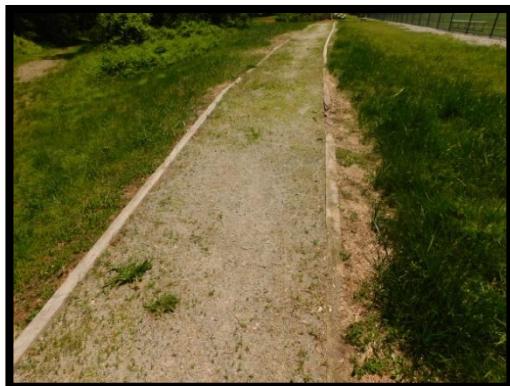
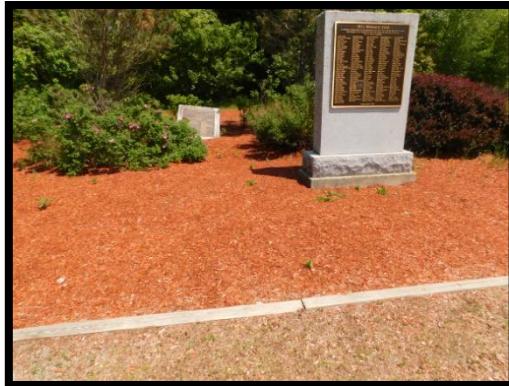
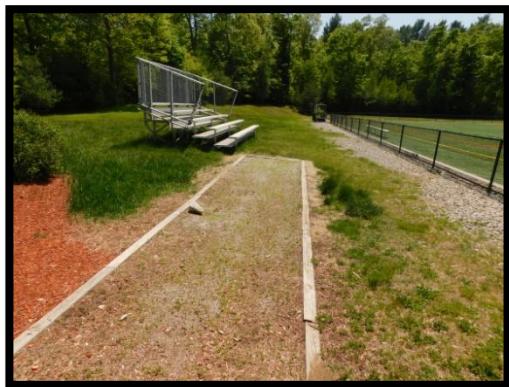
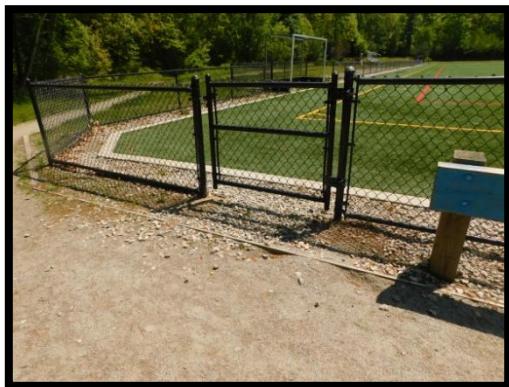
**General Description or Obstacle Which Limits Mobility or Access:** The surface of the designated accessible parking is a mixture of gravel, stone, and stone dust. The parking lacks striping. There is an abrupt change in level surface from the parking to the stone dust walkway to the bleacher and memorial area. The existing stone dust walkway is overgrown and does not fully extend beyond the bleachers or the memorial. There is no accessible route of travel from the parking to the field. The chain link gate to the field is locked and is not flush at the base. The portable toilet is not an accessible route of travel and is not fully "ADA compliant".

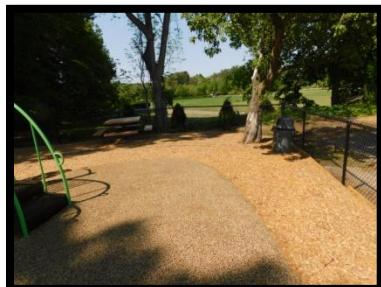
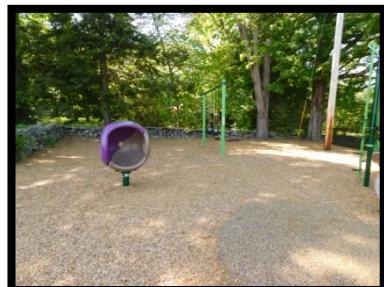
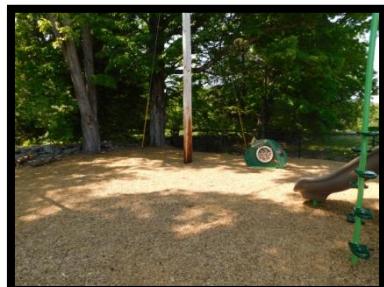
**General Description or Obstacle Which Limits Mobility or Access:** Although there is accessible parking adjacent to the Historical Museum building, there is no designated accessible parking and signage for the playground area. There is a paved rubberized accessible route into the playground area and to the larger playscape, however, no accessible route of travel exists fully around the playground area or to the remainder of the play equipment or bench. Non-compliant wood chips are the primary surface throughout the playground. There is no level area for a wheelchair next to the bench. The picnic table is not accessible. The running slope of the rubberized accessible route from the asphalt to the playground interior has a running slope of up to 8.8%. Depending on the location of the accessible route around the perimeter of the playground, the telephone "guy wires" could prove to be a protruding object as headroom is reduced due to the placement of the wires. The playground equipment is minimally compliant and at a minimum an accessible swing should be provided.

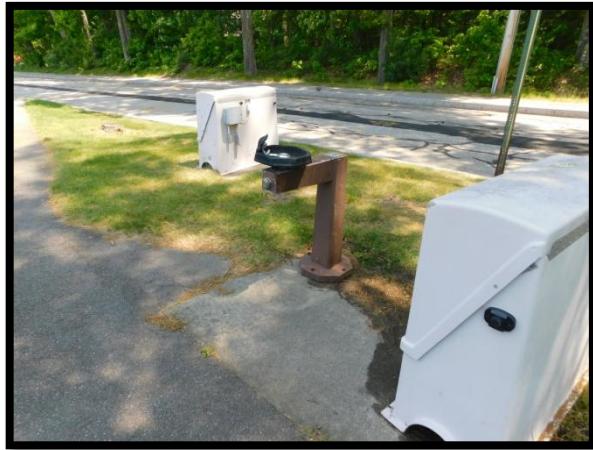
Photo Lunblad 2

<b>Drinking Fountain</b> The drinking fountain near the sidewalk and parking area is not "high-low".  <a href="#">See Photo Lunblad 2.</a>	211 602	36	<p>Option #1: Discontinue the use of the drinking fountain and place out of service.</p> <p>Option #2: Remove the existing drinking fountain and replace with a "high-low" drinking fountain or add a "high fountain". The drinking fountain must comply as follows:</p> <p>Protruding objects compliance of no &gt; 4" protrusion between 27" and 80" a.f.f. (307); 30"x48" clear space requirement (305), and knee/toe clearance (306). Knee clearance is 9" to 27" a.f.f; 25" deep max. at 9" a.f.f. or 11" deep min at 9" a.f.f. and 8" deep min at 27" a.f.f. Width of knee clearance s/b 30" wide min (306.3). Toe clearance as part of c.f.s. 17" min – 25" max, 9" high a.f.f., 30" wide (306.2). The spout s/b 5" max from the front edge of the unit (602.5). Flow of water 4" high min and spout located max 5" from front (602.6). The spout height s/b 36" max. a.f.f. for "low" and 38" min a.f.f. to 43" max a.f.f. for "high". The controls s/b operable w/one fist; no &gt; 5 lbs force (309.4).</p>	2	3	L	Up to \$1,500

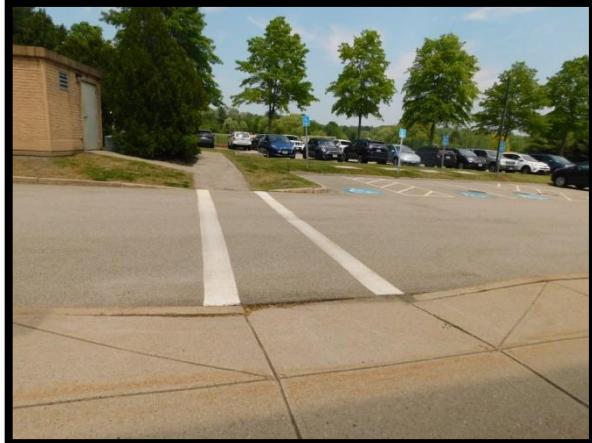
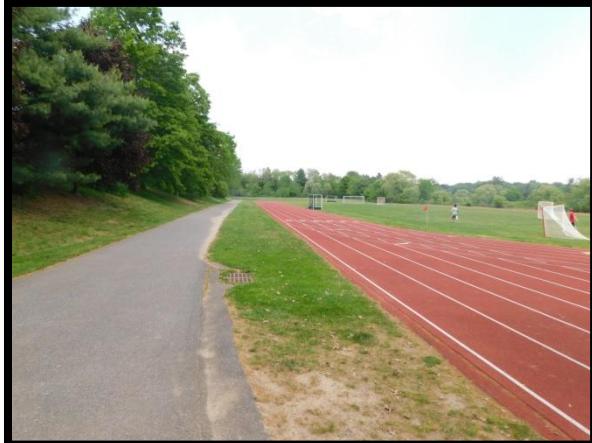
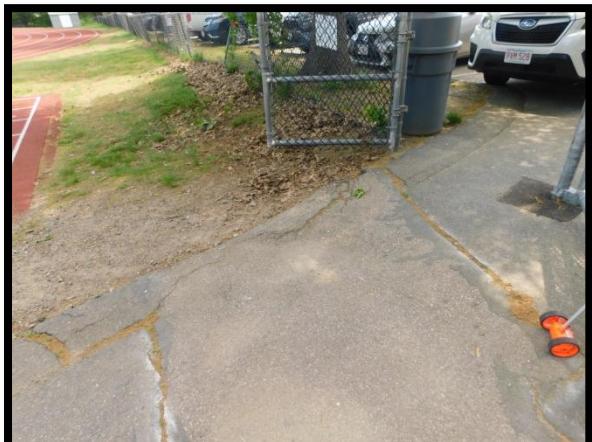
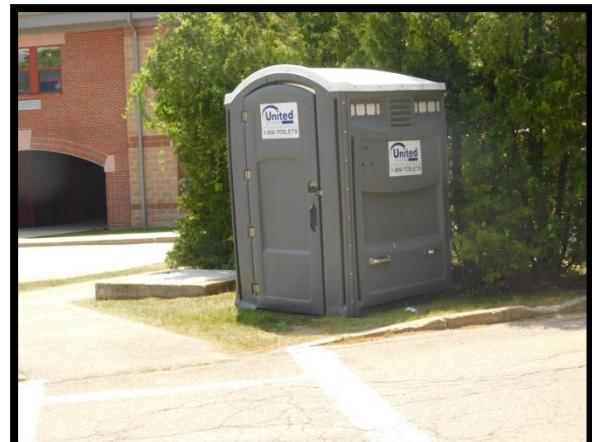
**General Description or Obstacle Which Limits Mobility or Access:** The curb ramps on the accessible route of travel from the school to the field and from the parking to the school lack detectable warning strips, have excessive running slopes, and abrupt changes in level surface. The portable accessible toilet is not on an accessible route of travel and is not fully "ADA" compliant. The approach to the gated entrance to the field has excessive running slopes due to sunken asphalt. The gate is not flush at the base. The drinking fountain is not "high-low". Assuming use of the outer track area as an accessible route around part of the track, there still needs to be an accessible route to the track.

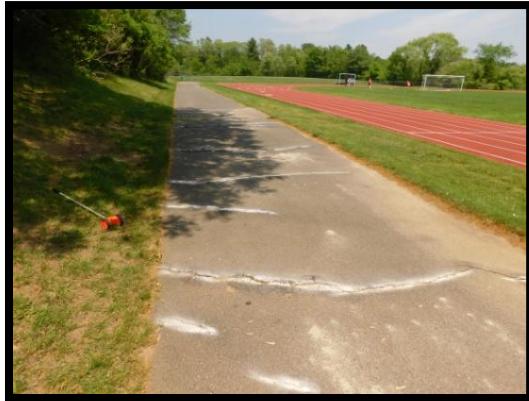
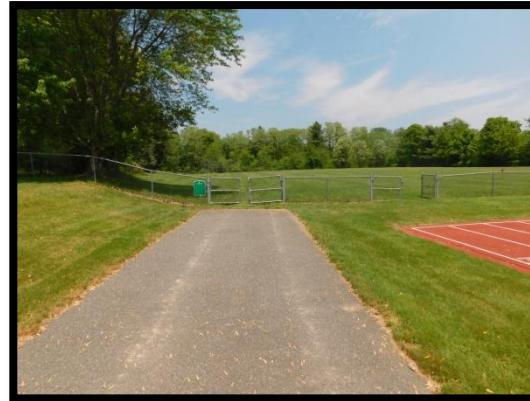
**General Description or Obstacle Which Limits Mobility or Access:** There is a paved accessible route to the edge of the softball field area. The paved accessible route is heaving and has numerous abrupt changes in level surface. There is no accessible route to the playing area itself and the player benches. The gate is not flush at the base.

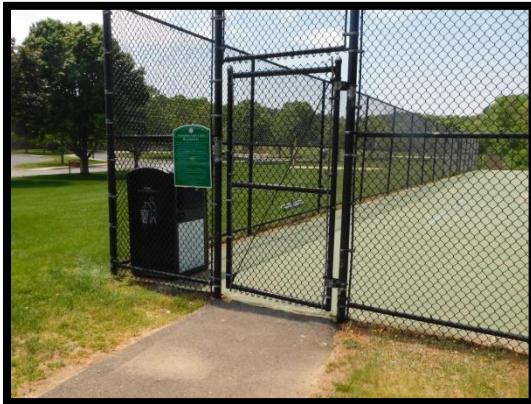
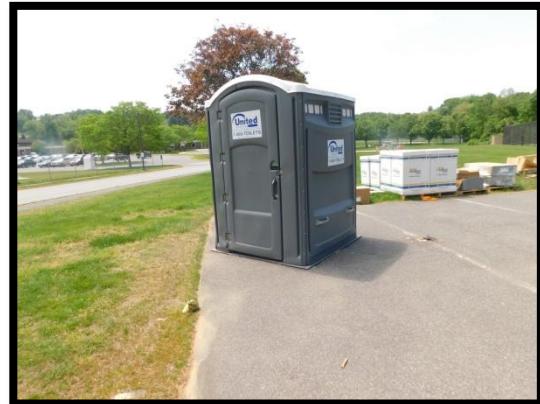
**General Description or Obstacle Which Limits Mobility or Access:** There is no designated accessible parking. The gate is not flush at the base and the latch is too high. The portable accessible toilet is not "ADA" compliant and is positioned in a manner on the asphalt making it difficult to access without going onto the adjacent grassed area.

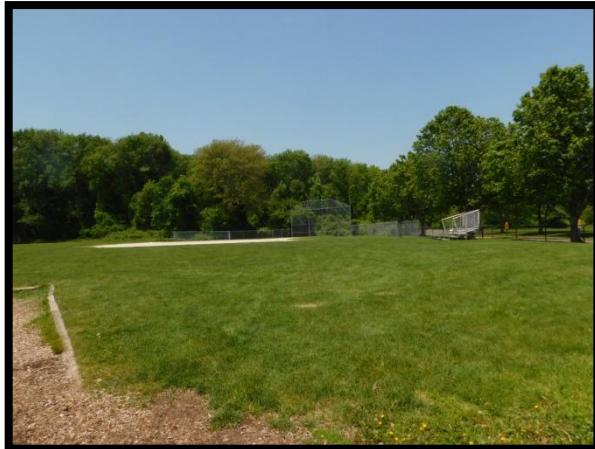
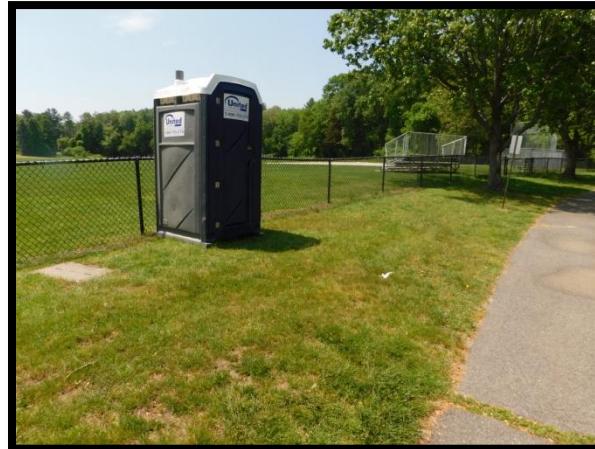
**General Description or Obstacle Which Limits Mobility or Access:** There is no accessible route of travel to and around the fields, bleachers, and benches. There are no level areas for wheelchairs adjacent to the spectator bleacher and bench seating. The portable toilet is not accessible.

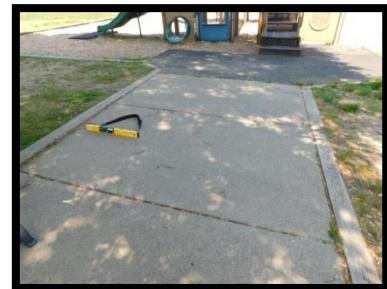
Photo Playground 3

<p><b>Picnic Table</b> The picnic table has only 11" of clear width and is not on an accessible route of travel.</p> <p><b>See Photo Playground 3.</b></p>	<p>226.1 902 403</p>	<p>19 22</p>	<p>At least 5% or at least one table must be accessible at each separate location. Replace the existing picnic table with one that is fully accessible. The table surface s/b 28" to 34" a.f.f. to the top surface with at least 27" knee clearance, 30" clear width, and 19" depth.</p>	<p>2</p>	<p>2</p>	<p>I \$750</p>

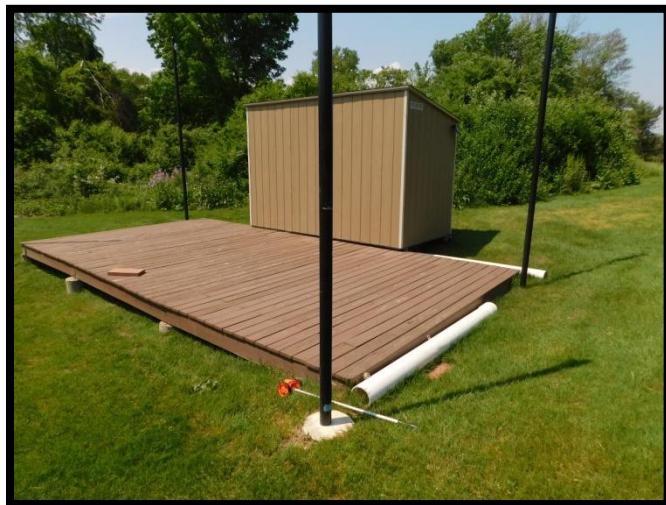
Photo Volleyball 1

**General Description or Obstacle Which Limits Mobility or Access:** There is no accessible route of travel to and around the volleyball area, picnic table and performance stage. There is a 6" abrupt change in level surface from the ground to the performance stage. The picnic table lacks sufficient clear width for a wheelchair.

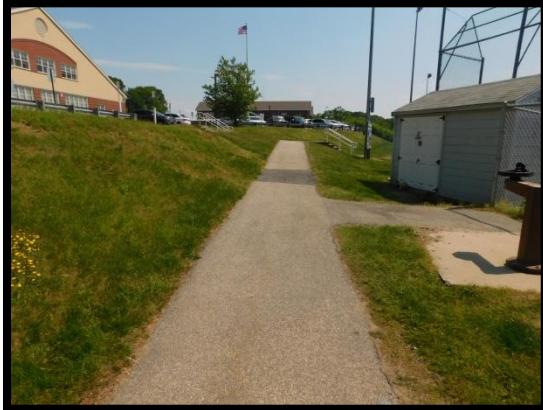
Photo Woodward 1

**General Description or Obstacle Which Limits Mobility or Access:** Based on the # of spaces in the parking lot, an additional accessible parking space is required. Signage for the existing spaces is too high. Neither of the 2 spaces are designated as van accessible. The drinking fountain is not "high-low". The sloped accessible route of travel from the school to the fields has areas of heaving, abrupt changes in level surface, and a segment with running slopes in excess of 5.0%. The portable accessible toilet is not "ADA" compliant. There is no accessible route of travel to and around the field area and to player benches.

Standards) and a maximum of 96" at the top (MAAB 521 CMR) and located in front of the space; slopes should not exceed 2% in any direction.				
			Lower the signage for the existing parking spaces so that the heights of the signs are no more than 96" a.f.f. to the top of the signs.				
<b>Drinking Fountain</b> The drinking fountain near the field entrance is not "high-low".	211 602	36	<p>Option #1: Discontinue the use of the drinking fountain and place out of service.</p> <p>Option #2: Remove the existing drinking fountain and replace with a "high-low" drinking fountain or add a "high fountain". The drinking fountain must comply as follows:</p> <p>Protruding objects compliance of no &gt; 4" protrusion between 27" and 80" a.f.f. (307); 30"x48" clear space requirement (305), and knee/toe clearance (306). Knee clearance is 9" to 27" a.f.f; 25" deep max. at 9" a.f.f. or 11" deep min at 9" a.f.f. and 8" deep min at 27" a.f.f. Width of knee clearance s/b 30" wide min (306.3). Toe clearance as part of c.f.s. 17" min – 25" max, 9" high a.f.f., 30" wide (306.2). The spout s/b 5" max from the front edge of the unit (602.5). Flow of water 4" high min and spout located max 5" from front (602.6). The spout height s/b 36" max. a.f.f. for "low" and 38" min a.f.f. to 43" max a.f.f. for "high". The controls s/b operable w/one fist; no &gt; 5 lbs force (309.4).</p>	2	3	L	Up to \$1,500

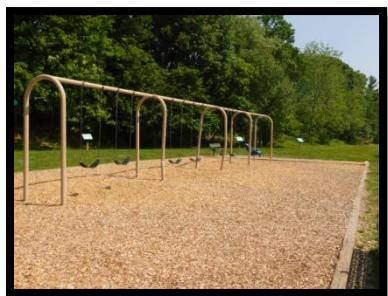
Photo Playground 1

**General Description or Obstacle Which Limits Mobility or Access:** There is no accessible route of travel to the picnic table and the table lacks sufficient clear width. The benches are located in different areas around the playground but only one is on an accessible route. The initial 10' of the asphalt walkway to the playground from the school has running slopes of up to 7.4%. In addition, vegetative overgrowth along the walkway restricts the clear width to 30" or less in areas. No accessible route of travel exists fully around the playground area or to the play equipment and components. An abrupt change in level surface of 1" results from the interior of the playground due to the wood edging. Non-compliant wood chips are the primary surface throughout the playground.

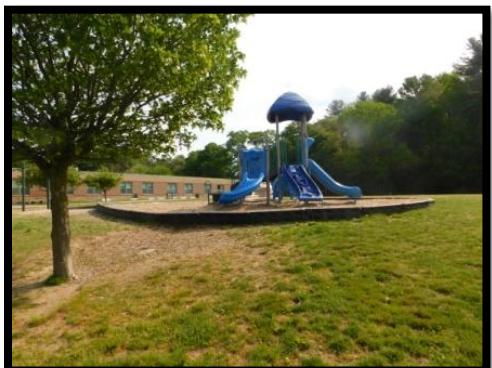
Photo Finn-Mooney 11

<p><b>Larger Playground Area:</b> There is no accessible route of travel to and around the entirety of the perimeter of the playground area. There is no accessible route of travel to and between play components. Non-compliant woodchips is the surface treatment for the entirety of play areas. <i>Note: Woodchips may only be considered as a possible option for the fall zone ground surface.</i></p>			
<p><b>See Photos Finn-Mooney 11, 12, 13, and 14.</b></p>			<p><b>Estimated Total Cost:</b> Up to \$132,400+</p>

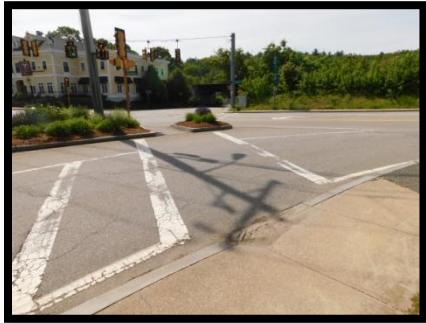
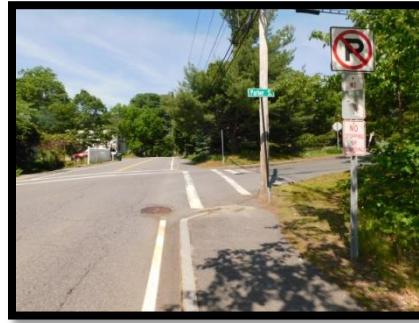
#### Lack of Detectable Warning Strips

- Southville Road and Cordaville Road
- River Street and Southville Road at Traingle Park (5)
- Parker Street and Southville Road (4)
- Harrington Street and Southville Road
- Bridge Street and Southville Road
- Near #174 Southville Road
- Near Fiddleneck Lane (2)

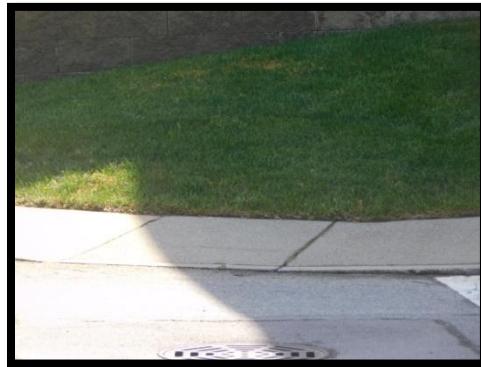
#### Lack of Level Landing at Top of Curb Ramp

- River Street and Southville Road at Traingle Park (6)
- Parker Street and Southville Road (2)
- Near #174 Southville Road
- Near Fiddleneck Lane

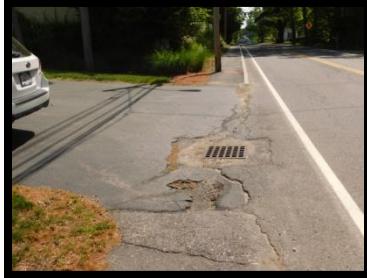
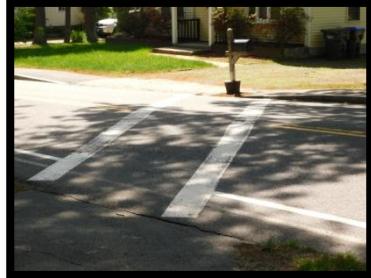
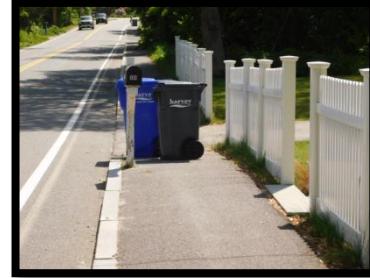
### Sidewalk and Curb Ramp Obstructions

- #105 Southville Road sidewalk deterioration and abrupt changes in level surface of 2+ inches
- #105 Southville Road catch basin in sidewalk
- Mailbox in middle of sidewalk at #194 Southville Road
- Recycling and trash bins blocking sidewalk at #176 and #184 Southville Road

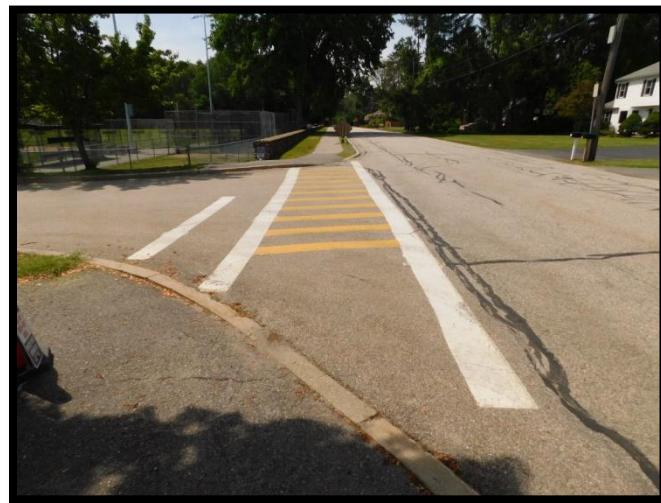
### Lack of Detectable Warning Strips

- Highland Street and Parkerville Road (2)
- Southville Road and Parkerville Road (2)
- Southwood Drive and Parkerville Road (2)
- Parkerville Road and Finn School Driveways (2)
- Wildwood Drive and Parkerville Road (2)
- Richards Road and Parkerville Road (2)

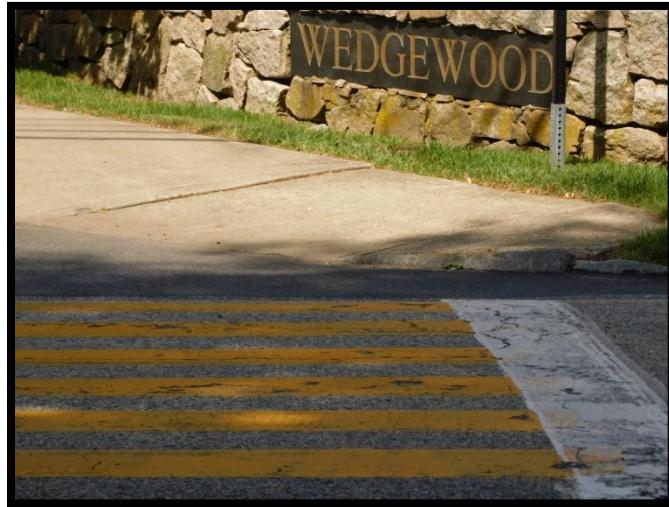
#### Lack of Level Landing at Top of Curb Ramp

- Southwood Drive and Parkerville Road
- Finn School driveway near school (2)
- Wildwood Drive and Parkerville Road (1)
- Richards Road and Parkerville Road (2)

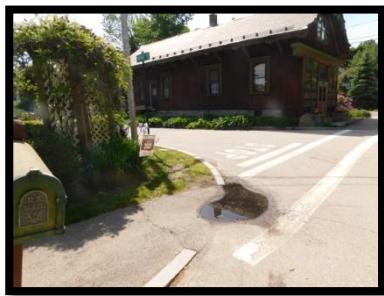
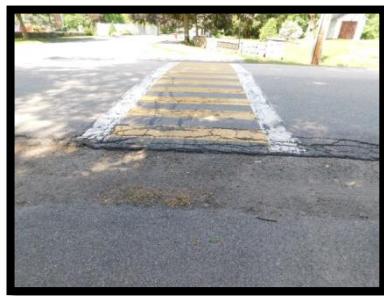
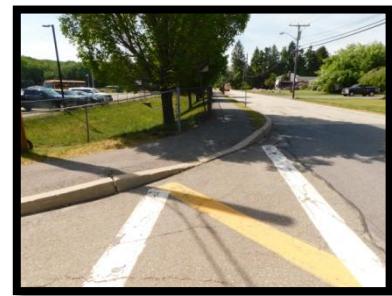
#### Sidewalk and Curb Ramp Obstructions

- Puddling of water at base of curb ramp at #26 Highland Street
- One inch abrupt change in level surface opposite Southwood Drive
- Southwood Drive concrete near Parkerville Road heaving creating  $\frac{1}{2}$ " to 1" abrupt changes in level surface
- Abrupt change in level surface of 1" to 4" at Finn School driveway crosswalk near school side

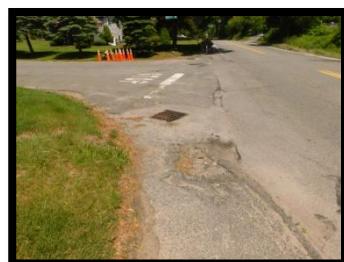
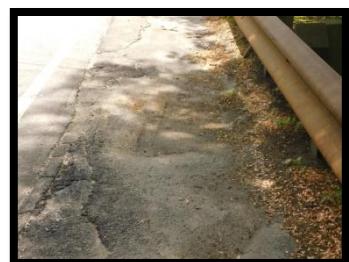
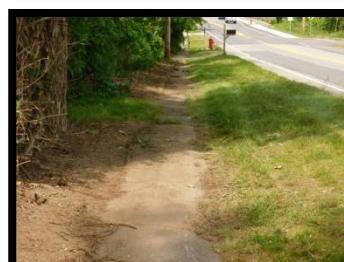
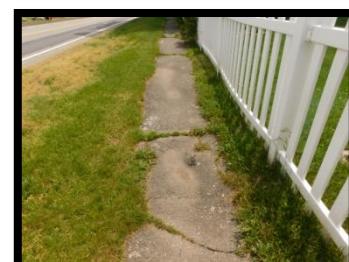
#### **Sidewalk and Curb Ramp Obstructions**

- Recycling and trash bins blocking sidewalk at #237 Cordaville Road
- Cordaville Raod and Richards Road crosswalk terminates at a guardrail
- Cordaville and Rockpoint Road curb ramp have 1" to 2" abrupt changes in level surface at the base and are severely deteriorated
- Catch basins are located at the base of the curb ramps (2) at Rockpoint Road and Cordaville Road
- Areas of sidewalk deterioration and heaving along southerly segments of Cordaville Road and in the vicinity of Cordaville Hall including restricted clear width
- Reduced width of curb ramp level landing at Rockpoint Road and Cordaville Road

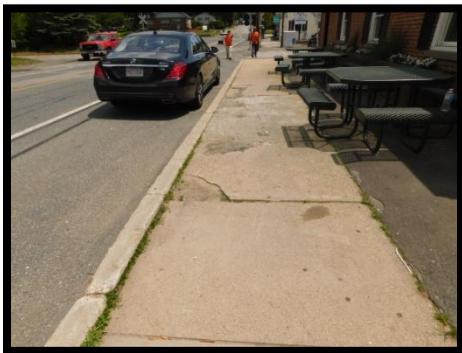
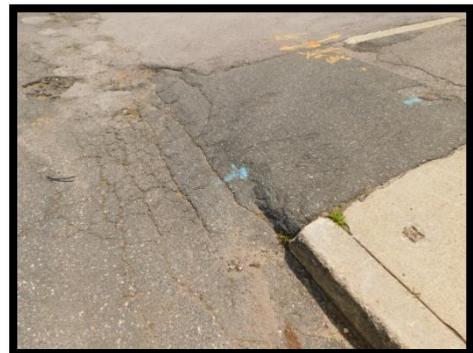
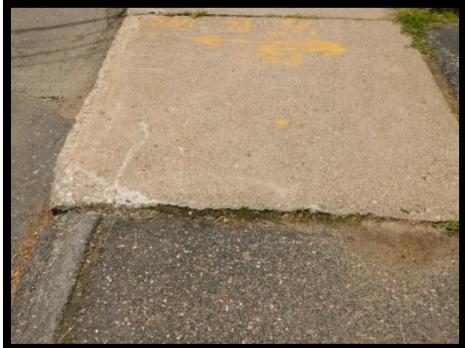
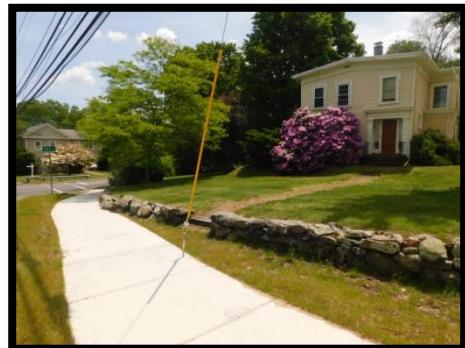
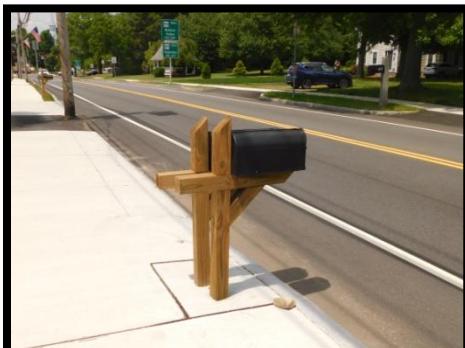
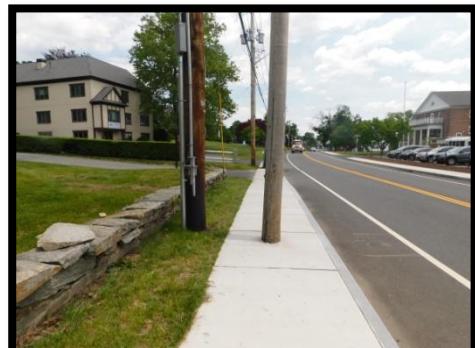
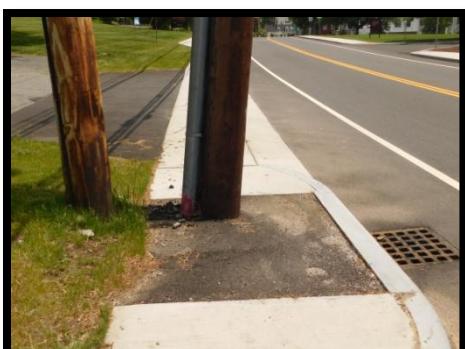
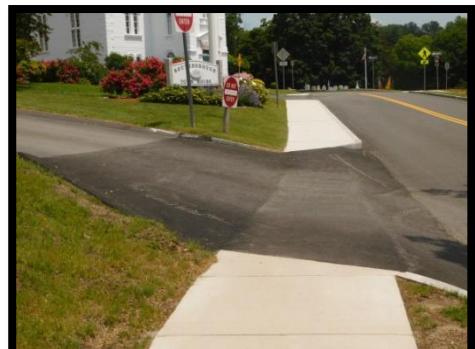
#### **Sidewalk and Curb Ramp Obstructions**

- Park Street and Main Street crosswalks/curb ramps have abrupt changes in level surface of up to 2"
- Concrete sidewalk at Mauro's Village Café has severe deterioration and abrupt changes in level surface
- Cross walk at Mauro's Café to Knights of Columbus lacks a curb ramp and has a 4" abrupt change in level surface
- Sidewalk transition from asphalt to concrete at Hiller's Cleaner's has an abrupt change in level surface of 1+"
- A telephone guy wire for telephone pole #5 creates reduced head room and is a protruding object
- Telephone poles in front of the Brackett House and between the Brackett House and a St. Mark's building reduce the sidewalk clear width to only 20" to 26"
- Mailboxes at #'s 18, 22, and 26 Main Street are protruding objects as they protrude more than 4" at a height of between 27" and 80" a.f.f. into the accessible route of travel

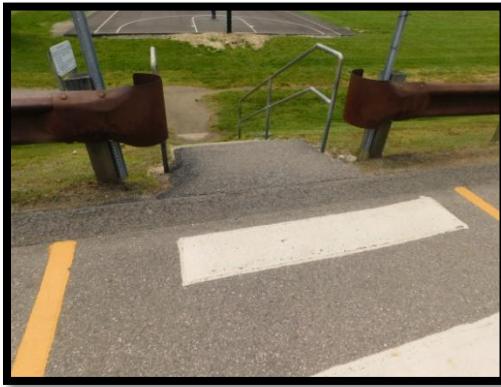
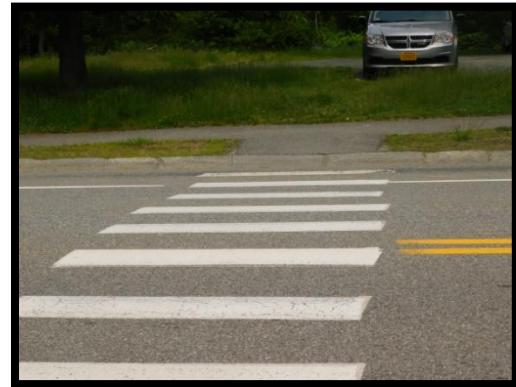
**Sidewalk and Curb Ramp Obstructions**

- Crosswalks/curb ramps across Central Street from the parking lot to the Fayville Recreation Area have abrupt changes in level surface of 3" on the field side and 6" on the parking lot side

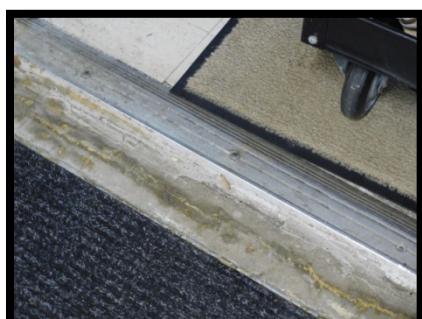
Photo Neary 13

See Photo <a href="#">Near 13</a> .				1	3	N	Up to \$7,500+
<b>Door Thresholds</b> The following thresholds have abrupt changes in level surface of up to 1¼": <ul style="list-style-type: none"> <li>• Main school entrance</li> <li>• Supt./Admin. Dept. entrance</li> <li>• Exit D-1</li> <li>• Exit D-4</li> <li>• Courtyard</li> <li>• Hallway double doors @ #7</li> <li>• Exit C-1</li> </ul>	404.2.5	26.10	Modify or replace the door thresholds such that there is no more than a ¼" abrupt change in level surface or up to ½" if beveled with a no more than 1:2 slope.	1, 2	3	N	Up to \$5,250+
See Photo <a href="#">Near 14</a> .				2	2,3	L	Up to \$150K+
<b>Doorway Maneuvering Clearances</b> The following have reduced maneuvering clearance (less than 18")	404.2.4	26.6	There should be a minimum of 18" clearance on the latch pull side of the door for maneuverability. Options for	2	2,3	L	Up to \$150K+

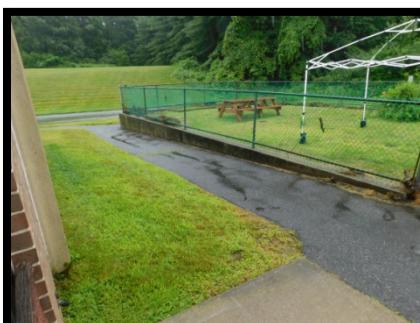
Photo Neary 28

<p>on the push side for the full width of the gate.</p> <p><b>See Photos Nearly 28 and 29.</b></p>		<p>Reconstruct the pad so that there is a 5' level landing at the doorway entrance (2.0% or less) and no more than a 5% running slope to the asphalt walkway.</p> <p>Replace and reconstruct the affected asphalt walkway so that the running slopes do not exceed 5.0%.</p> <p>If concrete and asphalt running slopes exceed 5.0%, Install paired ramp railings (lower railing 18" – 20" a.f.f.; upper railing 34" – 38" a.f.f.</p> <p><b>Picnic Tables</b> At least 5% or at least one table must be accessible at each separate location. Purchase 1 accessible picnic tables and locate it on an accessible route of travel in the outdoor area. The table surfaces s/b 28" to 34" a.f.f. to the top surface with at least 27" knee clearance, 30" clear width, and 19" depth.</p> <p><b>Chain Link Gate</b> Remove the gate or install smooth plating at the base of the gate.</p>	2	2	N	\$750
