Town of Southborough

Self-Evaluation and Transition Plan

June 2021

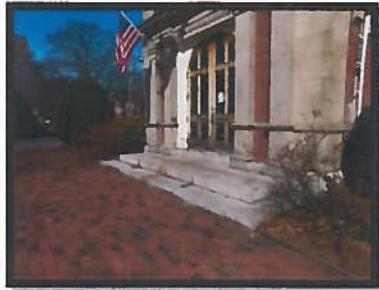
Front Entrance Stairs

A variance should be sought to keep the front entrance as "egress only" with proper directional signage and to maintain its current historical appearance with no further modifications. *See photo below.*

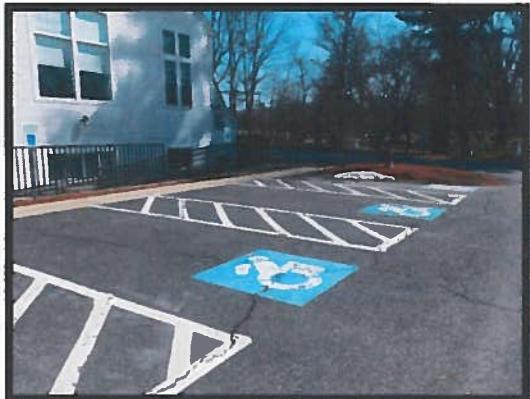
Photo Cordaville 11

BUILDING/BOH (LOWER LEVEL)		Type of Action to be Taken				P	F	TF	Cost Estimate
General Description of Obstacle		2010 ADAAG	MAAB 521 CMR						
Parking The middle designated accessible space lacks signage, whereas the other 2 spaces have signage that is too low. None of the spaces are designated as van accessible. See Photo Cordaville 11.	502	23		Signage must be set such that the signage height should be a minimum of 60" high at the bottom (2010 ADAAG Standards) and a maximum of 96" at the top (MAAB 521 CMR) and located in front of the space. Signage needs to be provided for the middle space and "van accessible" signage included for the space closest to the building entrance as it has a 12' wide access aisle.		1	2	I	\$75
Concrete Ramp to Accessible Entrance There are numerous abrupt changes in level surface throughout the ramp due to heaving and deterioration. The "level" top of the ramp has a running	403.4 405.7	22.4 24.4		Modify (grind, patch, and/or reset) concrete as may be required so that there are no changes in level surface of greater than $\frac{1}{4}$ ". Reset/reconstruct the top 9 feet +/- of the upper segment of concrete to create a top level		1	3	N	TBD – up to \$5,000

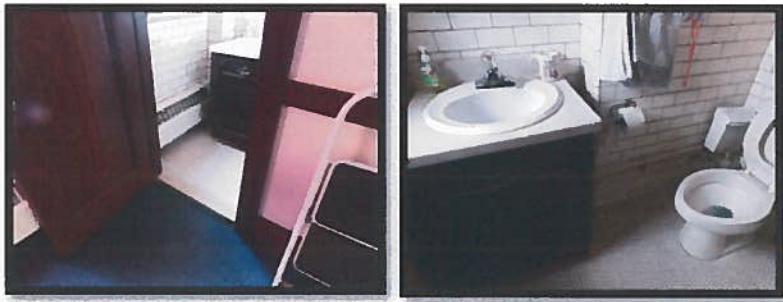
The Level 2 Library Director's office private bathroom has only 25" of clear width to gain access. The bathroom is only 3 feet wide and is wholly non-compliant due to lack of maneuverability, clearance, and accessible components. *See Photos Below*. As this is an employee only space and not open to the public, modifications would only be required as a reasonable accommodation request. No other action is required at the present time.

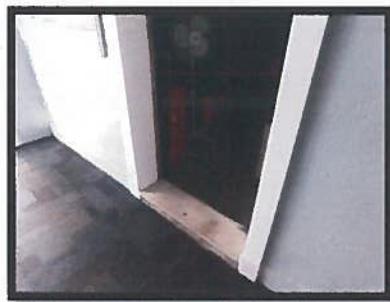
The Level 1 storage room near the Teen Room has 3" abrupt change in level surface to access the storage area. As this is not open to the public and restricted to employees only, modifications would only be required as a result of a reasonable accommodation request. No other action is required at the present time. *See Photo Below*.

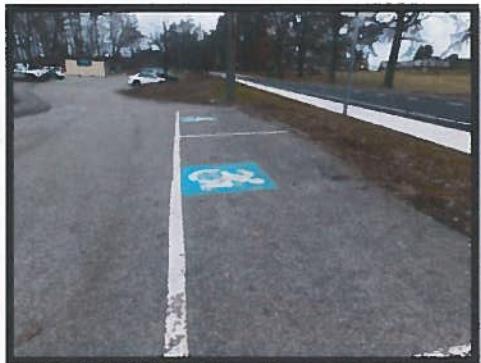
Photo Library 1

<u>General Description of Obstacle</u>	<u>2010 ADAAG</u>	<u>MAAB 521 CMR</u>	<u>Type of Action to be Taken</u>	<u>P</u>	<u>F</u>	<u>TF</u>	<u>Cost Estimate</u>
Parking None of 2 designated accessible parking spaces have signage or access aisles. There is no van designated accessible space. <i>See Photos Library 1 and 2.</i>	502	23	<p>Option 1: Reconstruct the accessible parking spaces as follows: stripe and designate a van accessible parking space with van accessible signage at a width of either 11' with a 5' access aisle or 8' with an 8' access aisle (2010 ADA Standards); stripe and designate the passenger vehicle accessible parking spaces at a width of 8' with 5' access aisles; signage must be set such that the signage height should be a minimum of 60" high at the bottom (2010 ADAAG Standards) and a maximum of 96" at the top (MAAB 521 CMR) and located in front of the space; slopes should not exceed 2% in any direction. <i>Note: Reconstruction of the accessible parking with compliant access aisles will severely restrict driveway access and pass-through.</i></p> <p>Option 2: Leave the current parking spaces without access aisles to be used by non-wheelchair users but for persons with other ambulatory or non-ambulatory disabilities. A variance should be sought to allow the designated spaces without access aisles to remain "as is". Construct 2 new accessible parking spaces (one van accessible) in the side parking lot closest to the accessible route to the library entrance.</p>	1	2	N	Up to \$350

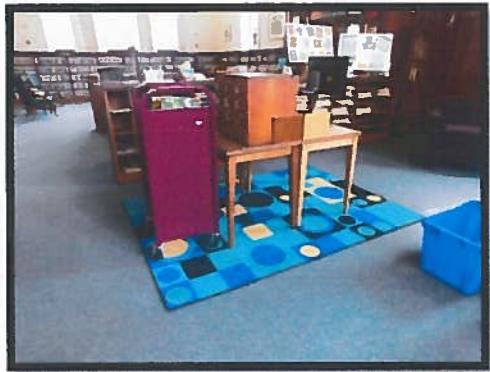
Photo Library 13

See Photo Library 12.							
Carpets and Rugs The rug in the Reading room under the card catalogue is not secured and serves as a tripping hazard.	302.2	29.3	Remove the rug/carpet.	4	1	I	\$0
See Photo Library 13.							
Children's Check-out Counter Although the check-out counter meets accessibility height requirements, the plexiglass does not allow for pass-through access to fully serve as a counter.	227 902	12.2	Modify the plexiglass to provide a pass-through at the accessible counter.	2	2	I	\$0
See Photo Library 14.

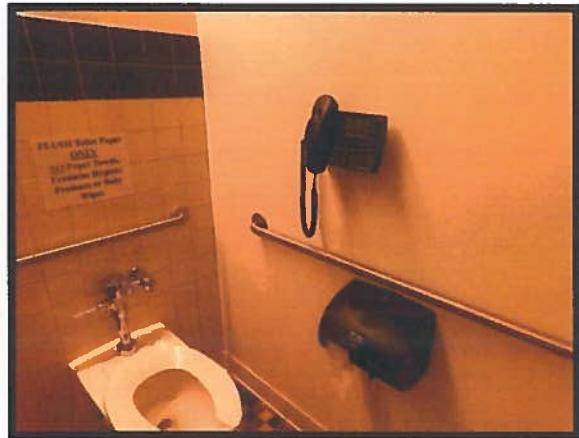
Photo Public Safety 4

<u>L1 Hallway (across from drinking fountain) and L1 Police (across #134)</u> The water closets are $\frac{3}{4}$ " to 1" too far from the nearest side wall.	604.2	30.7.2	Relocate the water closets so they are 18" o.c. from the nearest sidewall.	3	3	N	Up to \$1,000
<u>L1 Police (across #134)</u> The water closet seat is $\frac{1}{2}$ " too low.	604.4	30.7.3	Replace the existing seat with a raised seat so that the top of the seat is 17" to 19" a.f.f.	3	2	I	\$50
Dispatch The soap dispenser is 4 $\frac{1}{2}$ " too high.	308.2 308.3	30.12	Lower the dispenser to a height of no more than 42" a.f.f.	3	2	I	\$0
The telephone is located over the grab bars.	604	30	Relocate the phone closer to the wall corner or below the grab bar so it is not over the grab bars.	3	3	N	Up to \$150
See Photo Public Safety 4.

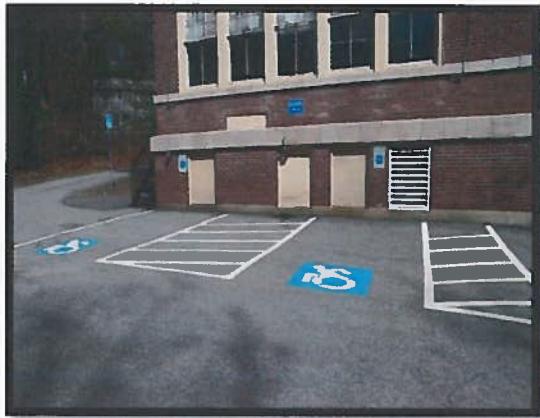
Photo South Union 1

General Description of Obstacle	2010 ADAAG	MAAB 521 CMR	Type of Action to be Taken	P	F	TF	Cost Estimate
Exterior							
Parking The designated accessible parking signage is 21½" to 23½" too low. Neither space is designated as van accessible. See Photo South Union 1.	502.6	23.6	Signage s/b raised so that the bottom of the signs are at least 60" a.f.f. and the top no more than 96" a.f.f. The 9' wide space with the 9' wide access aisle closest to the accessible route of travel to the accessible entrance should be noted as van accessible.	1	2	I	\$25
Picnic Table The side picnic table is not on an accessible route of travel and does not provide adequate knee clearance and depth. See Photo South Union 2.	226.1 902	19	At least 5% or at least one table must be accessible. Purchase 1 accessible picnic table and locate on an accessible route of travel. The table surface s/b 28" to 34" a.f.f. to the top surface with at least 27" knee clearance, 30" clear width, and 19" depth.	2	2	N	\$750

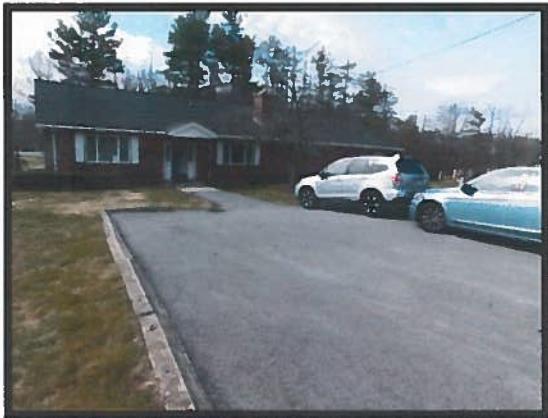
Photo Cemetery 1

General Description of Obstacle	2010 ADAAG	MAAB 521 CMR	Type of Action to be Taken	P	F	TF	Cost Estimate
Parking There is no designated accessible parking space inclusive of access aisle and signage. The designated accessible parking space must also be van accessible. See Photo Cemetery 1.	502 703.7.2	23	Stripe and designate a van accessible parking space with van accessible signage at a width of either 11' with a 5' access aisle or 8' with an 8' access aisle (2010 ADA Standards). Signage must be set such that the signage height should be a minimum of 60" high at the bottom (2010 ADAAG Standards) and a maximum of 96" at the top (MAAB 521 CMR) and located no more than 10' in front of the space.	1	3	N	Up to \$3,500

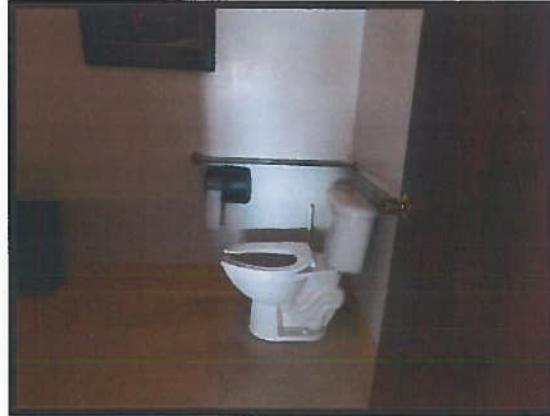
Photo Cemetery 4

The water closet flush control is on the near side and not the far or approach side.	604.6	30.7.5	Replace the water closet or the tank of the water closet with one that has a flush control on the approach or wide side.	3	3	N	\$125 to \$350
The side grab bar is 6" too short	604.5	30.8	Replace the grabs so that both are 42" in length.	3	2	N	\$700
The toilet paper dispenser is too close to the water closet.	604.7	30.7.6	Relocate the toilet paper dispenser so it is a minimum of 7" and a maximum of 9" in front of the water closet measured to the centerline of the dispenser and at least 24" a.f.f. <i>Note: There also must be at least 1½" clearance below the grab bar to the nearest object or fixture.</i>	3	2	I	\$0
The water closet is 22" o.c. to the near side wall, which is 4" too far.	604.2	30.7.2	Relocate the water closet so that it is 18" o.c. to the near side wall.	3	3	N	Up to \$500
See Photo Cemetery 4.							Total \$11,970+

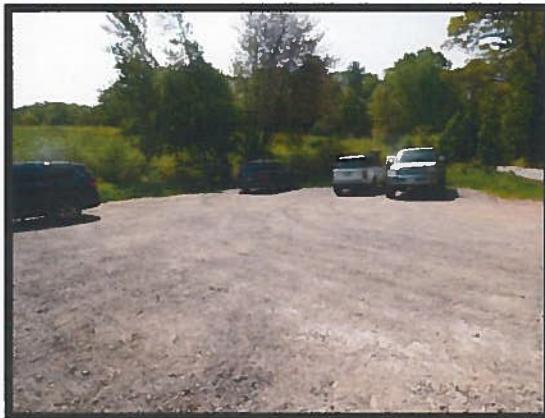
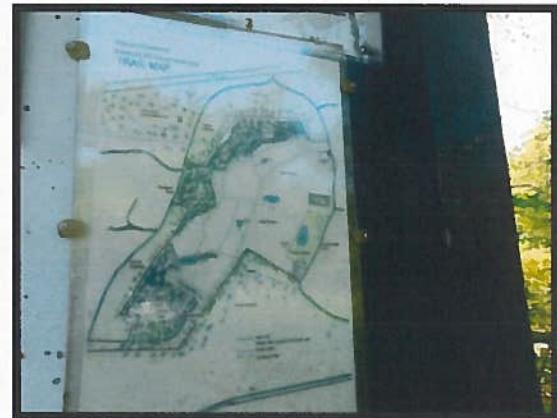
Trails. There are roughly 3 miles of trails on the site, but none are formally maintained to a standard that would be considered to be an accessible route of travel. The parking for the facility is an unimproved compacted stone dust surface. No signage or striping is provided.

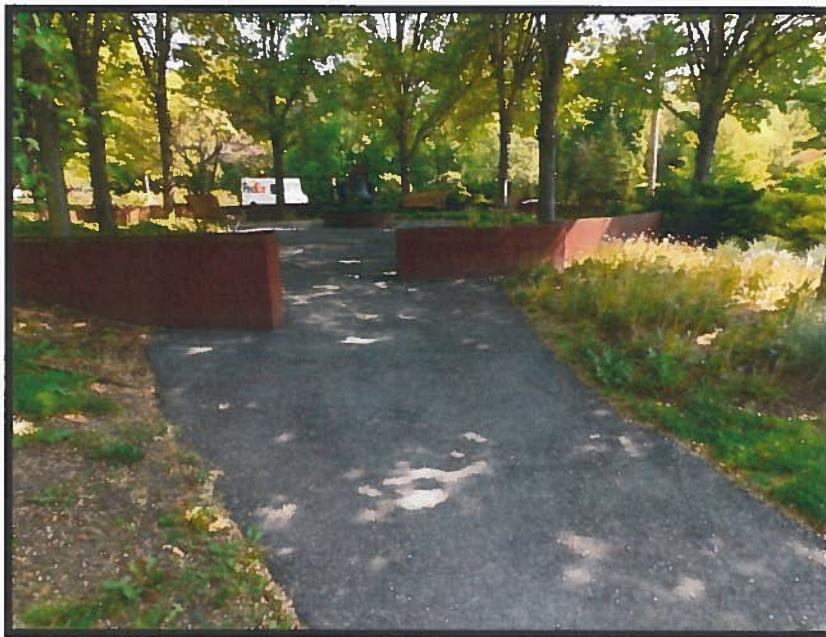
Photo Triangle Park 1

General Description or Obstacle Which Limits Mobility or Access: A section of the paved accessible route in the northern end of the park has significant sinking creating a 6+ inch change in level surface and a running slope of up to 27.8%. A roughly 6 foot segment of the walkway from Southville Road has a running slope that varies up to 6.6%.

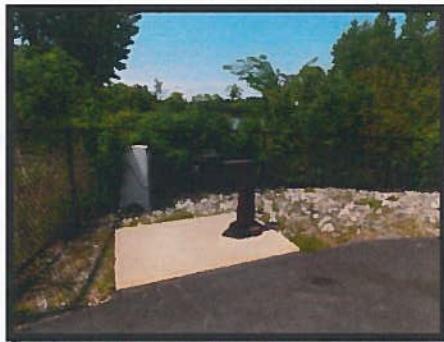
Photo Fayville 1

Drinking Fountain The drinking fountain is not "high-low". See Photo Fayville 1.	211 602	36	Option #1: Discontinue the use of the drinking fountain and place out of service. Option #2: Remove the existing drinking fountain and replace with a "high-low" drinking fountain or add a "high fountain". The drinking fountain must comply as follows: Protruding objects compliance of no > 4" protrusion between 27" and 80" a.f.f. (307); 30"x48" clear space requirement (305), and knee/toe clearance (306). Knee clearance is 9" to 27" a.f.f; 25" deep max. at 9" a.f.f. or 11" deep min at 9" a.f.f. and 8" deep min at 27" a.f.f. Width of knee clearance s/b 30" wide min (306.3). Toe clearance as part of c.f.s. 17" min – 25" max, 9" high a.f.f., 30" wide (306.2). The spout s/b 5" max from the front edge of the unit (602.5). Flow of water 4" high min and spout located max 5" from front (602.6). The spout height s/b 36" max. a.f.f. for "low" and 38" min a.f.f. to 43" max a.f.f. for "high". The controls s/b operable w/one fist; no > 5 lbs force (309.4).	2	3	L	Up to \$1,500

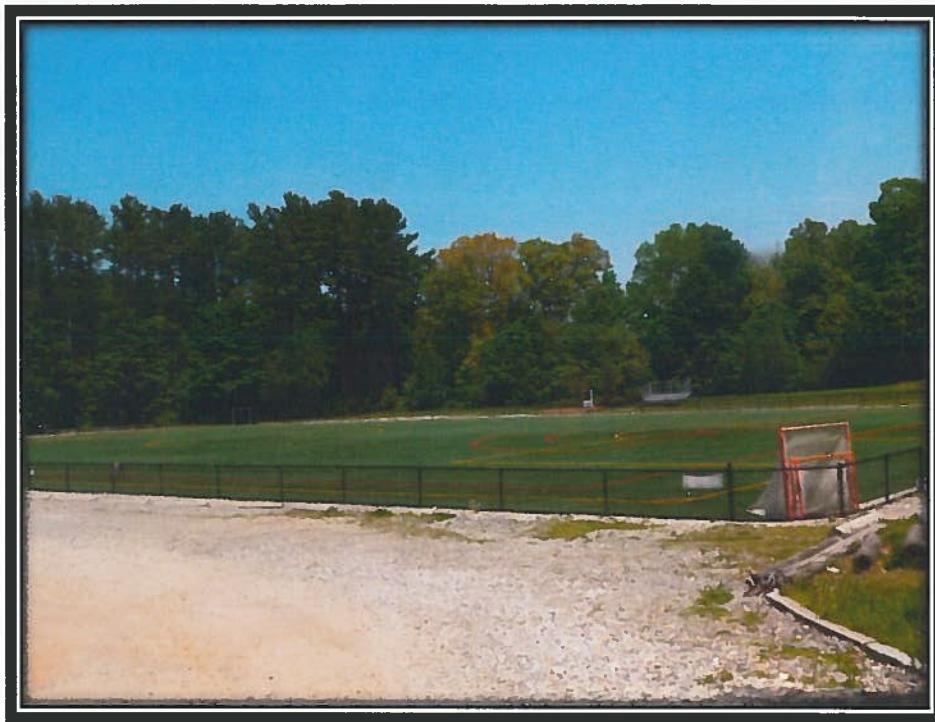
General Description or Obstacle Which Limits Mobility or Access: The surface of the designated accessible parking is a mixture of gravel, stone, and stone dust. The parking lacks striping. There is an abrupt change in level surface from the parking to the stone dust walkway to the bleacher and memorial area. The existing stone dust walkway is overgrown and does not fully extend beyond the bleachers or the memorial. There is no accessible route of travel from the parking to the field. The chain link gate to the field is locked and is not flush at the base. The portable toilet is not an accessible route of travel and is not fully "ADA compliant".

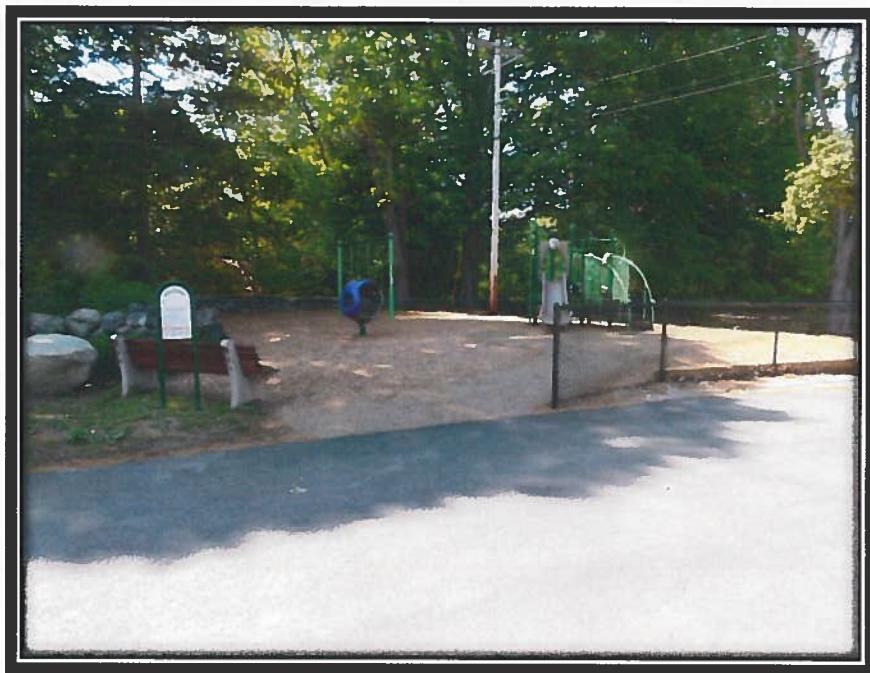
General Description or Obstacle Which Limits Mobility or Access: Although there is accessible parking adjacent to the Historical Museum building, there is no designated accessible parking and signage for the playground area. There is a paved rubberized accessible route into the playground area and to the larger playscape, however, no accessible route of travel exists fully around the playground area or to the remainder of the play equipment or bench. Non-compliant wood chips are the primary surface throughout the playground. There is no level area for a wheelchair next to the bench. The picnic table is not accessible. The running slope of the rubberized accessible route from the asphalt to the playground interior has a running slope of up to 8.8%. Depending on the location of the accessible route around the perimeter of the playground, the telephone "guy wires" could prove to be a protruding object as headroom is reduced due to the placement of the wires. The playground equipment is minimally compliant and at a minimum an accessible swing should be provided.

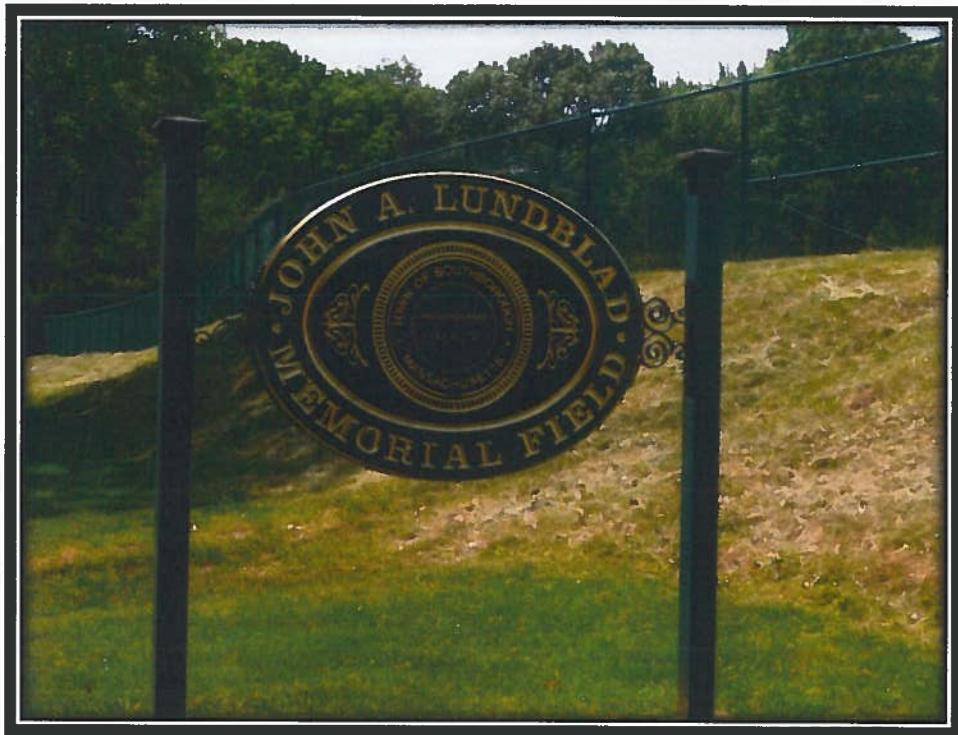
General Description or Obstacle Which Limits Mobility or Access: The facility has 2 designated accessible parking spaces in a "pull-off" area on Parkersville Road. The spaces are parallel to the road and lack access aisles. The signage for the spaces are too high. A drinking fountain near the parking is "low" only. Roughly 50' of the walkway has running slopes of 5% to 7.6%, which exceeds that allowed without railings and also exceeds the maximum 30' length of a ramp without a level landing. The clear width of the walkway is reduced to 24" in areas, which is less than the minimum required 36", due to excessive vegetative growth. There is no accessible route to and around the field.

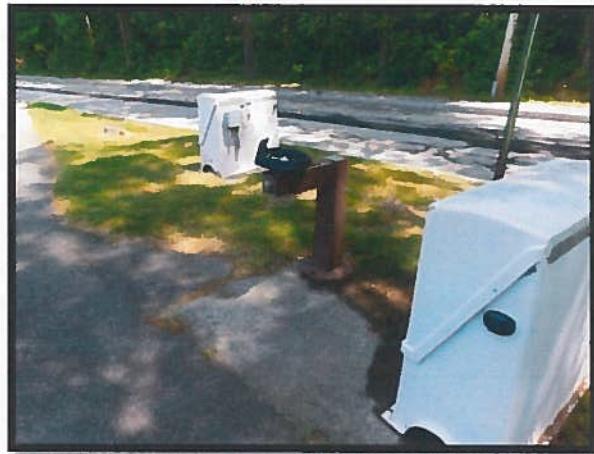
Photo Lunblad 2

Drinking Fountain The drinking fountain near the sidewalk and parking area is not "high-low". See Photo Lunblad 2.	211 602	36	<p>Option #1: Discontinue the use of the drinking fountain and place out of service.</p> <p>Option #2: Remove the existing drinking fountain and replace with a "high-low" drinking fountain or add a "high fountain". The drinking fountain must comply as follows:</p> <p>Protruding objects compliance of no > 4" protrusion between 27" and 80" a.f.f. (307); 30"x48" clear space requirement (305), and knee/toe clearance (306). Knee clearance is 9" to 27" a.f.f.; 25" deep max. at 9" a.f.f. or 11" deep min at 9" a.f.f. and 8" deep min at 27" a.f.f. Width of knee clearance s/b 30" wide min (306.3). Toe clearance as part of c.f.s. 17" min – 25" max, 9" high a.f.f., 30" wide (306.2). The spout s/b 5" max from the front edge of the unit (602.5). Flow of water 4" high min and spout located max 5" from front (602.6). The spout height s/b 36" max. a.f.f. for "low" and 38" min a.f.f. to 43" max a.f.f. for "high". The controls s/b operable w/one fist; no > 5 lbs force (309.4).</p>	2	3	L	Up to \$1,500

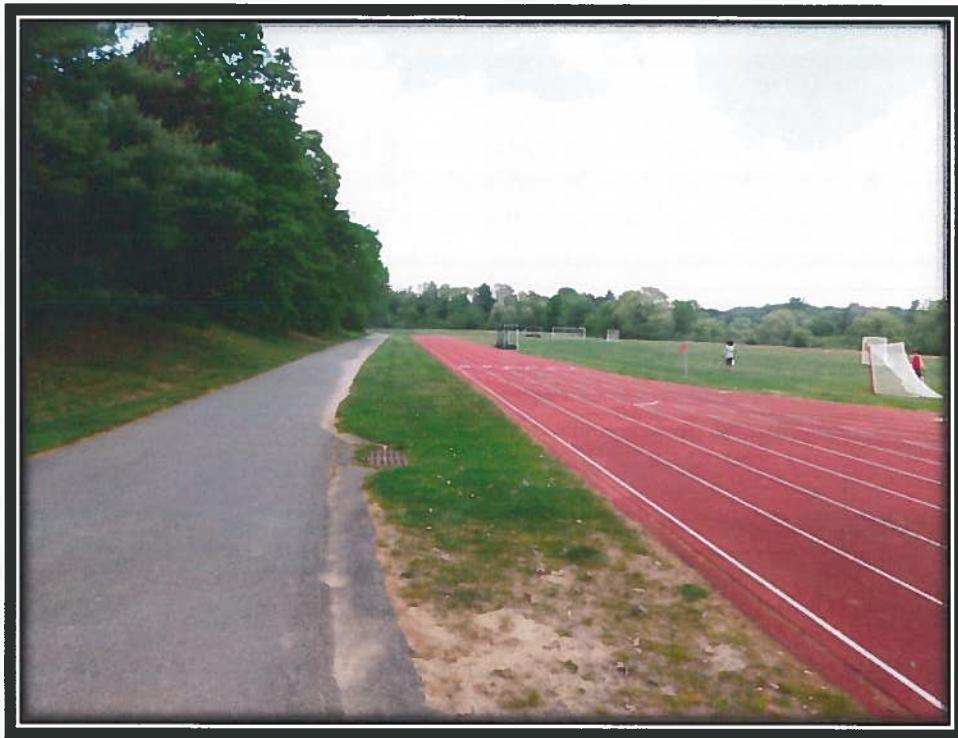
General Description or Obstacle Which Limits Mobility or Access: The curb ramps on the accessible route of travel from the school to the field and from the parking to the school lack detectable warning strips, have excessive running slopes, and abrupt changes in level surface. The portable accessible toilet is not on an accessible route of travel and is not fully "ADA" compliant. The approach to the gated entrance to the field has excessive running slopes due to sunken asphalt. The gate is not flush at the base. The drinking fountain is not "high-low". Assuming use of the outer track area as an accessible route around part of the track, there still needs to be an accessible route to the track.

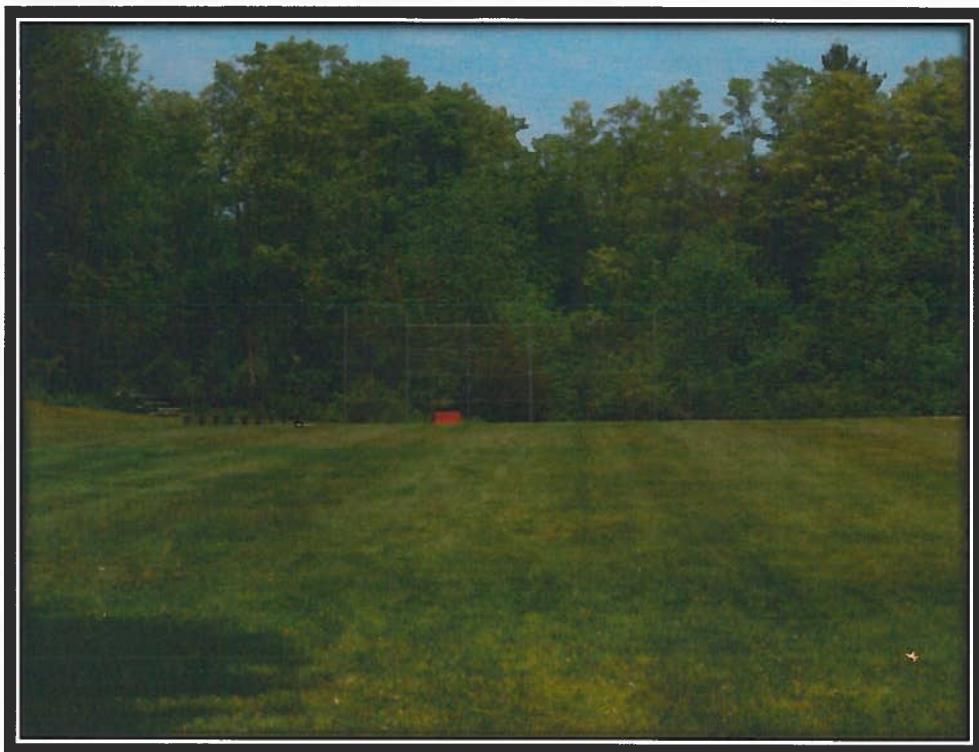
General Description or Obstacle Which Limits Mobility or Access: There is a paved accessible route to the edge of the softball field area. The paved accessible route is heaving and has numerous abrupt changes in level surface. There is no accessible route to the playing area itself and the player benches. The gate is not flush at the base.

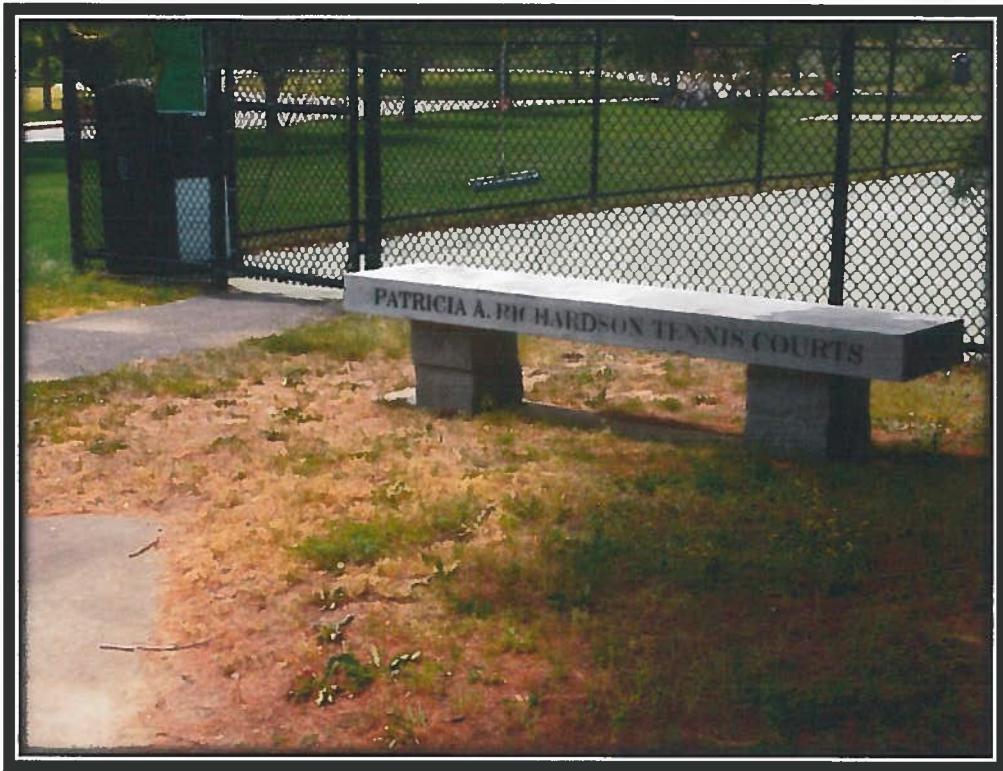
General Description or Obstacle Which Limits Mobility or Access: There is no designated accessible parking. The gate is not flush at the base and the latch is too high. The portable accessible toilet is not "ADA" compliant and is positioned in a manner on the asphalt making it difficult to access without going onto the adjacent grassed area.

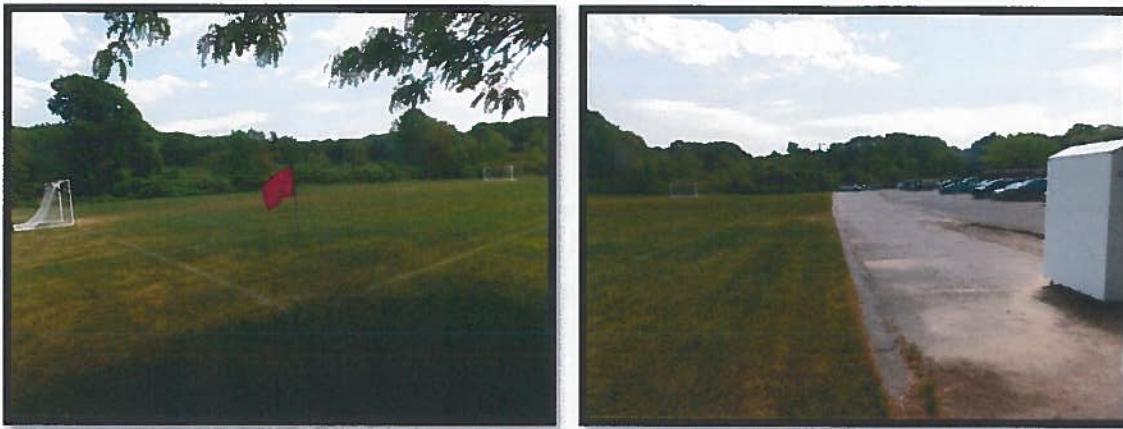
General Description or Obstacle Which Limits Mobility or Access: There is no designated accessible parking. There is no accessible route of travel to and around the field.

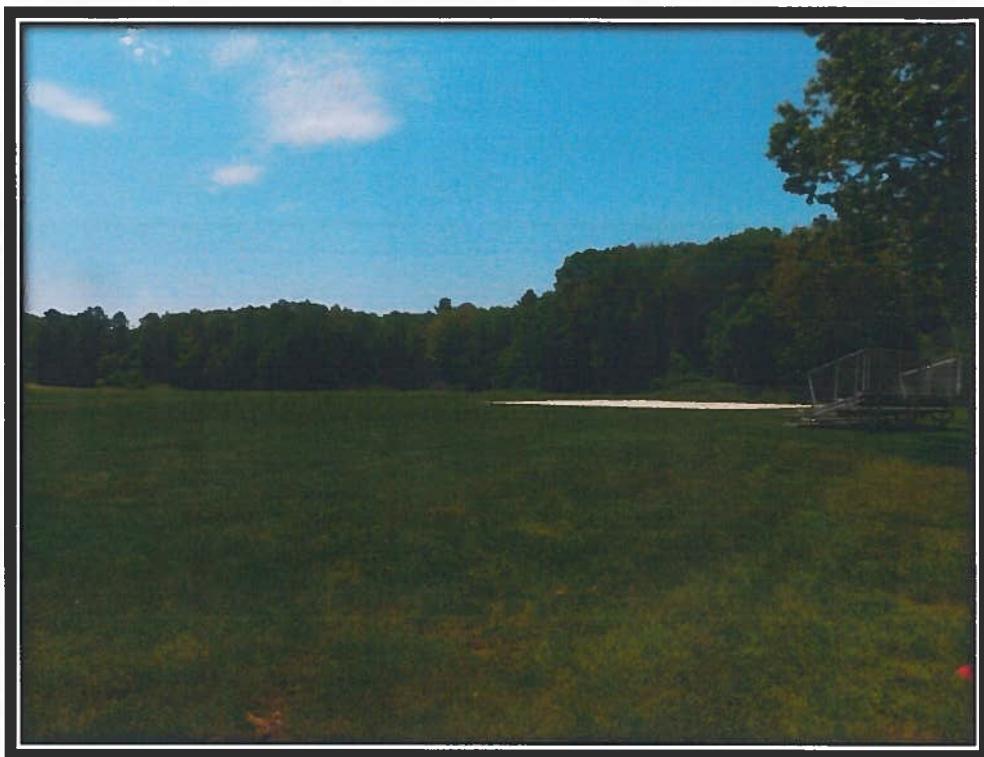
General Description or Obstacle Which Limits Mobility or Access: There is no accessible route of travel to and around the fields, bleachers, and benches. There are no level areas for wheelchairs adjacent to the spectator bleacher and bench seating. The portable toilet is not accessible.

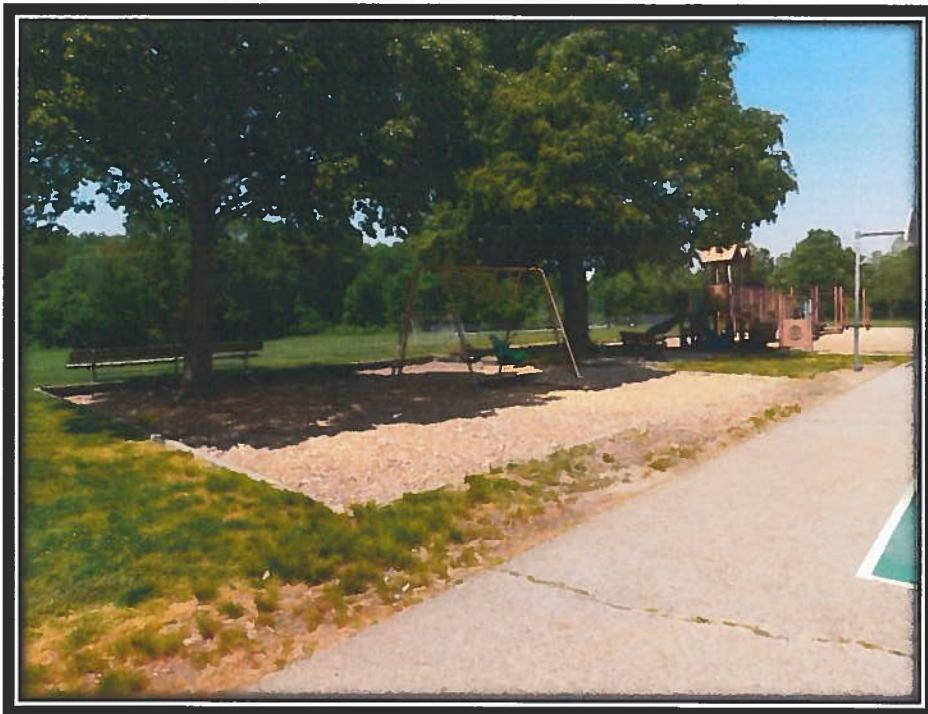
General Description or Obstacle Which Limits Mobility or Access: There is a paved rubberized accessible route into the playground area to the larger playscape and to the accessible swing, however, no accessible route of travel exists fully around the playground area or to the remainder of the play equipment. Non-compliant wood chips are the primary surface throughout the playground. There is no level area for a wheelchair next to the bench as the cross slopes exceed 2.0%. The accessible route to both the accessible swing and larger playscape also have cross slopes that exceed 2.0%. The nearby drinking fountain is not a "high-low" fountain. The playground equipment is moderately accessible.

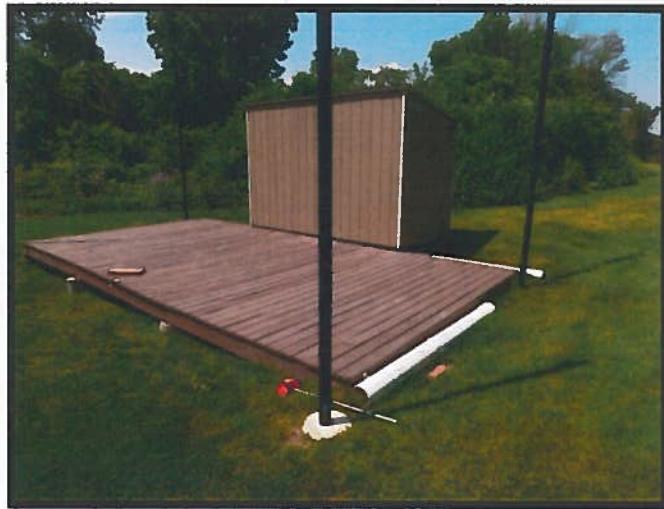
Photo Volleyball 1

General Description or Obstacle Which Limits Mobility or Access: There is no accessible route of travel to and around the volleyball area, picnic table and performance stage. There is a 6" abrupt change in level surface from the ground to the performance stage. The picnic table lacks sufficient clear width for a wheelchair.

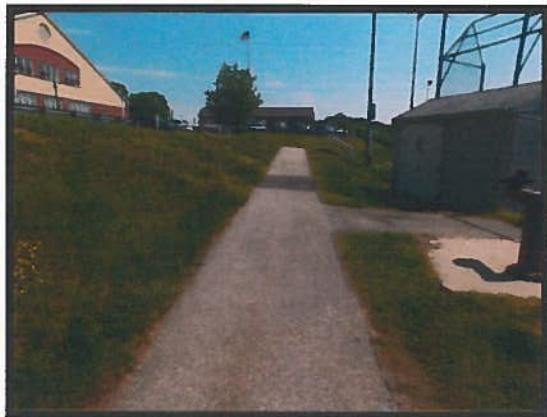
Photo Woodward 1

General Description or Obstacle Which Limits Mobility or Access: Based on the # of spaces in the parking lot, an additional accessible parking space is required. Signage for the existing spaces is too high. Neither of the 2 spaces are designated as van accessible. The drinking fountain is not "high-low". The sloped accessible route of travel from the school to the fields has areas of heaving, abrupt changes in level surface, and a segment with running slopes in excess of 5.0%. The portable accessible toilet is not "ADA" compliant. There is no accessible route of travel to and around the field area and to player benches.

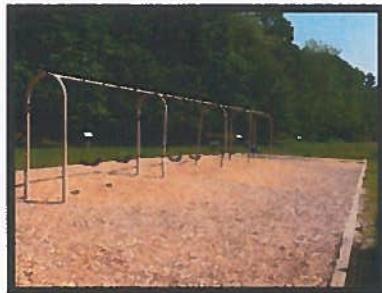
Photo Playground 1

General Description or Obstacle Which Limits Mobility or Access: There is no accessible route of travel to the picnic table and the table lacks sufficient clear width. The benches are located in different areas around the playground but only one is on an accessible route. The initial 10' of the asphalt walkway to the playground from the school has running slopes of up to 7.4%. In addition, vegetative overgrowth along the walkway restricts the clear width to 30" or less in areas. No accessible route of travel exists fully around the playground area or to the play equipment and components. An abrupt change in level surface of 1" results from the interior of the playground due to the wood edging. Non-compliant wood chips are the primary surface throughout the playground.

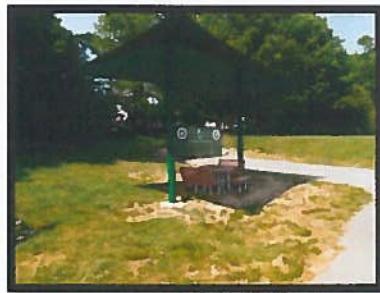
Photo Playground 3

See Photos Playground 1, 2, and 3.							
Picnic Table The picnic table has only 11" of clear width and is not on an accessible route of travel.	226.1 902 403	19 22	At least 5% or at least one table must be accessible at each separate location. Replace the existing picnic table with one that is fully accessible. The table surface s/b 28" to 34" a.f.f. to the top surface with at least 27" knee clearance, 30" clear width, and 19" depth.	2	2	I	\$750
See Photo Playground 3.

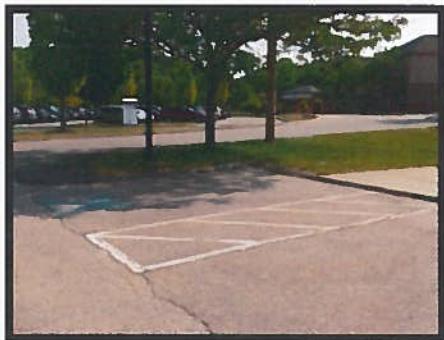
Photo Finn-Mooney 1

General Description or Obstacle Which Limits Mobility or Access: The 2 designated accessible parking spaces lack signage. Neither space is designated as van accessible. The portable toilet is not fully "ADA compliant" and is not on an accessible route of travel. There are no accessible routes of travel to and around the ball fields, pitching/batting cages, soccer field, bleachers, concession stand, broadcast booth, and other amenities. The paved accessible route of travel to the tennis courts has running slopes that vary between 5.0% and 6.0% with no railings. There are abrupt changes in level surface to access baseball dugouts. Both the broadcast booth and concession stand have knob-style hardware and excessive abrupt changes in level surface into the buildings. The concession stand counter is too high. None of the picnic tables in the concession stand area or in the fields are accessible. Chain link gates throughout are not flush at the base and have latches that are too high. Bleacher seating throughout lack level spaces for wheelchairs.

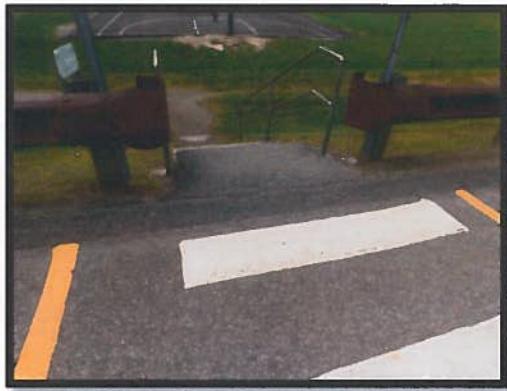
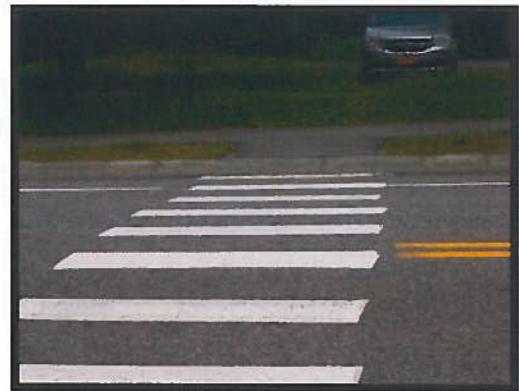
Sidewalk and Curb Ramp Obstructions

- Crosswalks/curb ramps across Central Street from the parking lot to the Fayville Recreation Area have abrupt changes in level surface of 3" on the field side and 6" on the parking lot side

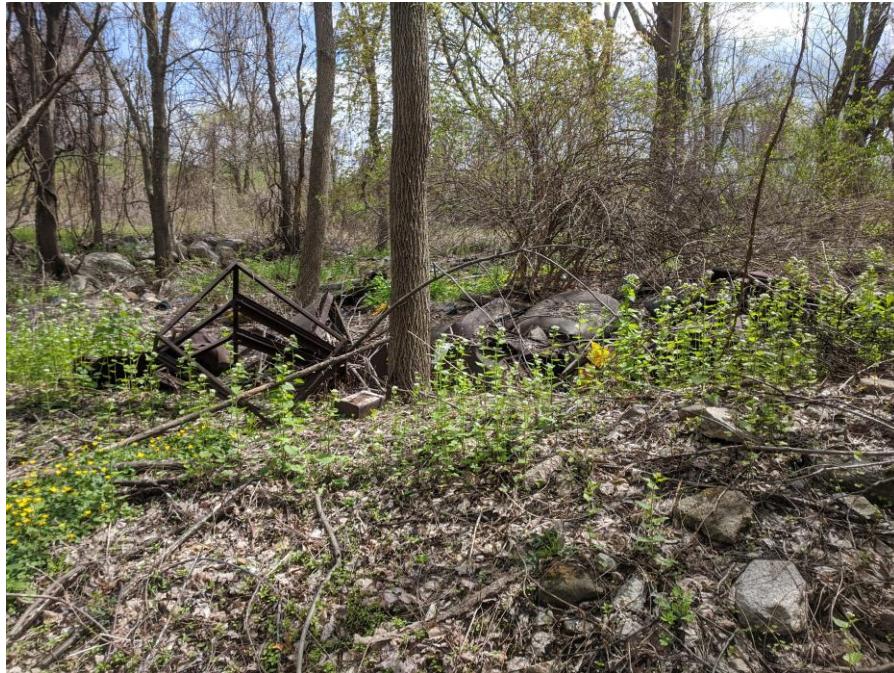
Photograph 7: Debris within wetland resource area Buffer Zone.

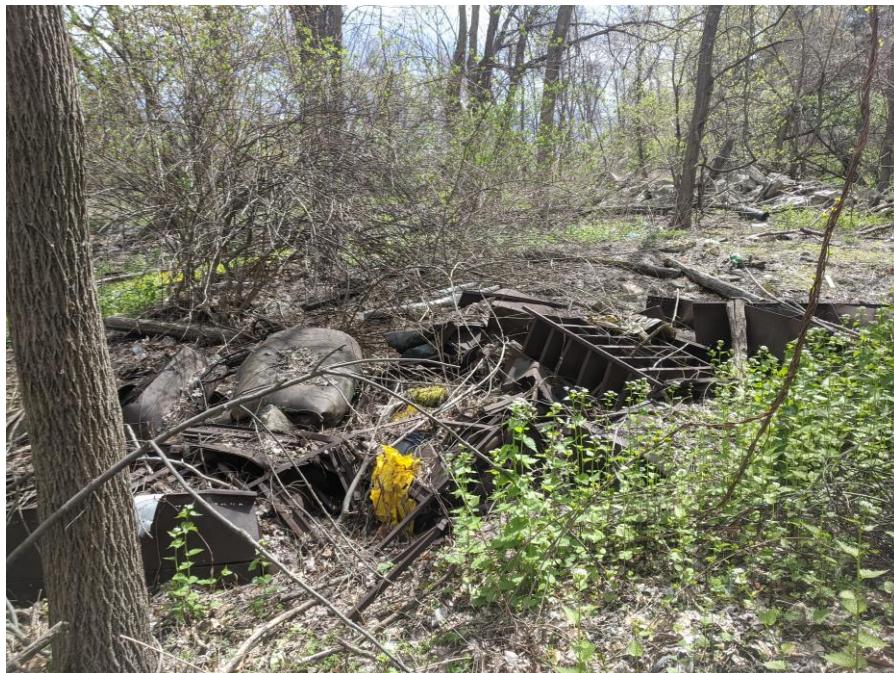
Photograph 8: Debris within wetland resource area Buffer Zone.

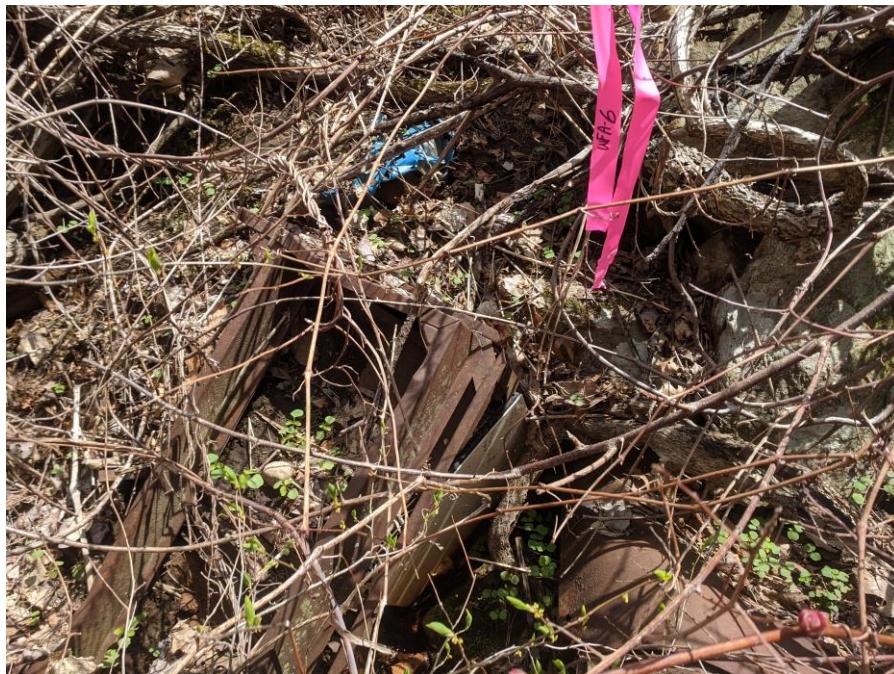
Photograph 9: Debris within wetland resource area (Bank).

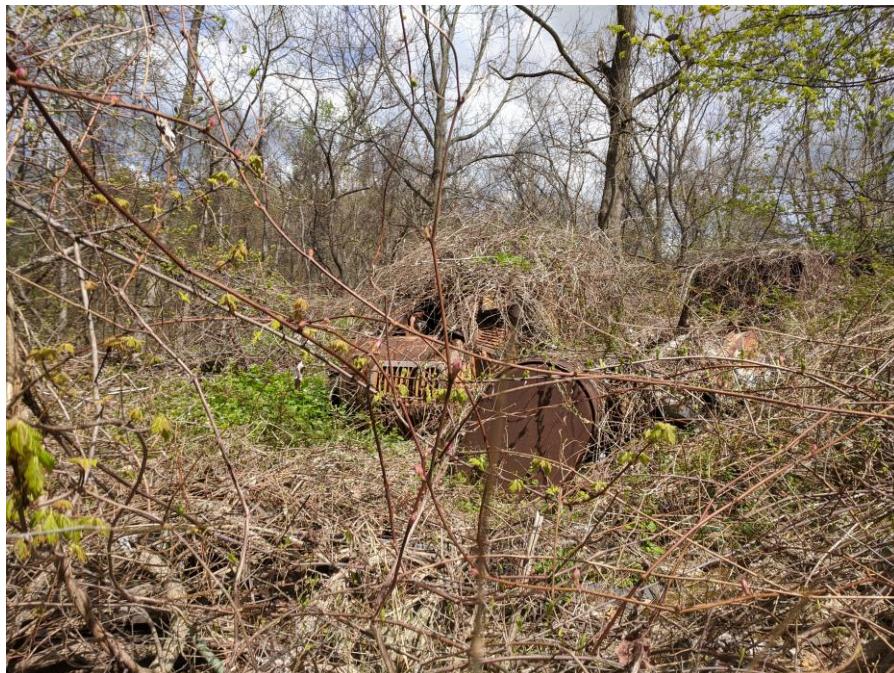
Photograph 10: Debris within wetland resource area Buffer Zone.

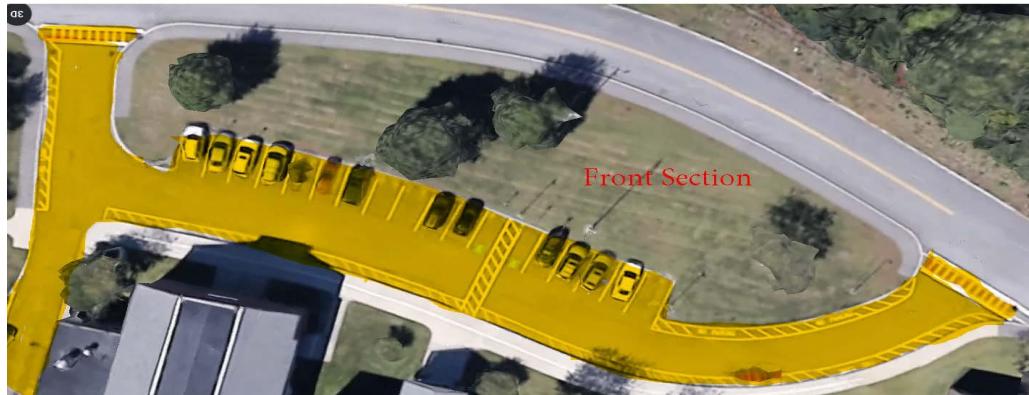
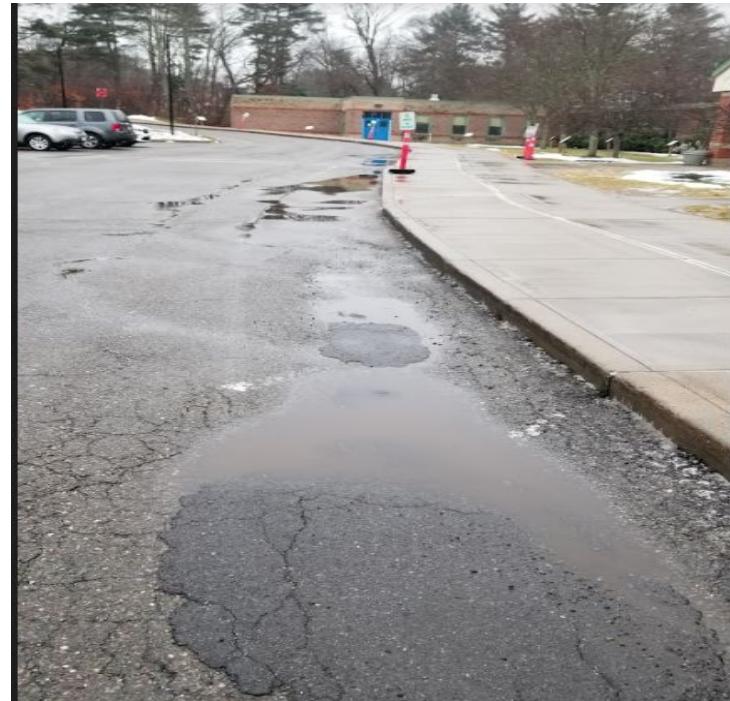
Front Section - Approximately 15,000 square feet

- The parking lot, play areas, and walking path were part of the renovation project in 1998.
- The asphalt areas have been maintained and patched several times.
 - DPW has supported repair work - including potholes and crack sealing.
- The current asphalt is failing around the building:
 - Front Section- failure caused by high car, van, and bus traffic that has compromised the surface.
 - Rear Section- typical cracking has impacted many areas.
- We are researching options to stabilize the front travel lane to support high level of traffic and heavy vehicles (vans/buses).
