## **FLAGG ROAD TREE EVALUATION REPORT**

**TOWN OF SOUTHBOROUGH, MA**

**John T Campanini, Jr., Consulting Arborist**

**September 2020**

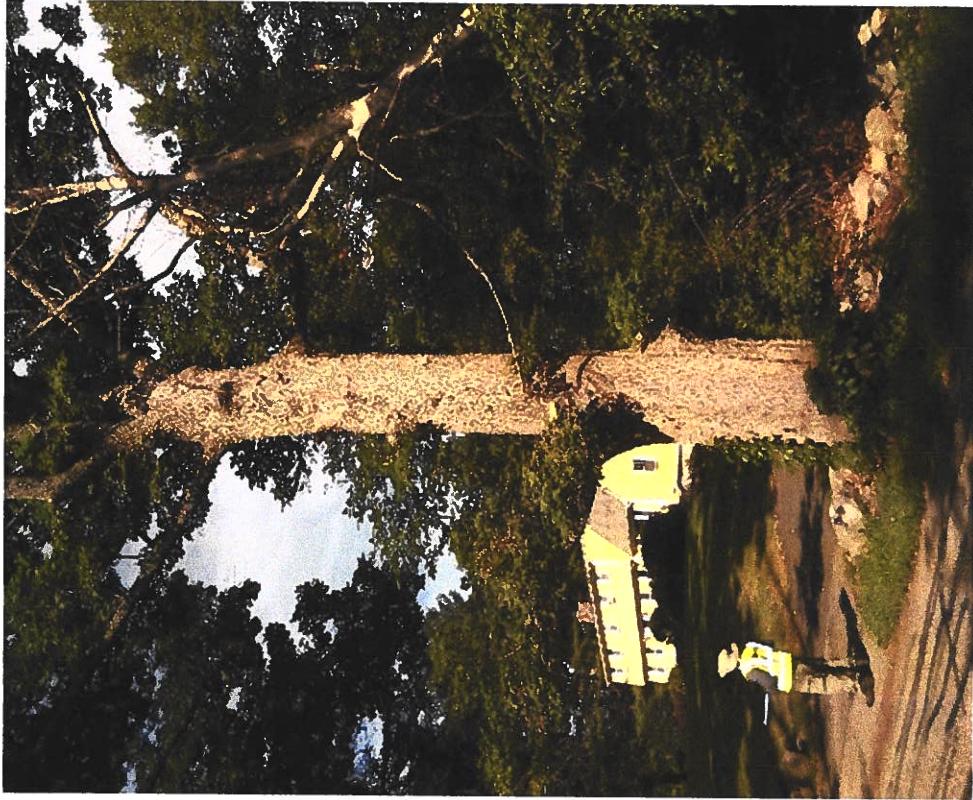
5 Flagg Road (42.297907 x -71.545856)

Comments: This White Ash (east side of road in photo) exhibits several major structural defects. The worse is the loss of nearly 20% of the tree's upper crown. Many stubs exist, showing where the missing branches once stood. There are also cavities and wood decay at the top of the trunk where the crown is broken. The Ash is structural unsound and unsafe. Should the tree fail completely (i.e., at the trunk base), the potential tree fall zone is 2,250 feet. Major at risk targets include the roadway, wall, landscaping and utility transmission wires.
